Rockfall hazard assessment based on semi-automatic point cloud analysis from UAV data

Karin Bergbjørn

Master's thesis in geology GEO-3900 - December 2018

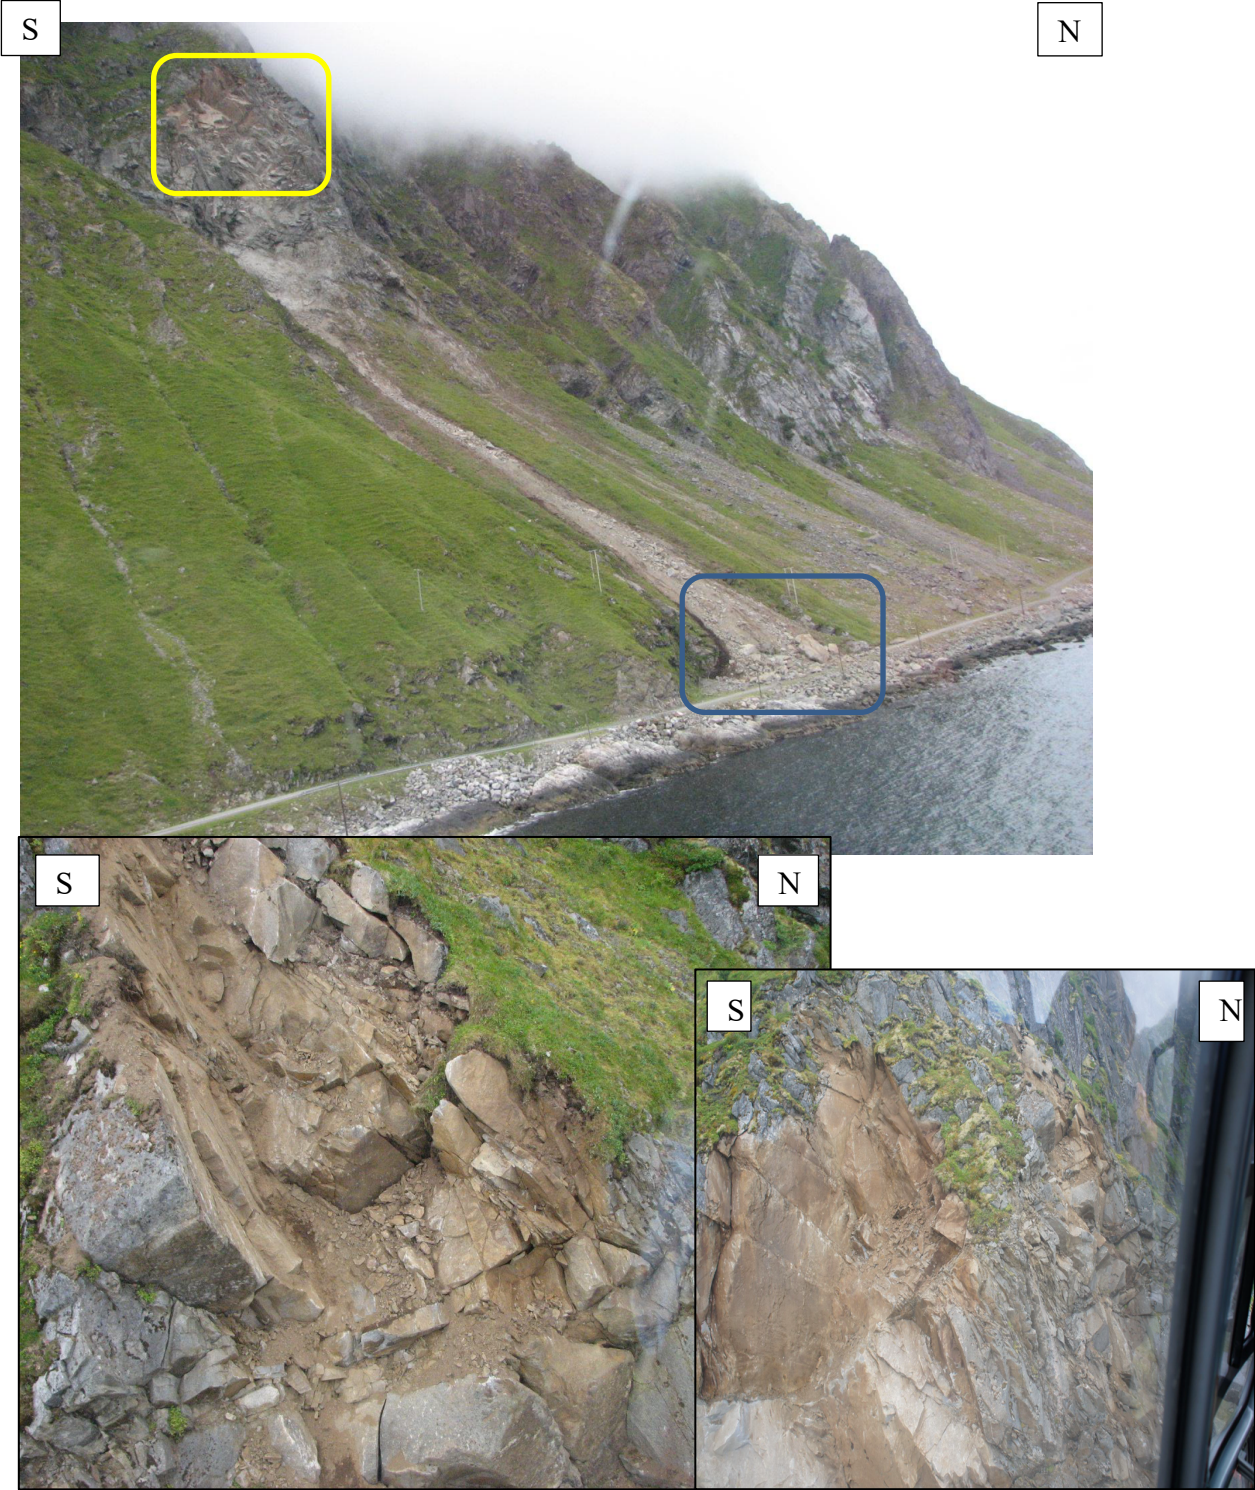
In 2011 there were two events following major rainfall, 19th of July a large rockfall of 70-100 m^3 reached the road, and a couple of days later on the 25th of July a rock avalanche of 2000 m^3 closed the road (Fig. 18 and 19). After the rock avalanche in 2011 the source area was flushed with water from helicopter (Kvalvågnes, 2011), which cleared 100 m^3 of rock masses. In November 2017 there weren't any unusual amount of precipitation but 16-25th November 2017 a rock avalanche of 3000 m^3 from the same source closed the road (Fig. 20). After the incident the road has been recommended to be closed in wintertime when

Fig. 18 Pictures taken from helicopter after the rock avalanche in 2011, showing the release area (yellow), and avalanche path and deposit (blue). Visible joint sets and more loose blocks underneath a thin layer of soil. Picture taken by Persson, SVV, 2011

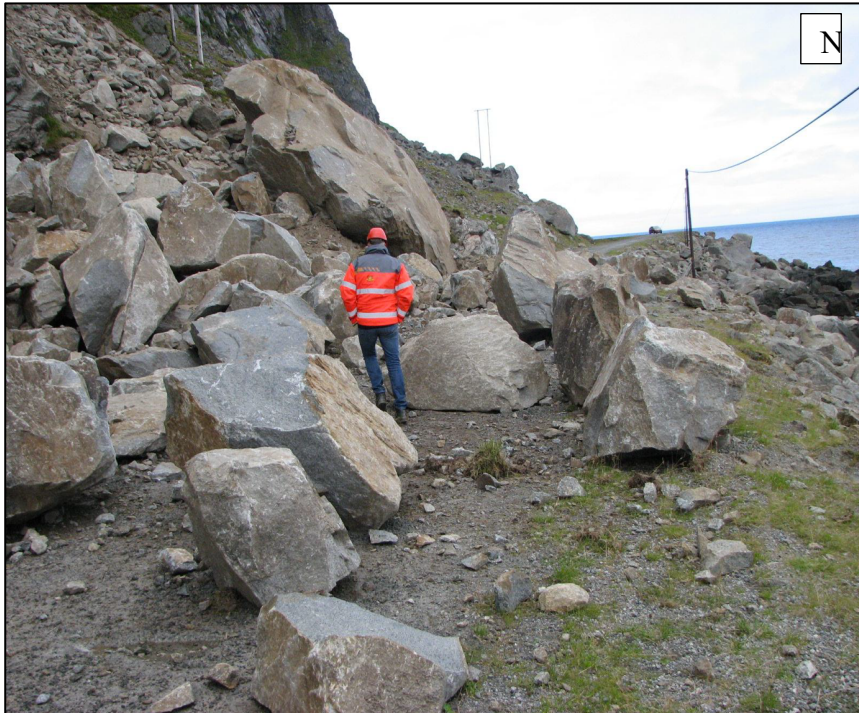
Fig. 19 Debris on the road, after the rock avalanche in 2011. The large boulder in front of the man is still in place, keeping the talus slope stable. Picture by Persson, SVV, 2011

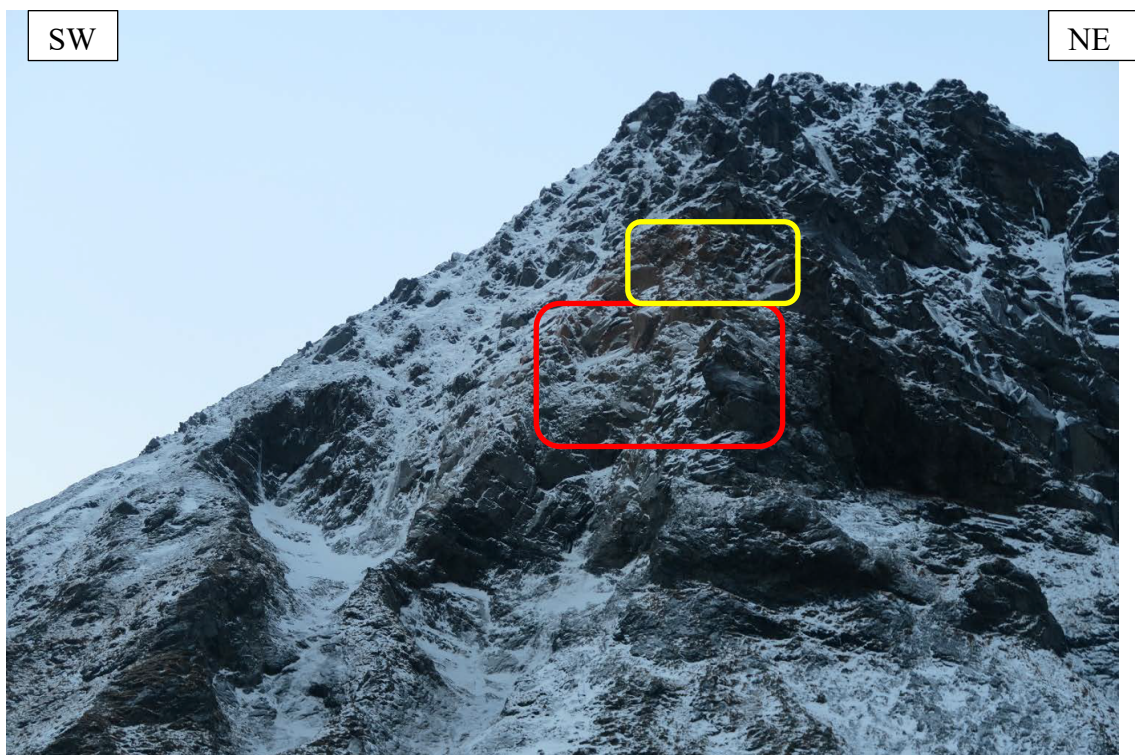
Fig. 20 Release area after the rock avalanche in 2017. The release area in 2011 is marked in yellow, and the fresh from 2017, in red. Picture by Aronsen, SVV, 2017

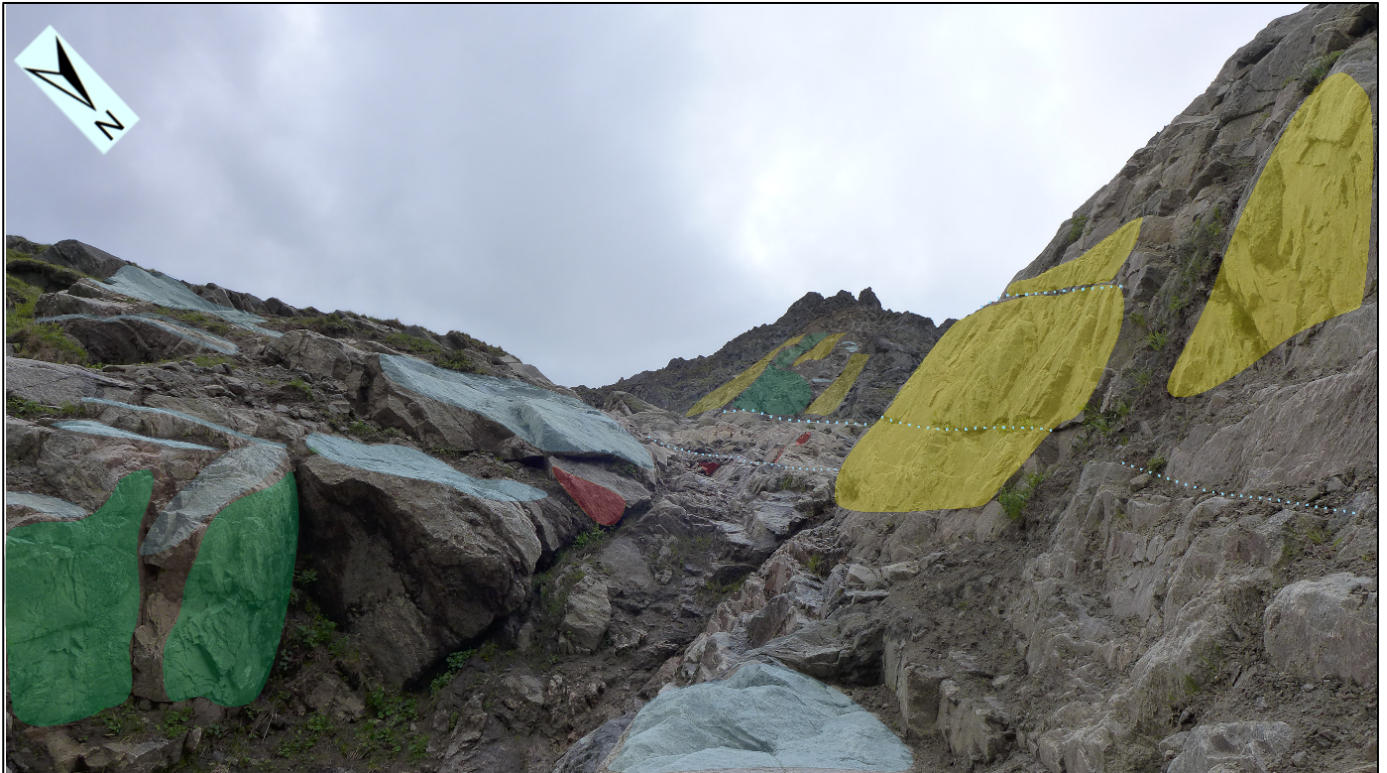
Fig. 41 Outcrop 1.b looking up towards the source area. Yellow surfaces are the steep north-south striking planes of J1, blue J2, green J3, and red the foliation. Dotted lines show joint sets of J2. From location 1.2 the source area 2011/17 and surfaces are easily identified and comparable.

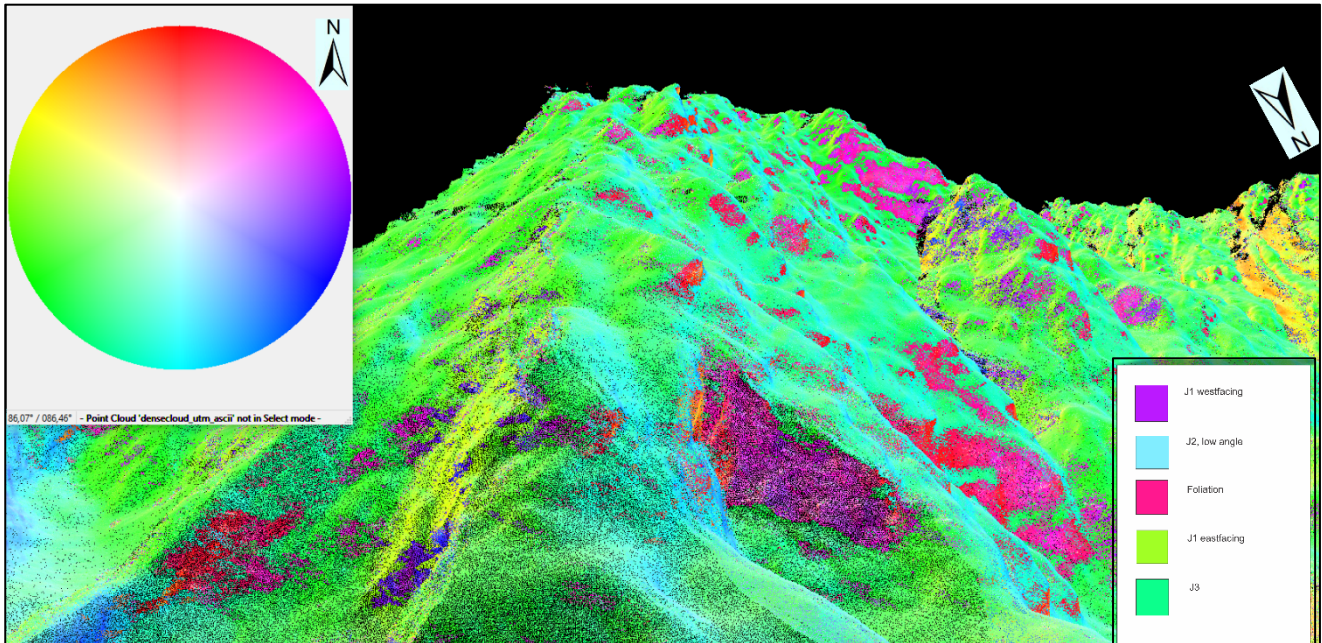
Fig. 55 Close up of release area of the rock avalanche on the southern part of the wall (dihedral left in picture). The large areas of overhanging foliation dipping to SSW are clearly seen in the lower part of the face, at the same height as the overhanging area (blue) in the opposite wall. The NE facing (green) surfaces is interrupted by fractures/joints from the low angle N facing structures (light blue). This image also visualizes well the many pillars that the slope consists of.

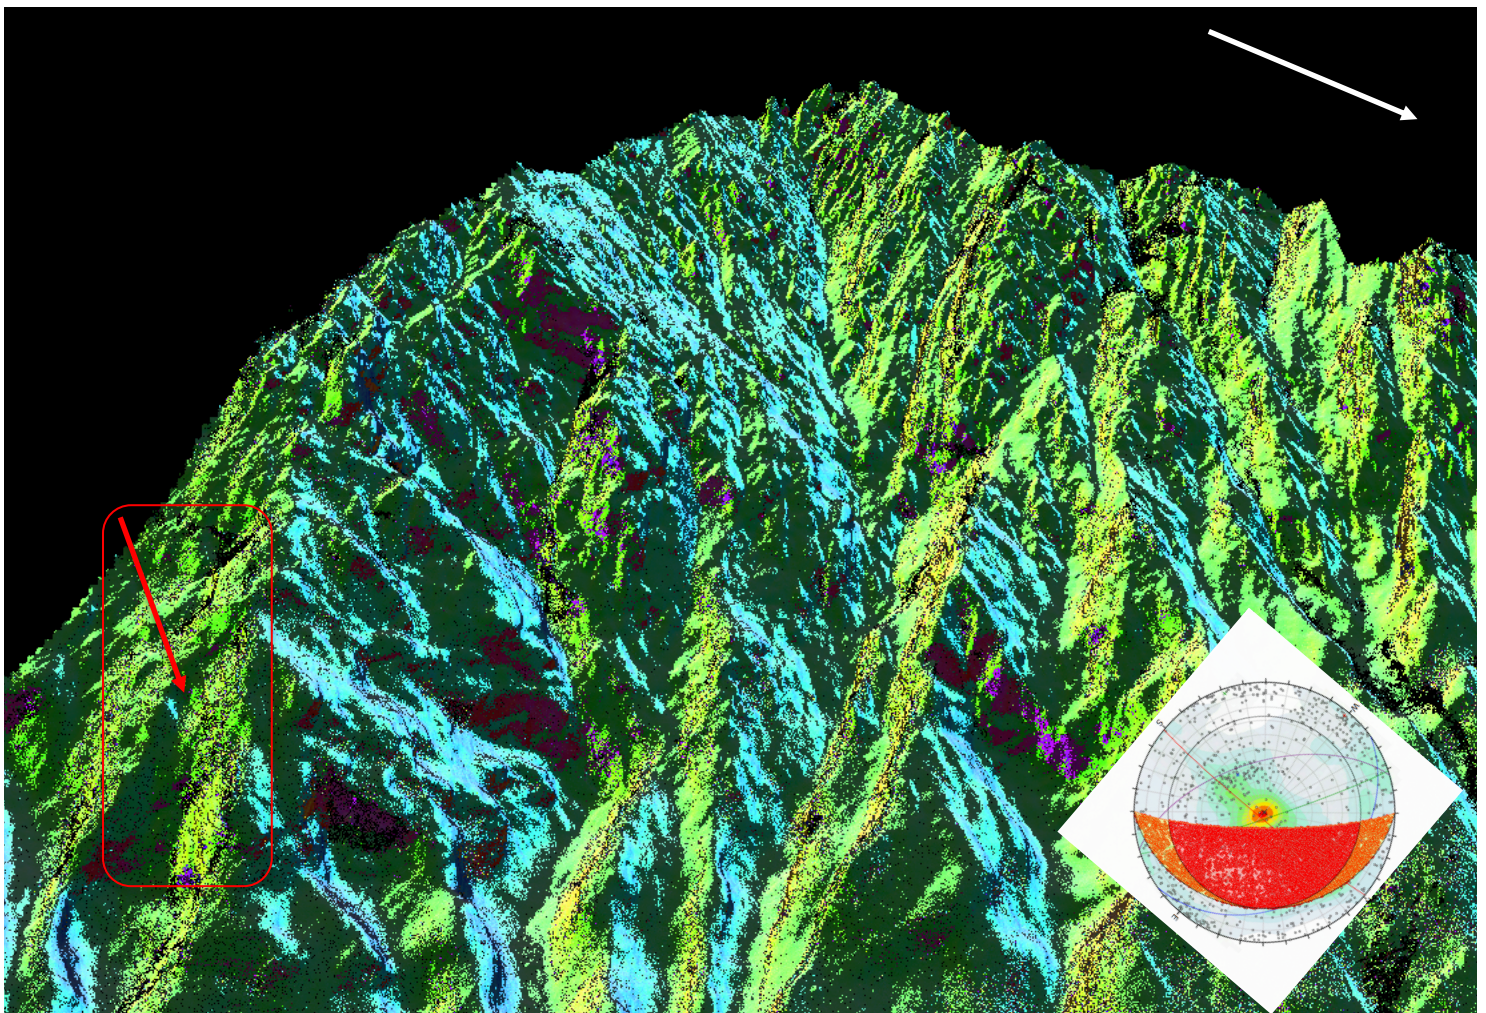
Fig. 61 Model in Coltop3D has highlighted the critical joint sets J1 and J2 for wedge failure. J1 is highlighted in a yellow/green color, J2 as light blue. Red rectangle indicates the 2011/17 release area. Red arrow indicates a dihedral that is created due to the intersecting of J1 and J3 (not highlighted). The joint sets of J2 is traced through J1 and also present in the opposing wall. Kinematic analysis rotated to fit the slope direction.

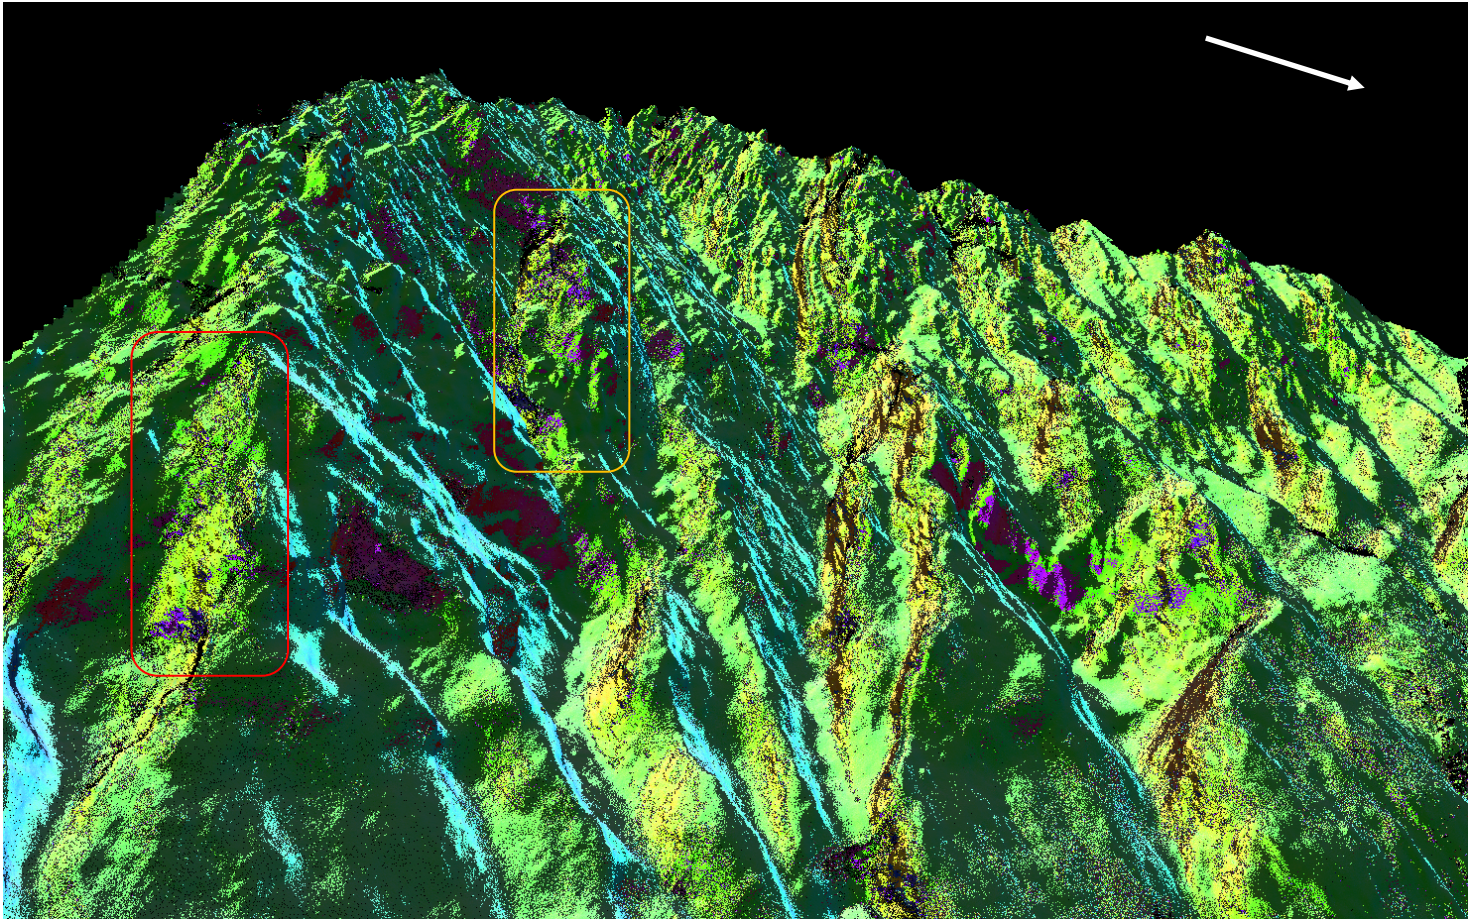
Fig. 62 The source area is within the red box. This image visualizes well how J2 (light-blue) splits J1 (green/yellow). The two joint sets interact and creates the structure of the ridge above the release area and isolates independent blocks and small pillars. The large pillar in the middle of the image (orange box) is also isolated by J2.

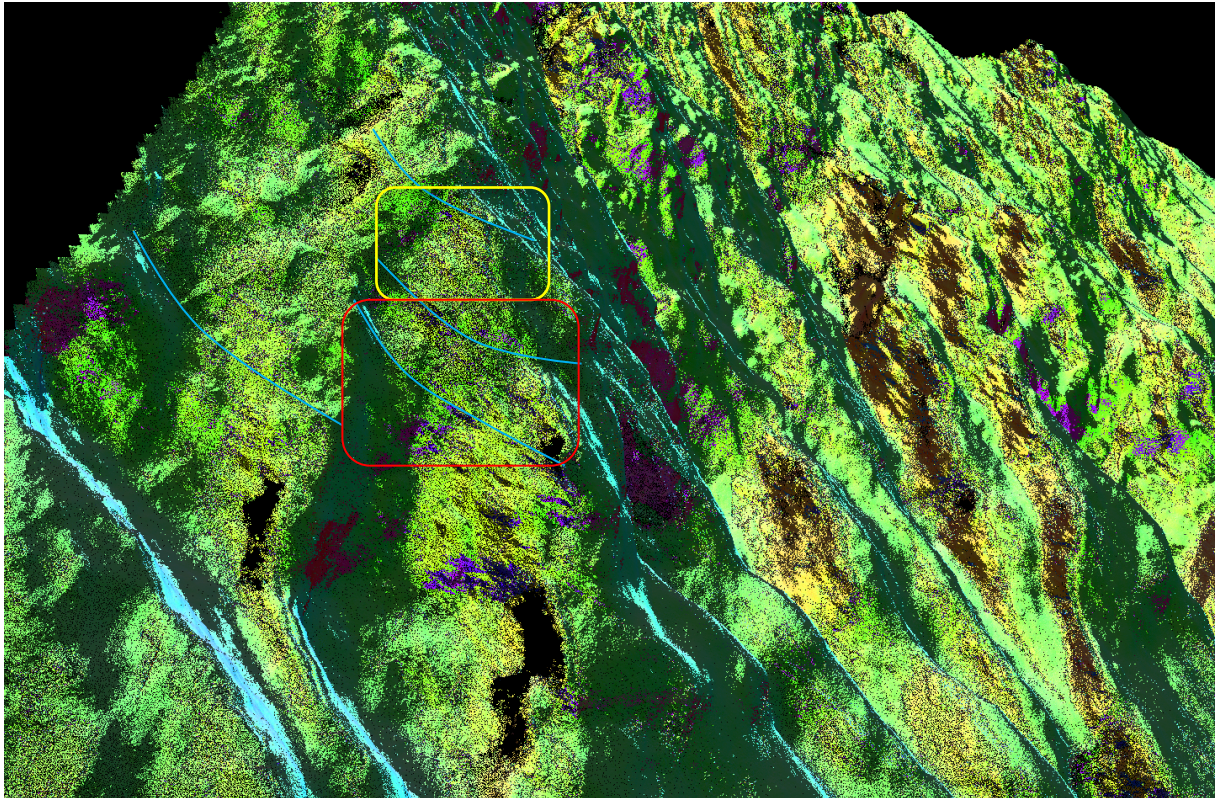
Fig. 63 View from east and a close-up of the dihedral in the release area (yellow box=2011, red box=2017). Blue lines tracing N dipping J2 joints, traceable in both opposing walls. The J2 joints intersects J1 E facing surfaces and are visible in other structures as well, as the non-highlighted N facing J3. Violet indicates a steep W facing variation (overhanging structures) of J1.

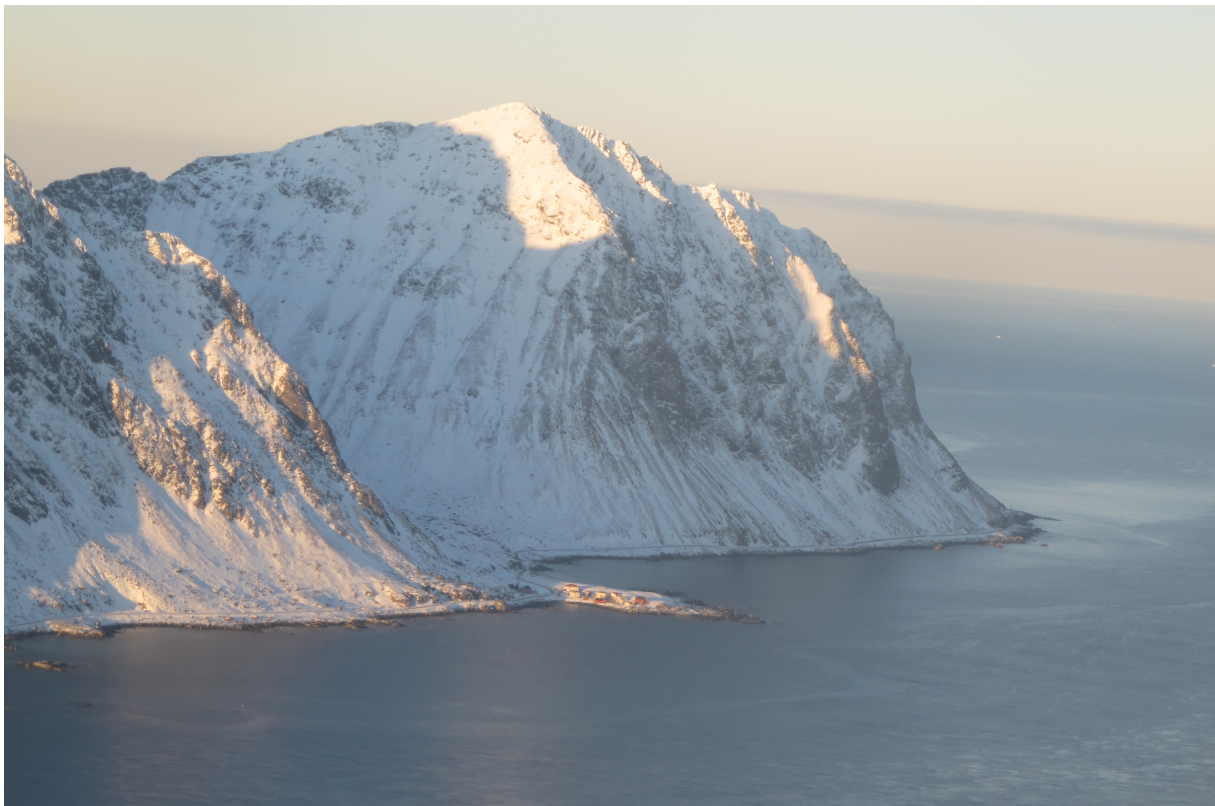
Fig. 63 Photo of Slettind (in the middle of the picture), taken from helicopter by Viggo Aronsen in 2013. Note the steep colluvial fans, short run-out zone without ease in slope, and how there is little deposition on the slope below the rockwall
