Structural assessment and characterization of the unstable rock slopes at Mellomfjellet, Nordreisa

GEO-3900 Master's thesis in Geology

May 2019

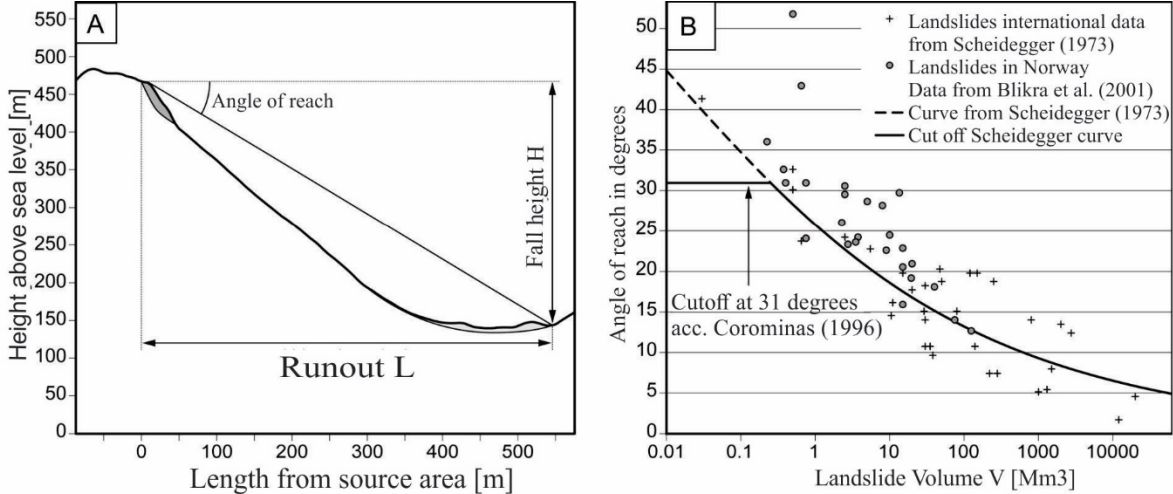
Figure 12 A – Angle of reach. B – Scheidegger curve along with data from Blikra et al. (2001). Obtained from Oppikofer et al. (2016)

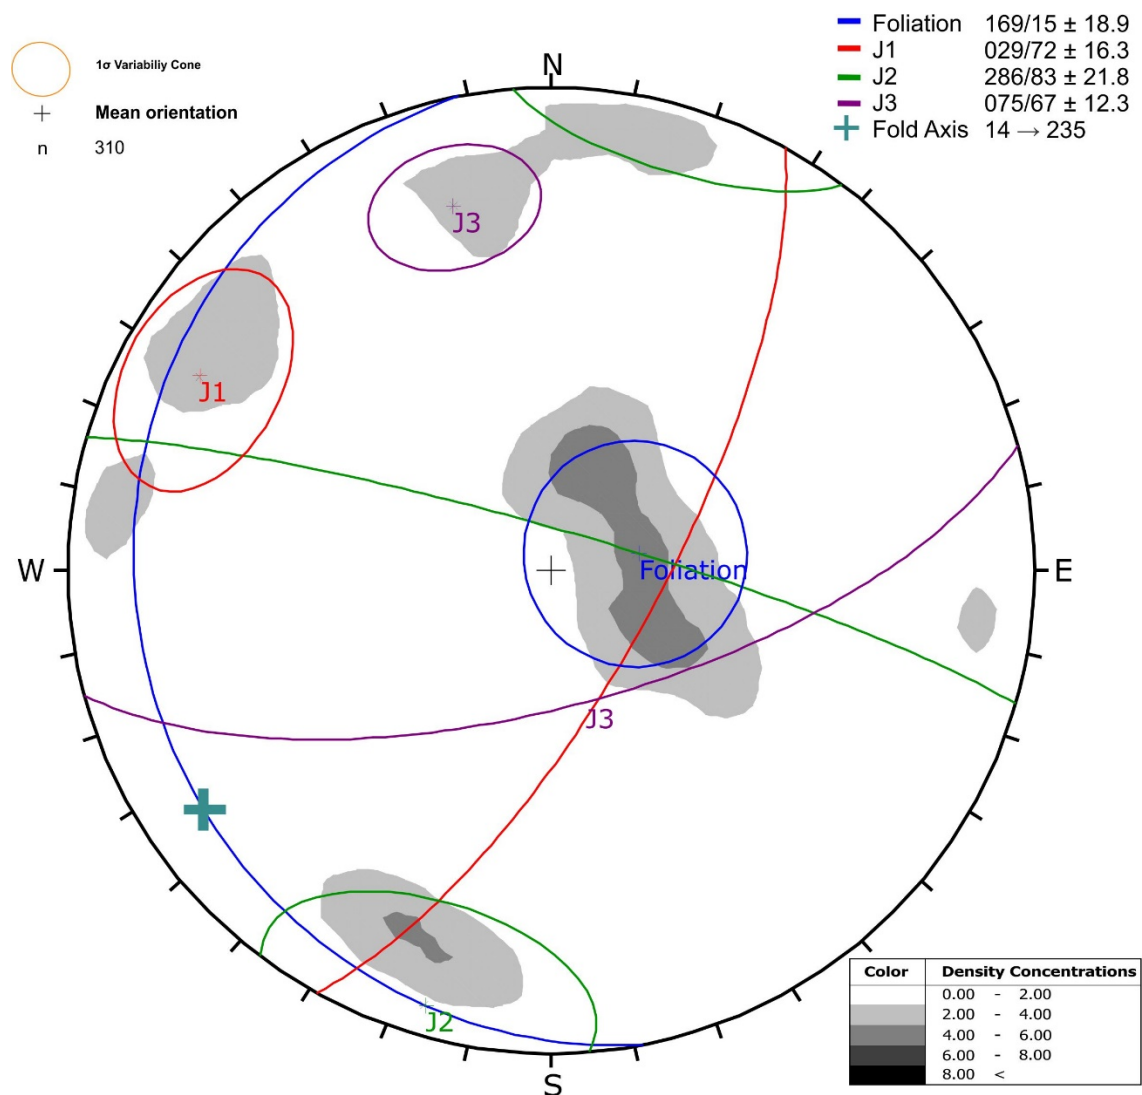
Figure 16 Stereonet displaying contours of discontinuity poles and assigned sets from MF1.

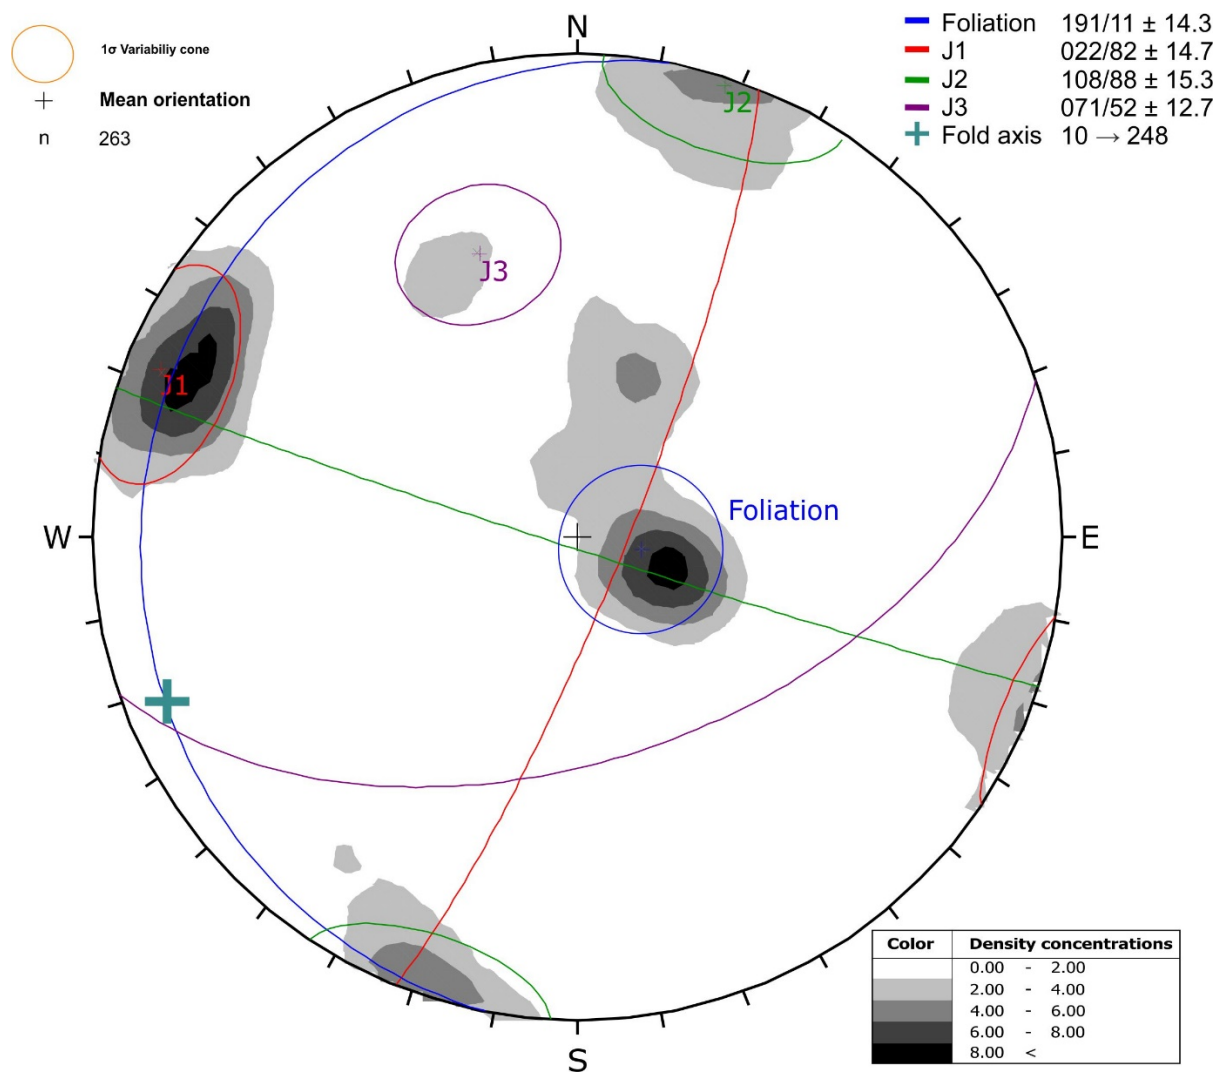
Figure 17 Stereonet displaying contours of discontinuities poles and assigned sets from MF2.

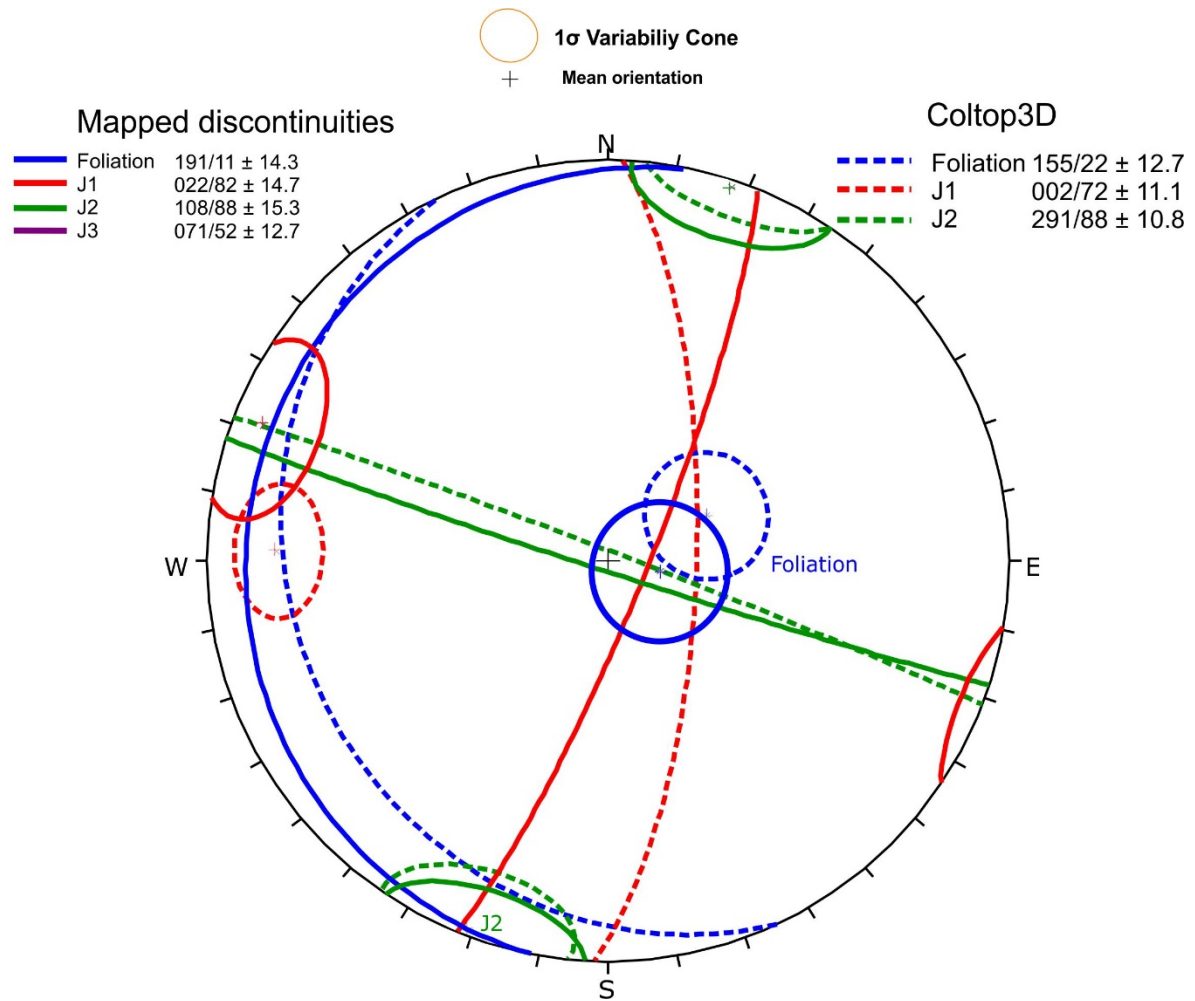
Figure 20 Structural data obtained from Coltop3D compared to mapped discontinuities at MF2.

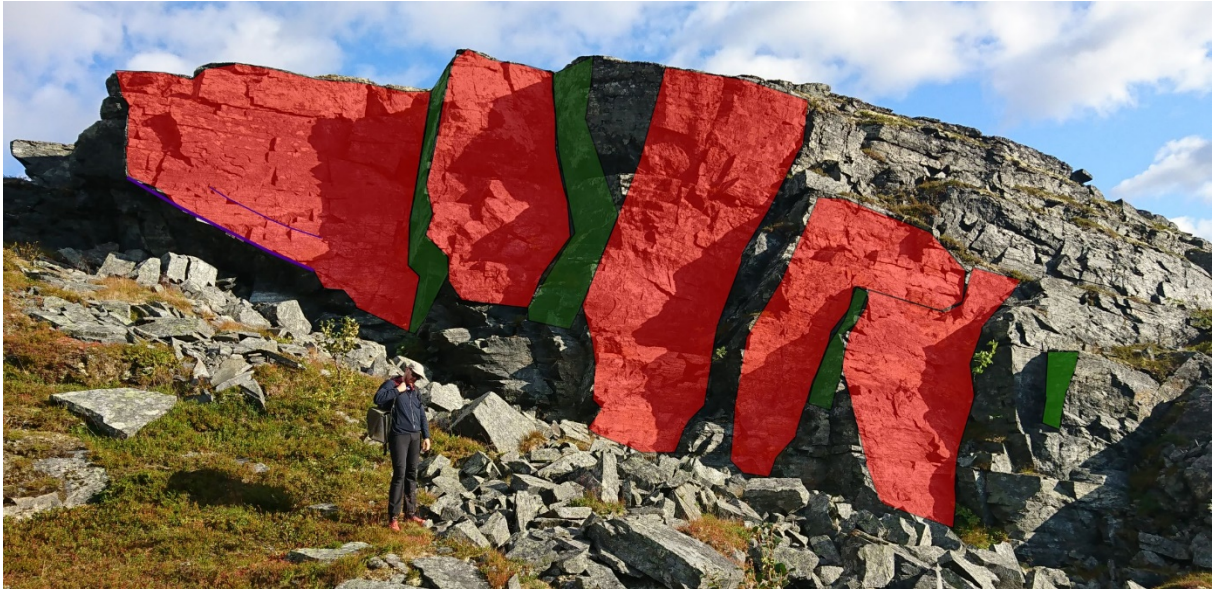
Figure 23 J1 – red and J2 – green. Display the persistence of J1 and the interaction between J1 and J2 at the back-scarp. Photo looking east and author for scale.

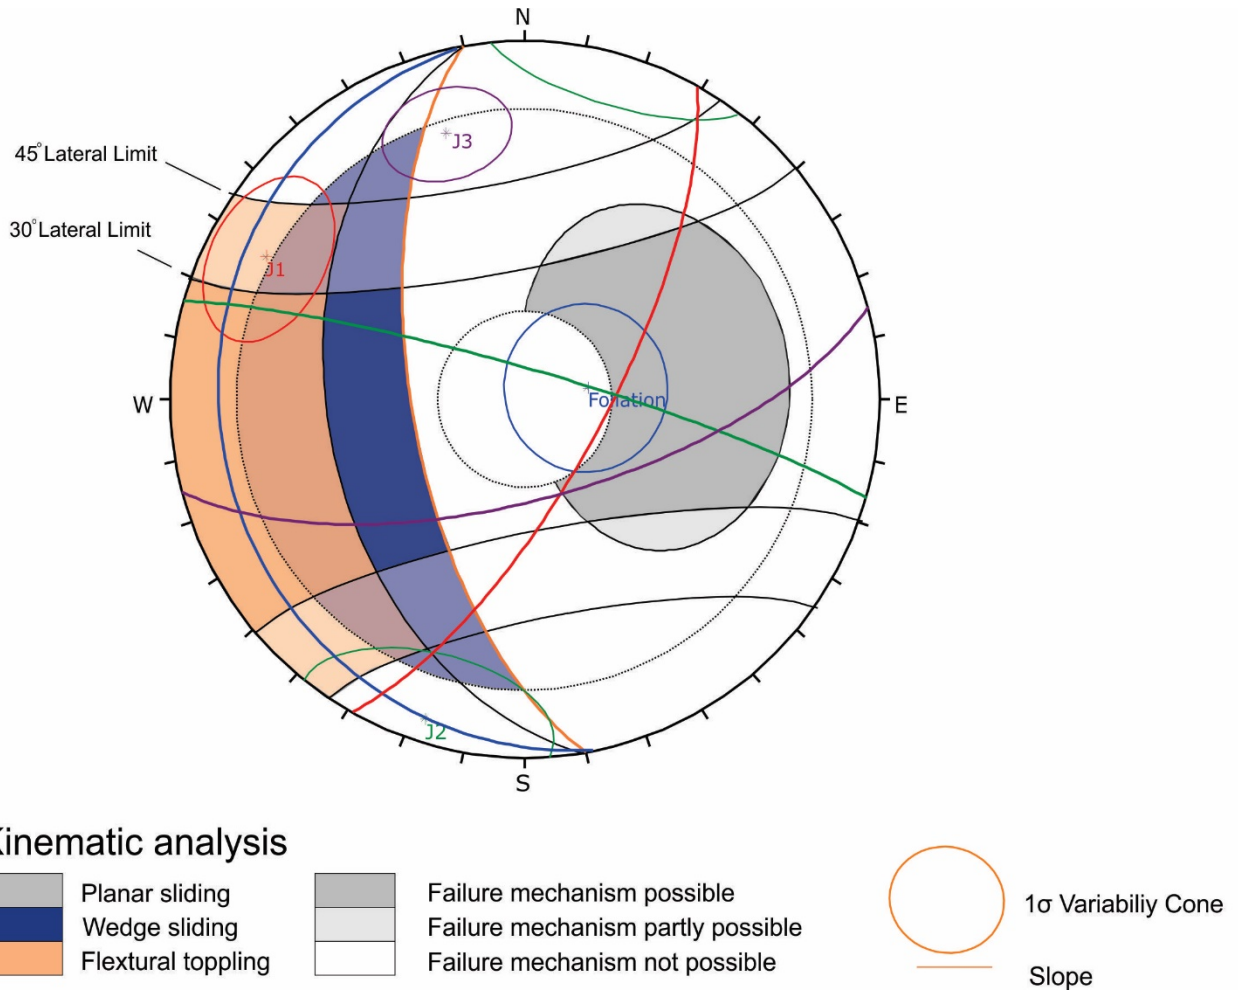
Figure 26 The kinematic analysis at MF1. The foliation is not steep enough to intersect in the critical area for wedge sliding. Parts of the foliation are located in the critical area for planar sliding.

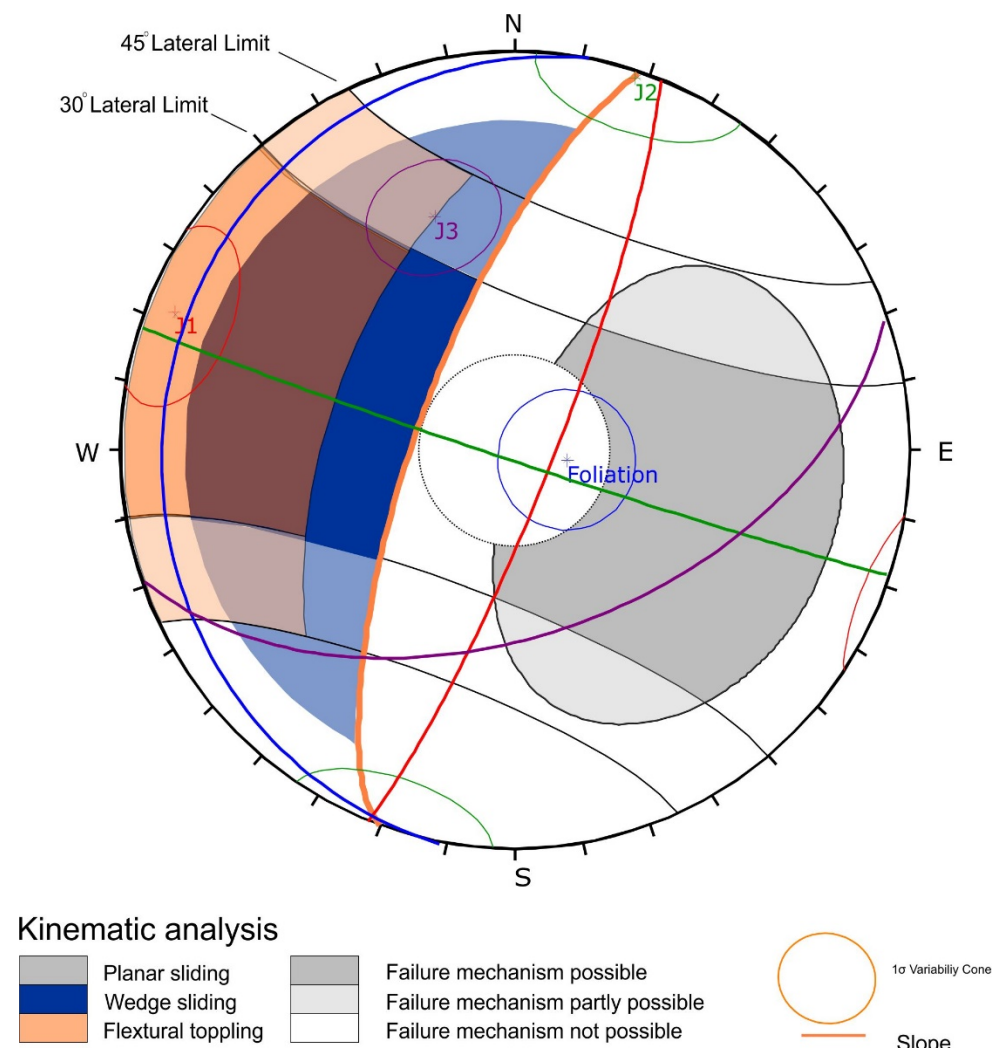
Figure 27 Kinematic analysis at MF2. J1 is fully enclosed in the possible failure mechanism for flexural toppling. Foliation dips to gentle to intersect with other joint sets in the critical area for wedge sliding.

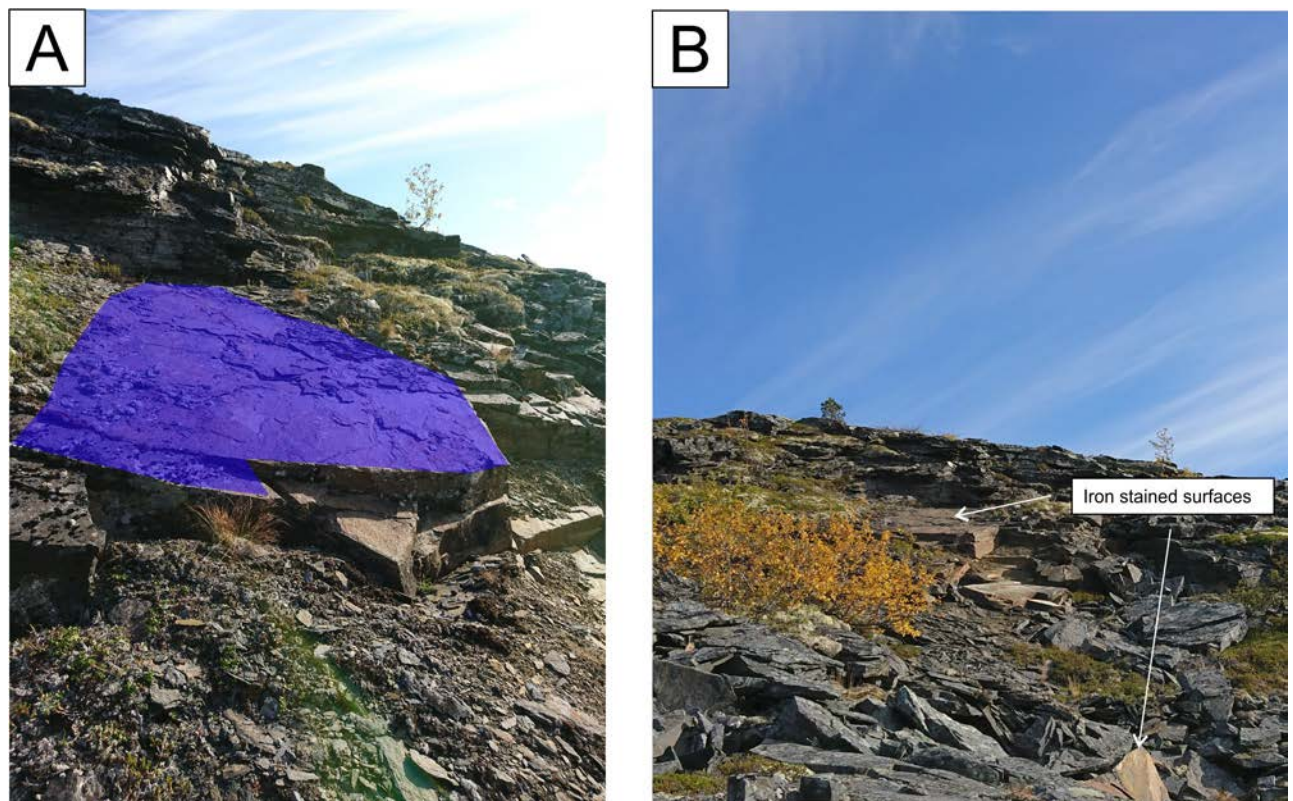
Figure 28 A – Planar sliding observed at MF1. Picture looking east-southeast. B – Fresh block with iron staining in the talus material from the planar sliding mechanism failure.

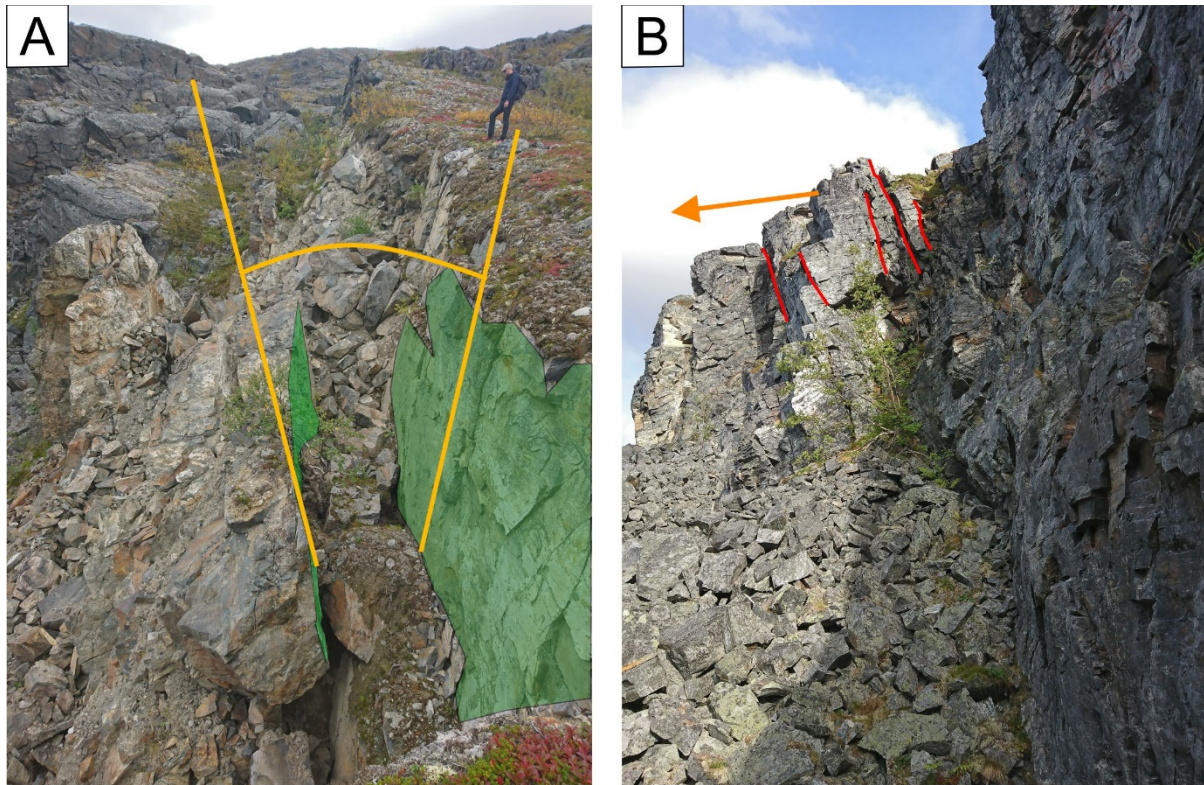
Figure 29 A – Toppling along J2 at back-scarp of MF1. Free hanging roots and loose sand in the ditch indicates quite recent activity. Picture towards east along J2. B – The structures allow for toppling in orange arrow direction from J1 (red) at the back-scarp of MF2. Picture towards north along back-scarp and J1.

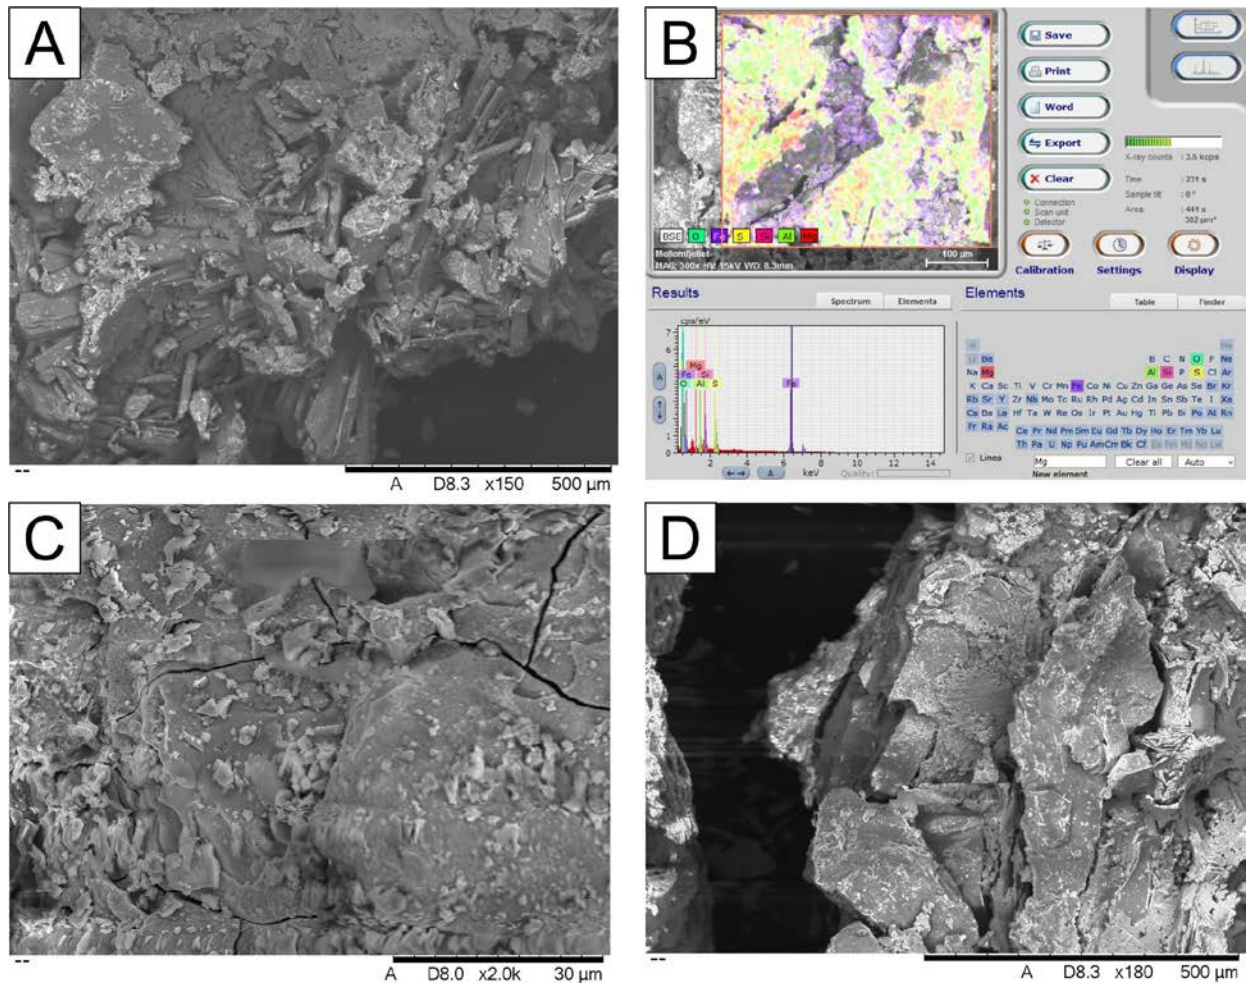
Figure 31 SEM-analysis of hand specimen from the felsic intrusion. A – Flaky texture observed in the SEM-microscope. B – Chemical signals from iron (Fe), magnesium (Mg), silicon (Si), Oxygen (O), sulfur (S) and Aluminum (Al). Chemical signal for typical clay aluminosilicates. C – Up-close picture, note the scale and the cracks. D – Flaky texture.

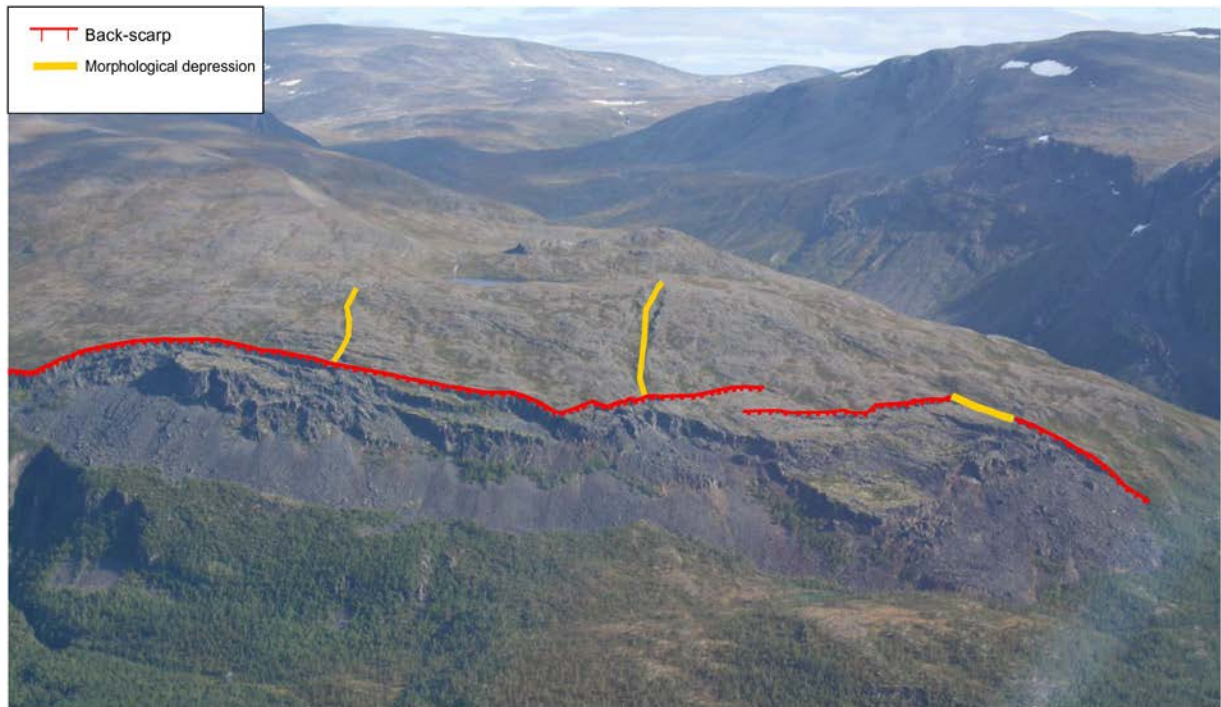
Figure 34 Aerial photo looking southeast at Mellomfjellet that display the continuous and discontinuous behavior of the back-scarp for MF2 and MF1 respectively.

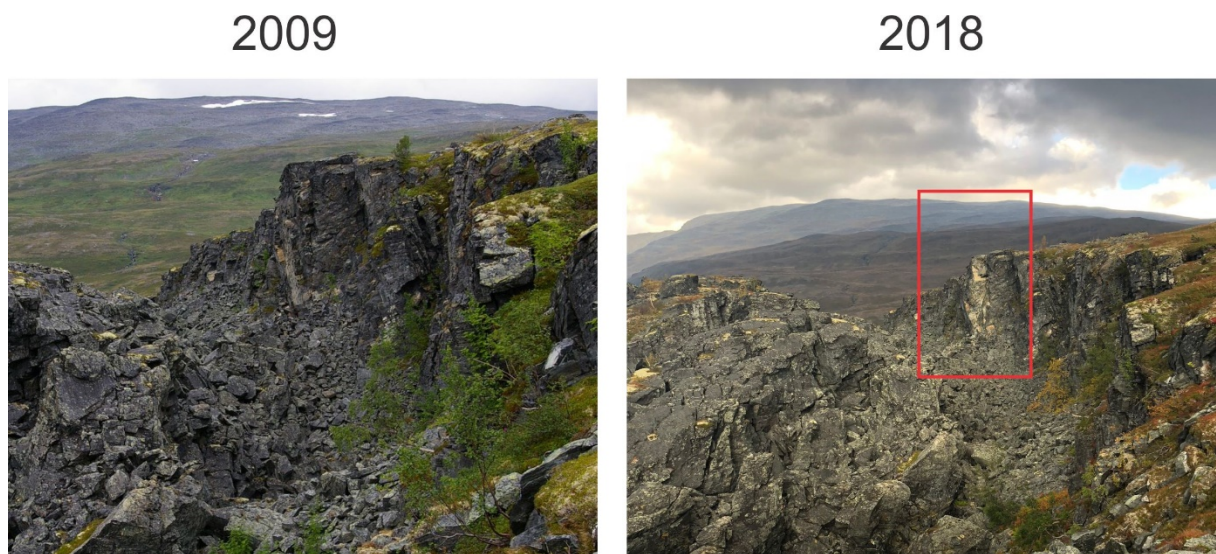
Figure 35 A recent rock-fall observed at the back-scarp at MF2. The release area is marked with the red rectangle. Bright colors indicate the fresh surfaces.

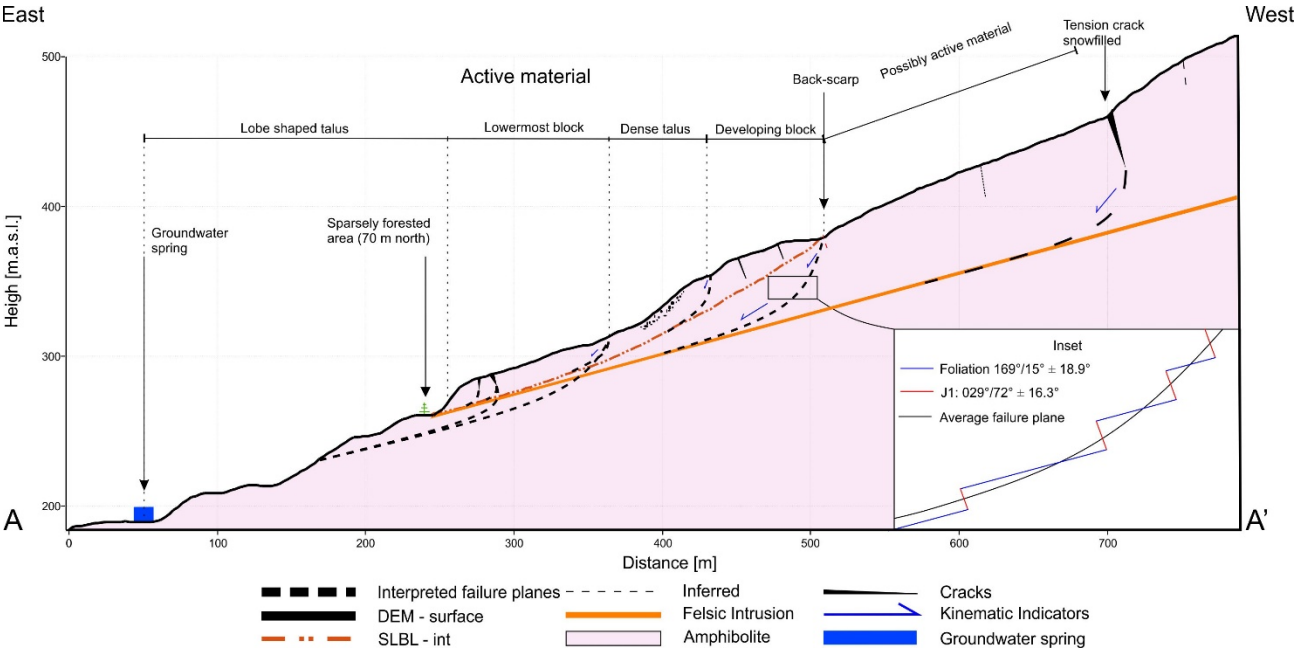
Figure 46 Geological profile over MF1. The intermediate SLBL from the analysis is included to represent a possible failure surface. Inset displaying a feasible mechanism of failure. J2 and J3 are omitted as J2 is parallel to the profile and J3 only is found in relation to the morphological depressions located away from A – A'.

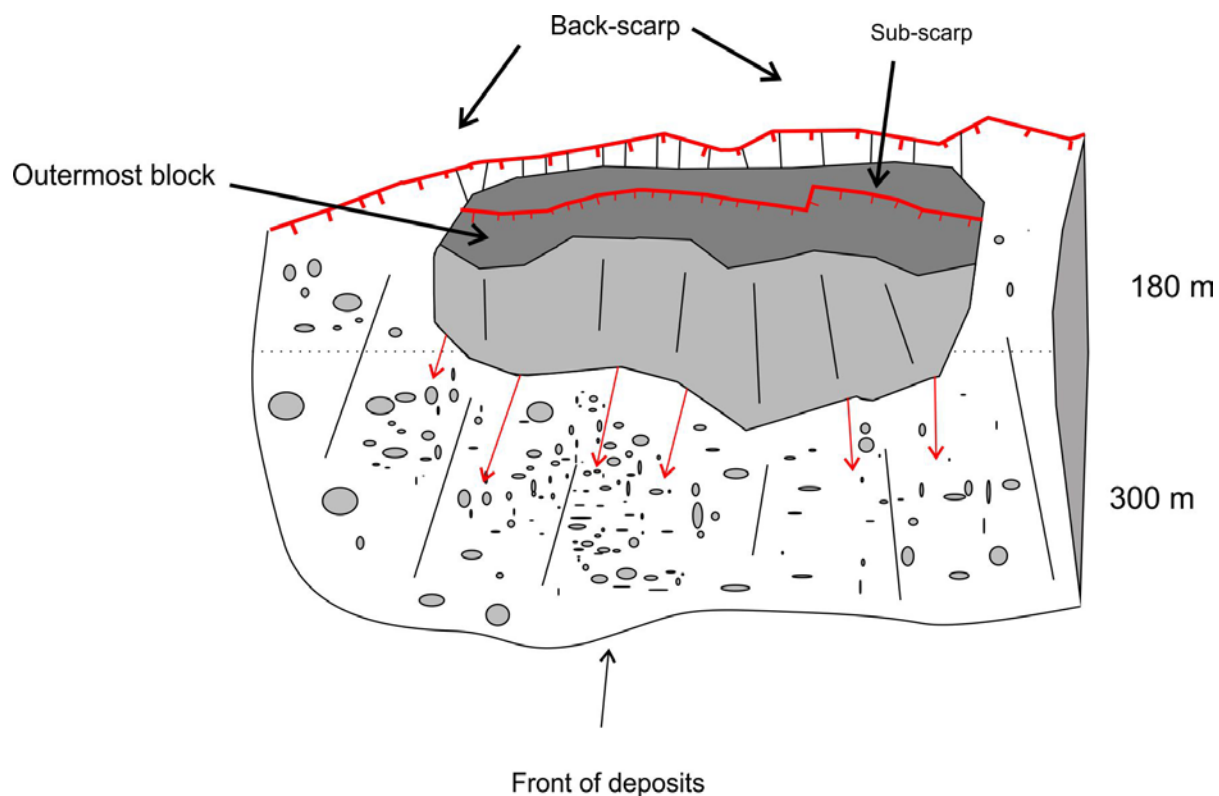
Figure 51 A 3D schematic sketch focusing on the unstable blocks at the URS at MF2 (block seen in morphological map; Figure 32). Red arrows are indicating displacement directions.

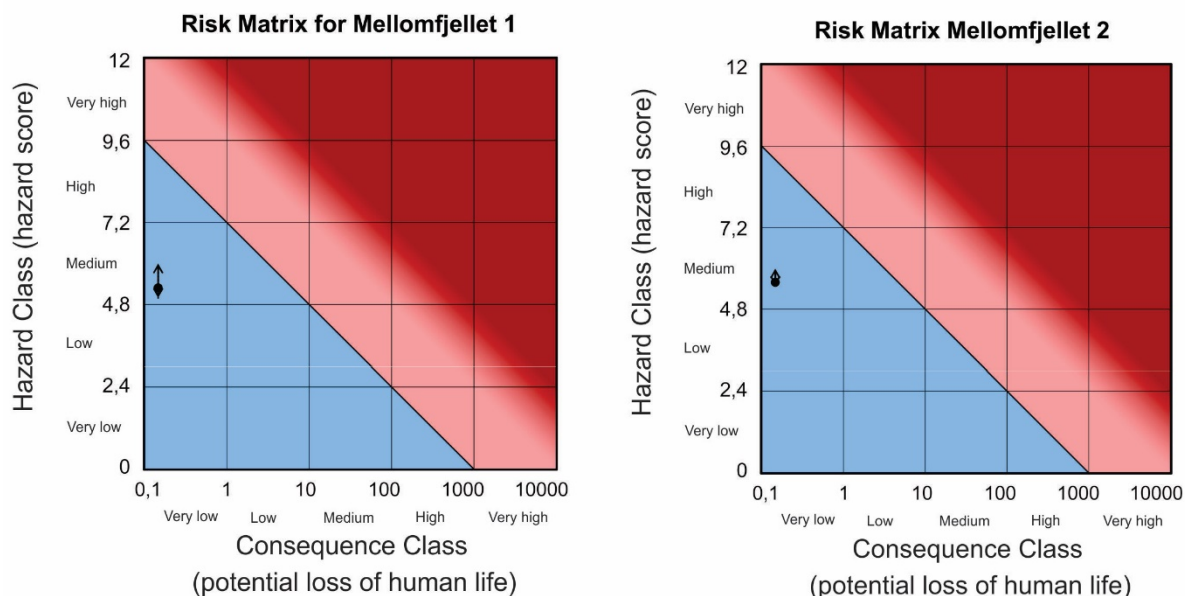
Figure 55 The risk matrices for MF1 and MF2. Note that both plot in the low risk class.
