# Structural assessment and characterisation of the rock slope failure at Skredkallen, Vannøya

*Structural analysis using field and desktop methods*

**Leif Trønnes**

*Master thesis in GEO-3900 May 2019*

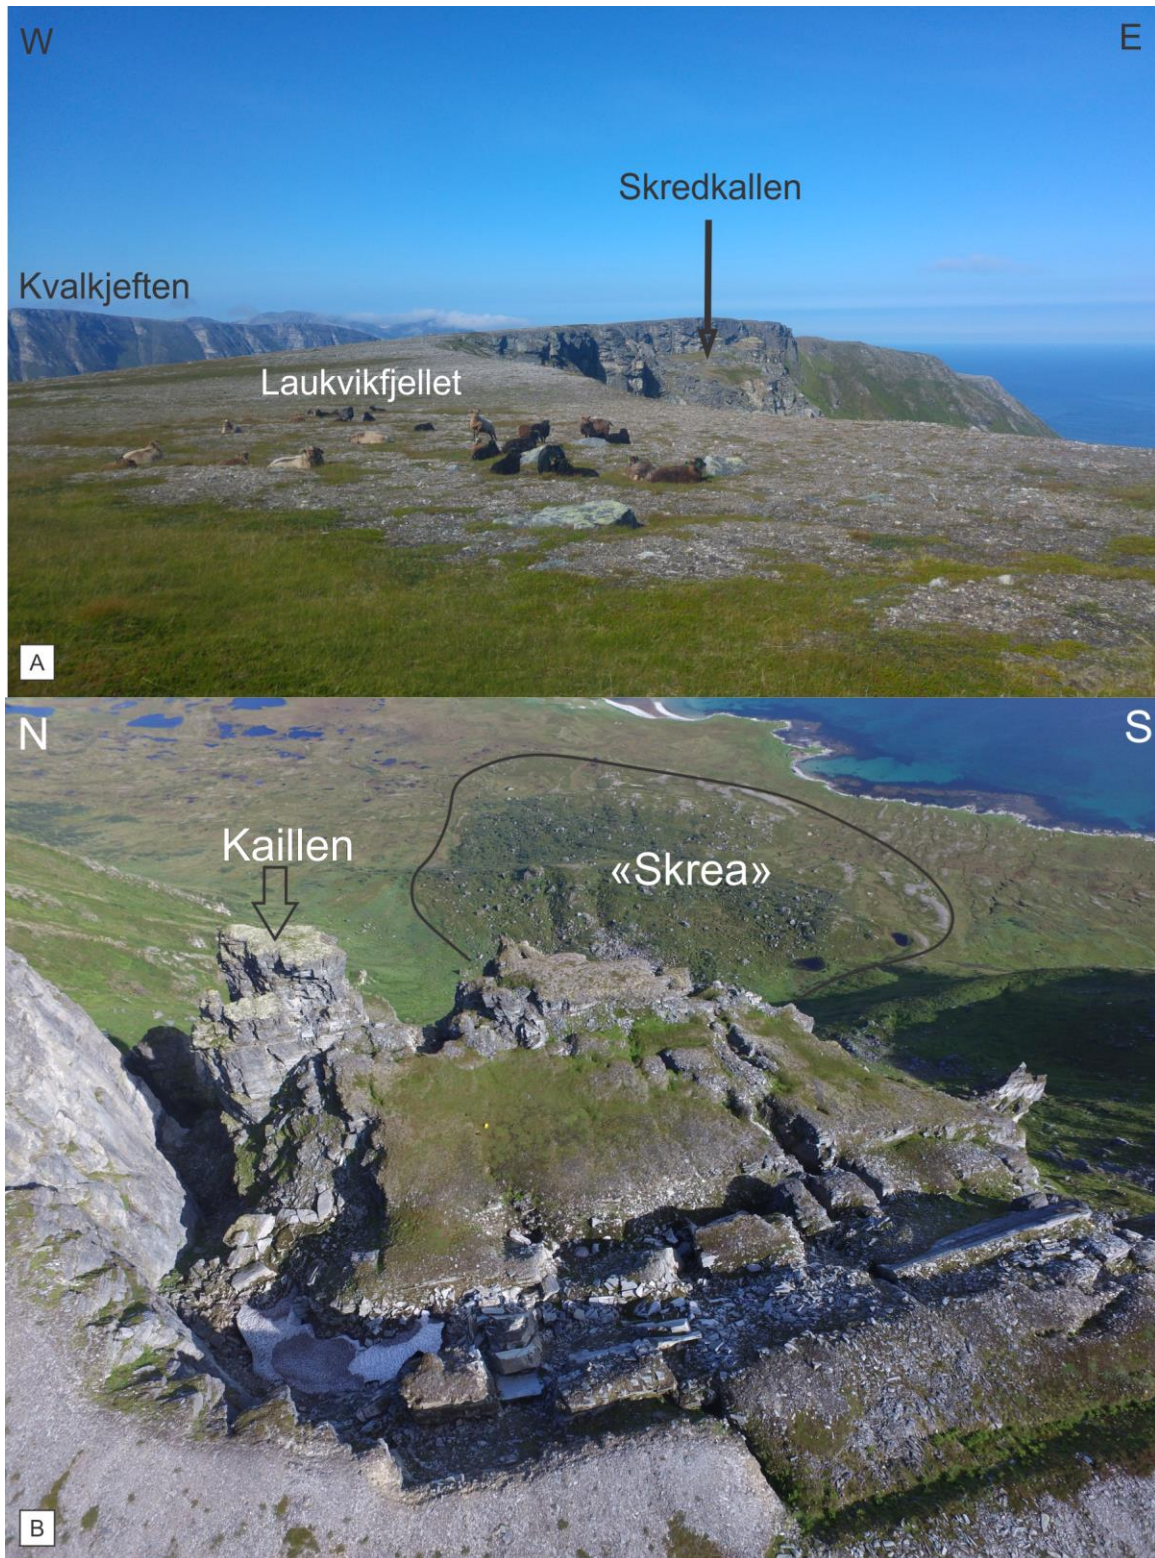
Figure 2 – A: Location of Skredkallen relative to Laukvikfjellet. B: Drone photo. Location of the column Kaillen and Skrea.

Skredkallen (482 m asl) is an actively deforming URS located on the east-facing slope of Laukvikfjellet (Figure 2A). It has been identified as moving downslope (towards NE) by means of satellite InSAR (insar.ngu.no). Future events pose a threat to hiking trails, an uninhabited cabin and a holiday cabin at the base of the URS. A large portion of the mountain side has collapsed probably sometime after deglaciation, as evidenced by the talus material below the URS. Within the instability there are multiple detached terraces, and a tall column of rock called 'Kaillen' which is still deforming. The main active terrace has subsided c. 20 m. Fresh talus deposits can be found underneath the southeastern section of this terrace, meaning that this slope is actively deforming. The talus material in the lowermost part of the slope, make up a 500 m wide area stretching as far out as 1.3 km from the source area at Skredkallen. This area is locally termed 'Skrea' and consists of blocky avalanche deposits with some vegetation (Figure 2B). Anecdotal evidence, in the form of local legends, tells of historic events linked to avalanche activity and ongoing creeping movement. One legend tells of a man (Søren Andresen, b. 1754) screaming so loudly from the top of Laukvikfjellet that it led to a large rock avalanche event, and the deposit of 'Skrea'. The most recent rock avalanche occurred in the 1950s, as reported by local residents, and resulted from the collapse of a tall column of rock called 'Kvinnen'. Multiple local residents ('Slettnes på Vannøya' facebook group, 2018, pers. commun.) have reported that in the past people were able to jump onto the 'Kaillen', the tall column of rock. The grandmother of Signy Karlsen, Mathilde (b. 1880), was able to jump this distance as a child. Today the same distance requires a jump of at least 10 m, a generally impassable jumping distance.

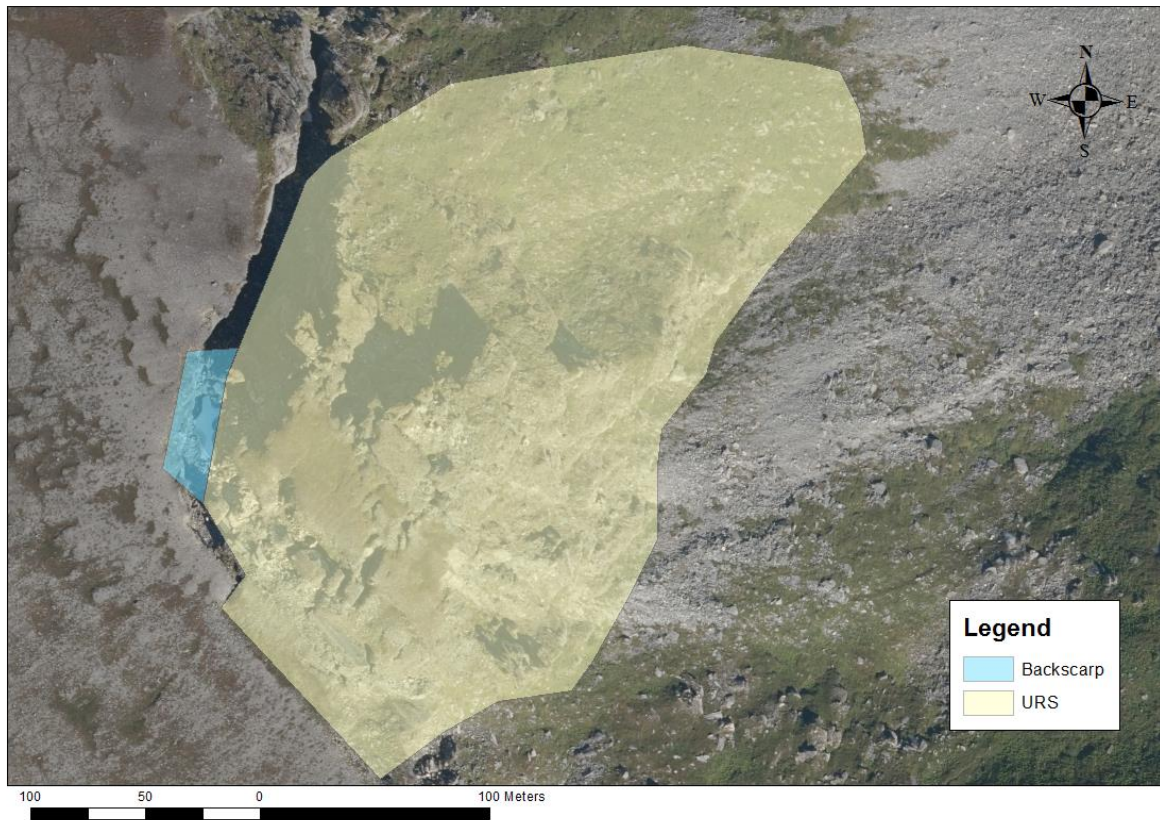
Map 6 - Projects in AgiSoft Photoscan

Agisoft Photoscan is a software product that performs photogrammetric processing of digital images and generates 3D spatial data to be used with Geographical Information System (GIS) and other applications. In this study the software was used to make two dense point clouds; one

of the lateral backscarp to perform structural analysis in Coltop-3D, and one of the whole URS to create a high resolution DEM of the area as well as a 3D model for other purposes (Map 6).

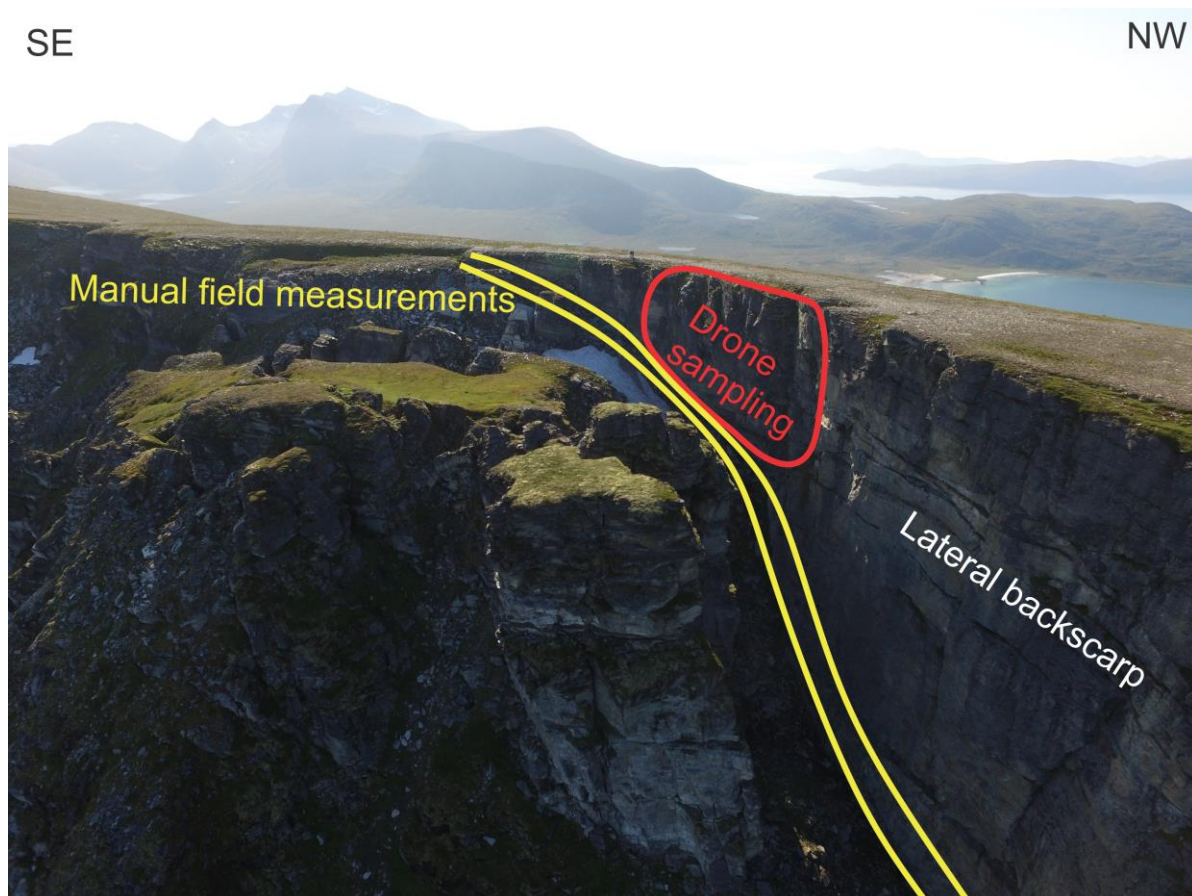
Figure 9 - Drone photo. Location of structural measurements for structural analysis.

Structural analysis was performed on two datasets, manual field measurements and structural data from a dense point cloud made in AgiSoft Photoscan (backscarp project) (Figure 9). The structural data from the point cloud were obtained using Coltop-3D software.

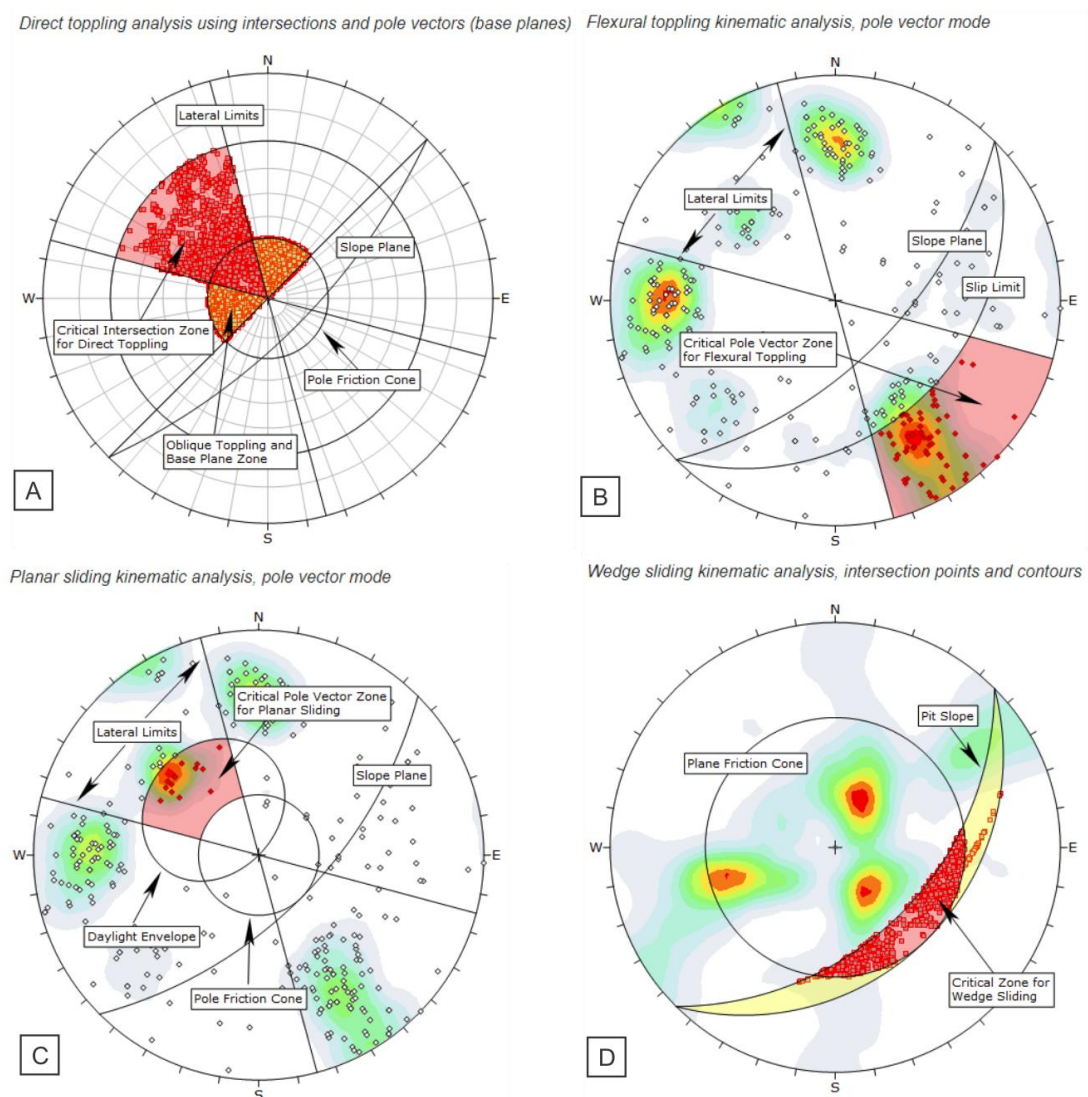
Figure 12 - Kinematic analysis on A: direct toppling, B: flexural toppling, C: planar sliding and D: wedge sliding. Figures modified after Rocscience (2018).

Based on the output results from the kinematic analysis, presented in stereonets (Figure 12), it is possible to see which joint sets that contributes to a feasible failure. If the location of a pole or a great circle lies within or cross-cut red, green or yellow colored fields, the joints they represent contributes to failure. The results in Dips 7.0 also includes tables with percentage on number of critical and total number of feasible failures, which is used to decide which joint sets that contribute the most to failures.

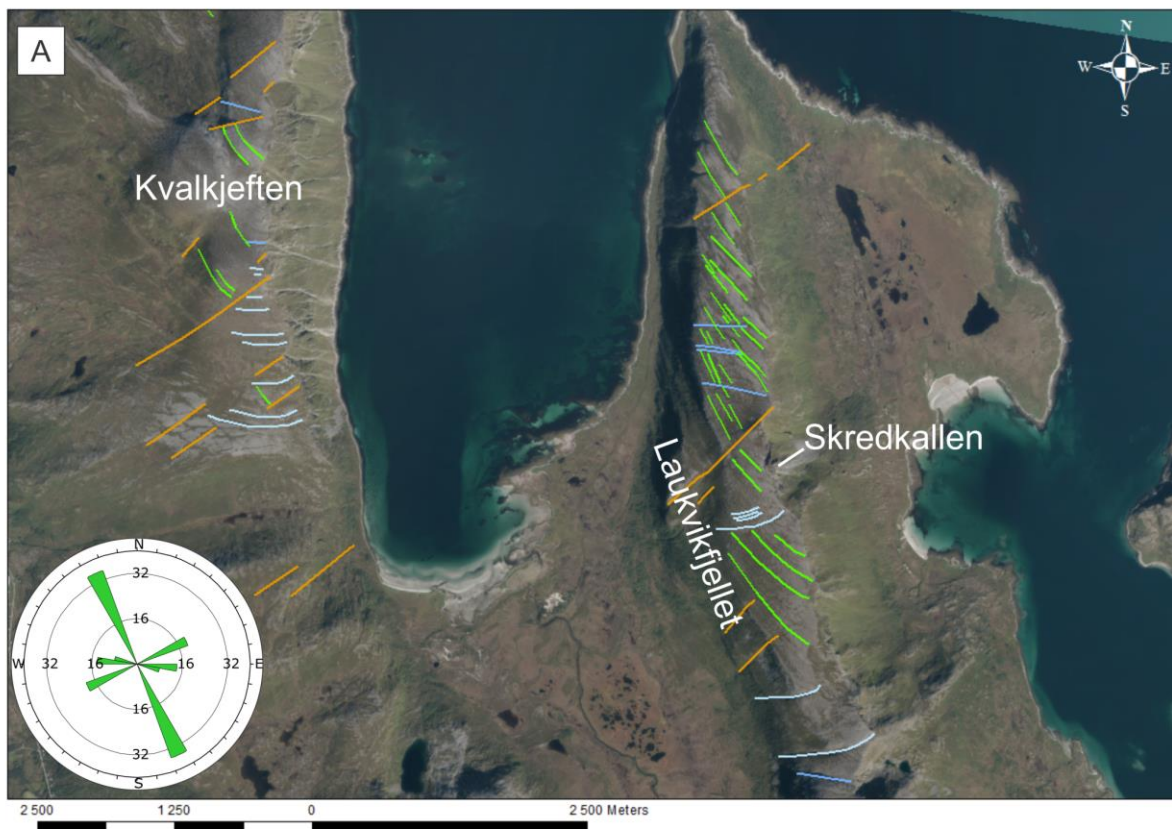
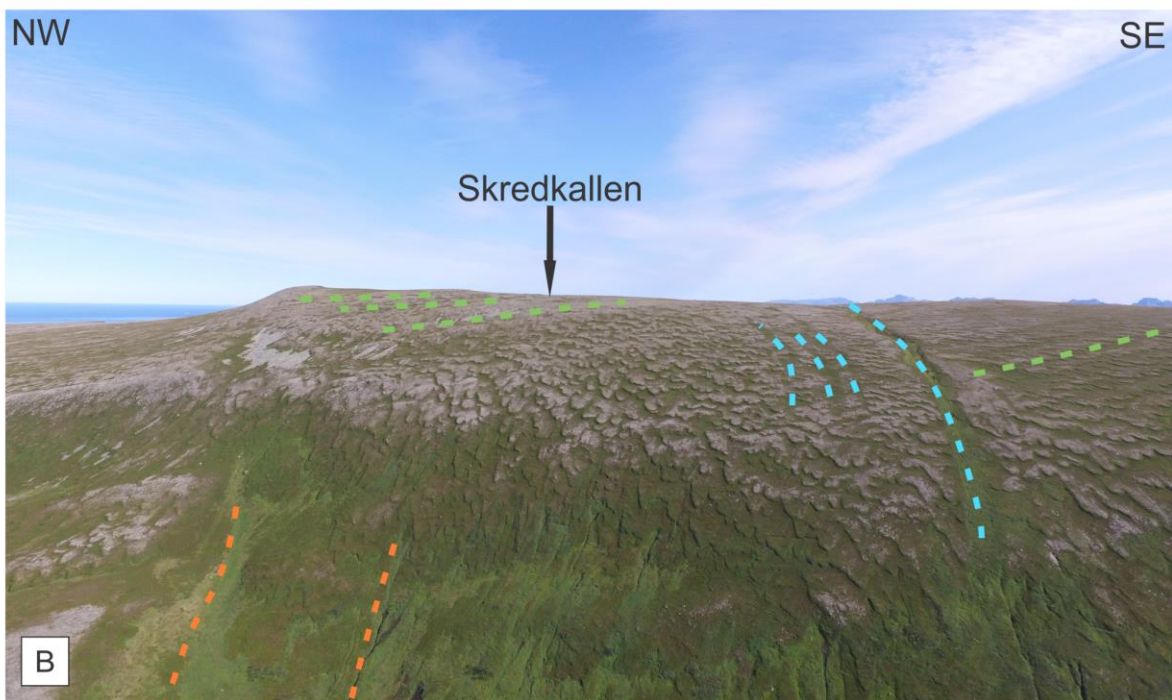
Figure 13 – A: Lineaments on Laukvikfjellet and Kvalkjeften. B: Drone photo. Lineaments on the western face of Laukvikfjellet. Note the change in surface topography just NW of Skredkallen.

Lineaments best seen on a regional scale, can be found on the mountain ridges on Laukvikfjellet and Kvalkjeften, displaying a wide range of orientations and geometries (Figure 13A). The lineaments on the western face of Laukvikfjellet are displayed in (Figure 13B). In particular two sets of lineaments are repeating: NE-SW (orange) or E-W (blue). These can be found in areas where the relatively flat mountain ridges of Laukvikfjellet and Kvalkjeften show great changes in surface topography, either in steep slopes such as northwest of Skredkallen, along streams or even small canyons located south on Laukvikfjellet. In addition there are two sets oriented NNW-SSE (green) and E-W (light blue) which both display a distinctive curved geometry. These can be recognized either as depressions along streams or small steps in the surface topography.

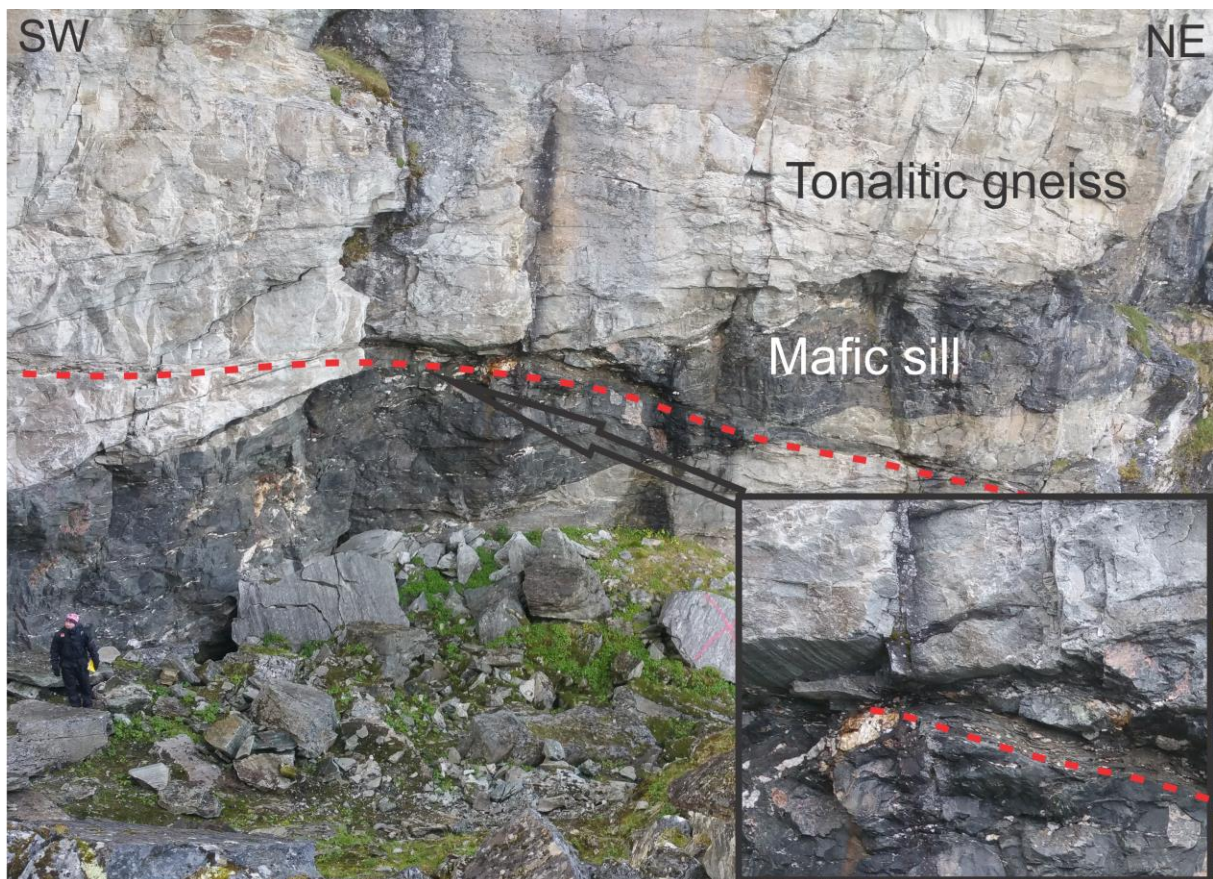
Figure 14 - Station 7. From the lateral backscarp on Skredkallen. Mafic sill in tonalitic gneiss. Red stippled line displaying the lower boundary of an ‘internal shear zone’.

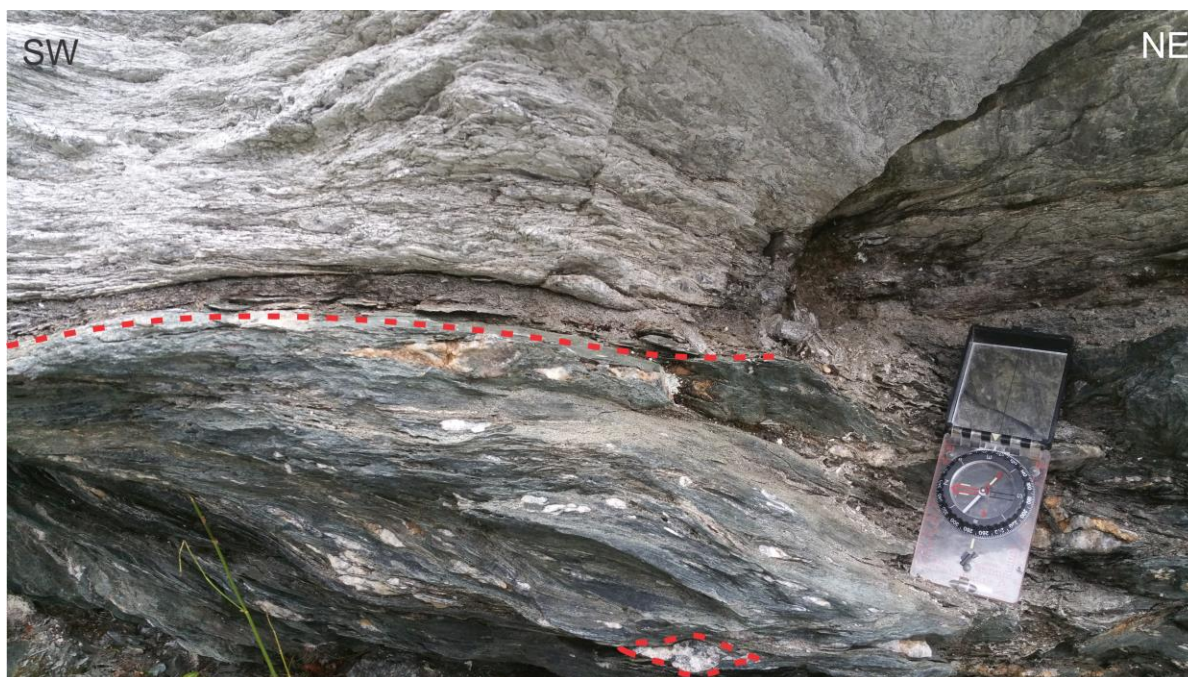
Figure 15 – Station 10. 'Internal shear zone'. Phyllitic (upper) and mylonitic (lower) separated by the red stippled line. Note the symmetric sigmoid porphyroblast indicating pure sense of shear.

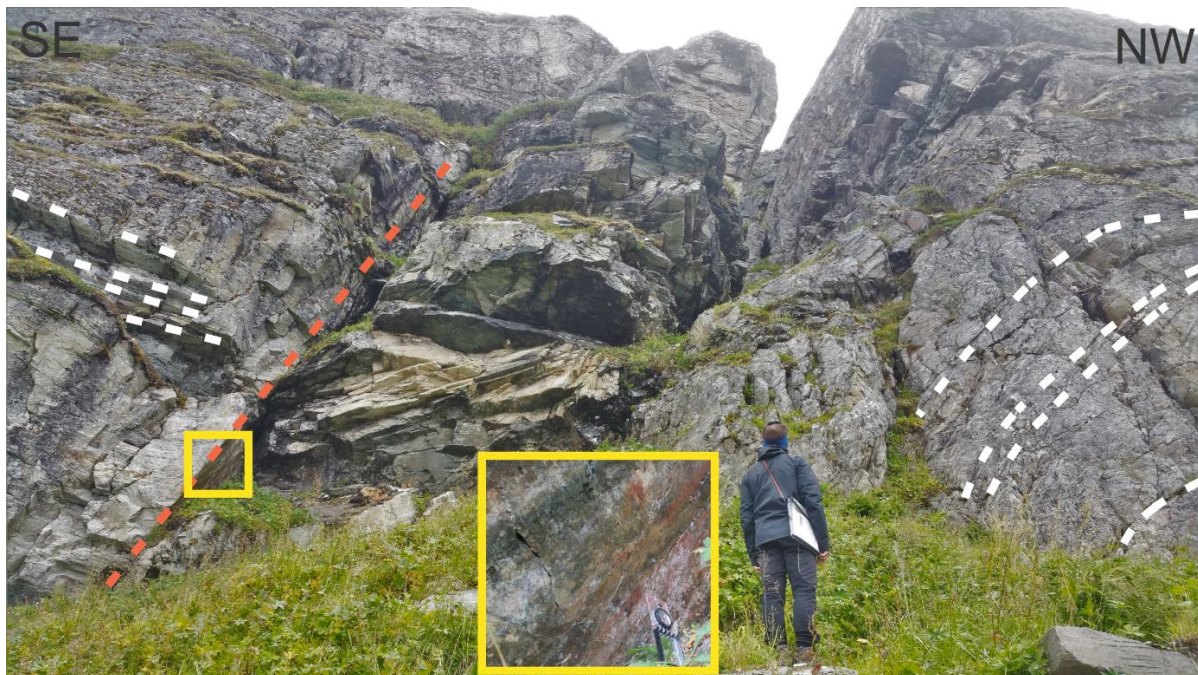
Figure 16 – Station 2. Right: foliation folded steeply towards SE. Left – planar foliation. Orange stippled line: bedrock structure/small fault. Inset: smooth stained surface of the 'fault'.

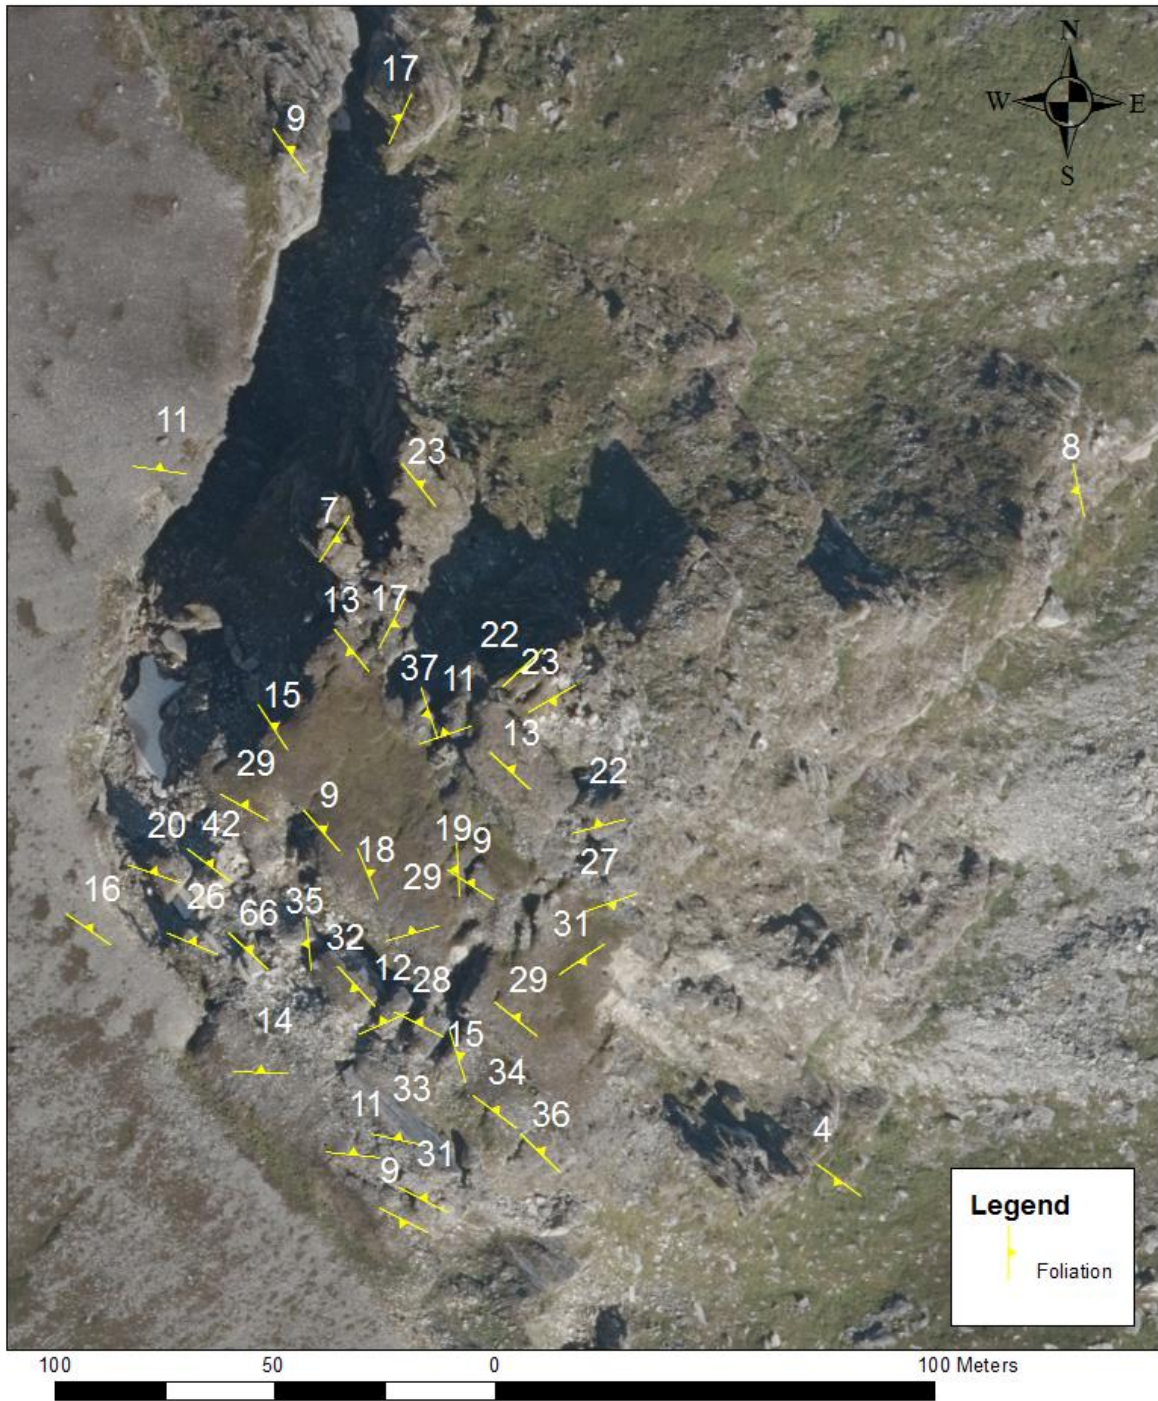
Map 9 - Foliation measurements. Note that the foliation usually strikes either NW-SE.

The foliation along the backscarp is dipping gently towards NNE ( $292/14 \pm 13.8$ ), with dip angle variations up to  $13^\circ$ . The foliation is thickly layered, well developed and displays mica-rich surfaces. Slickenslided surfaces with sense of shear trending NW-SE can be found along the foliation. Stretching lineations (ductile structure) visible from the intersection between joint sets and foliation or cleavage and foliation dipping gently towards NW, are very abundant. The foliation in and around Skredkallen appeared planar, or unfolded. Two km south of Skredkallen, on top of Laukvikfjellet, there was a 0.5 m wide fold with a gently NW-dipping axial plane (Trend/plunge -  $304/34$ ). A folded foliation was also observed along the backscarp (Figure 16, station 2), dipping steeply towards SE and terminating against a planar bedrock structure with very low roughness, probably a small scale inherited fault (Figure 16). However, these observations are outside the defined instability area. The main parts of the URS show a foliation orientation which is very similar to the foliation mapped in the backscarp, but slightly tilted in varying directions. Smaller parts of blocks are generally tilted either towards NE or SW, as seen by the foliation which often strikes NW-SE (Map 9).

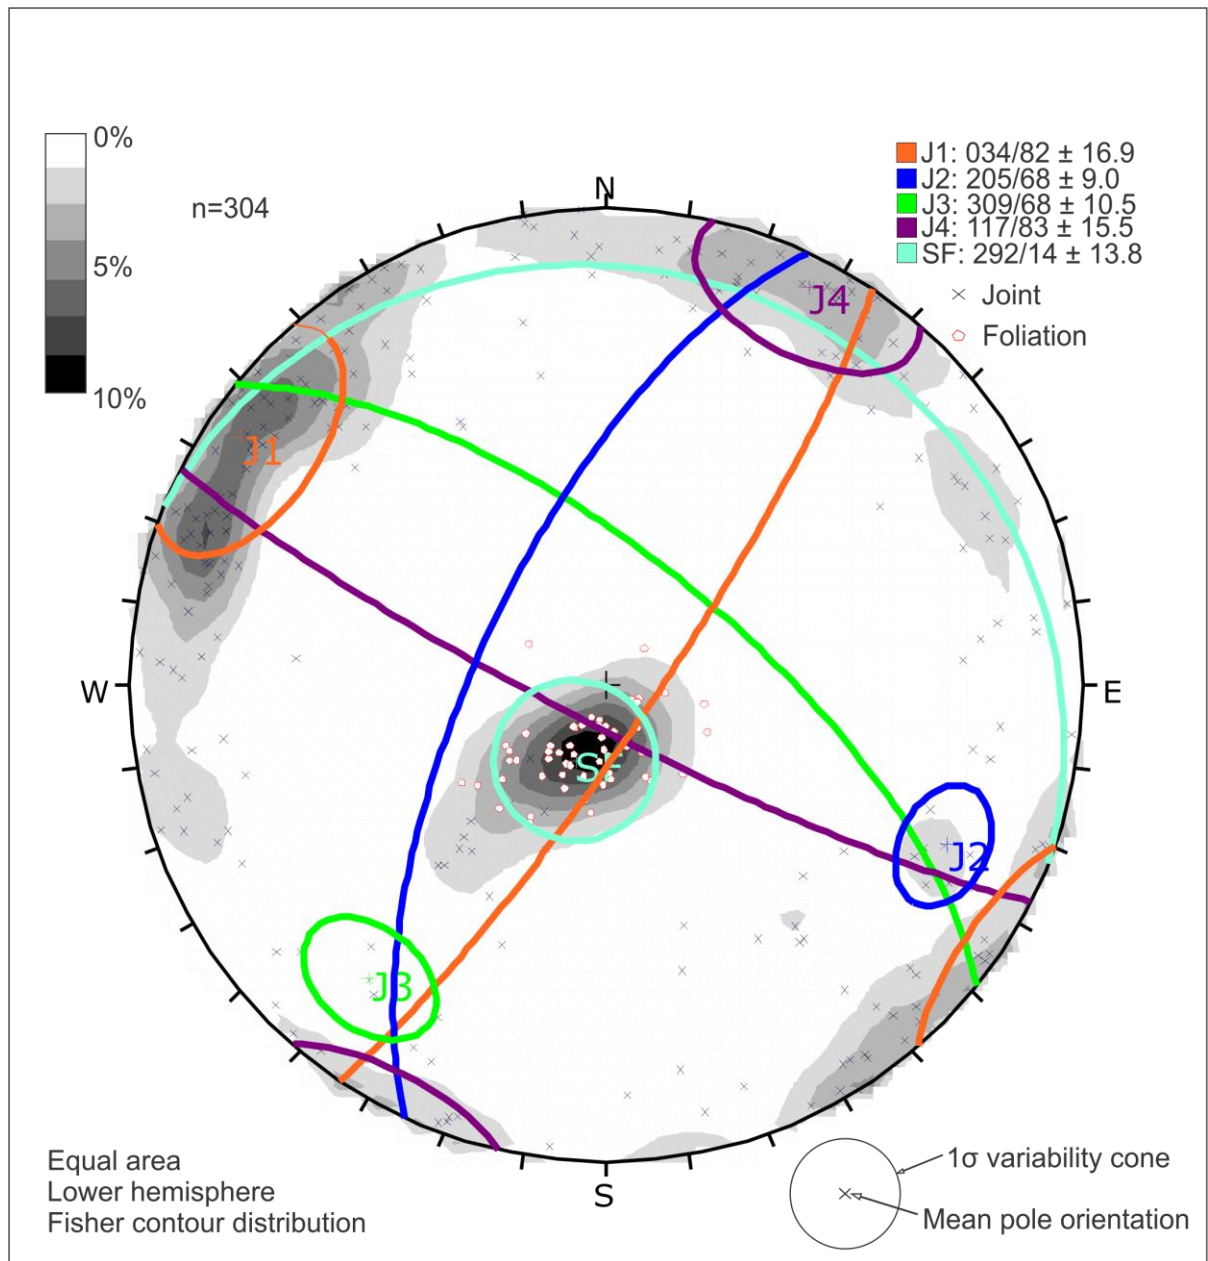
Figure 17 - Stereographic analysis from Dips 7.0.

Four joint sets and foliation were identified in Dips (Table 4). The most dominant joint set on Skredkallen is Joint set 1 (J1) striking NNE-SSW and dipping steeply towards ESE. Joint set 2 (J2), striking NNE-SSW and dipping moderately towards NNW, were observed only occasionally. Joint set 3 (J3) striking NW-SE and dipping moderately towards NE, was difficult to measure in the field, although many observations of its occurrence were made. J3 would likely show a much greater pole concentration if the main backscarp striking NW-SE was more exposed. Most measurements were taken from outcrop slopes which were oriented so that J3 and foliation (SF) did not daylight. Joint set 4 (J4) striking NW-SE and dipping steeply towards SW, is the second most prominent joint set on Skredkallen.

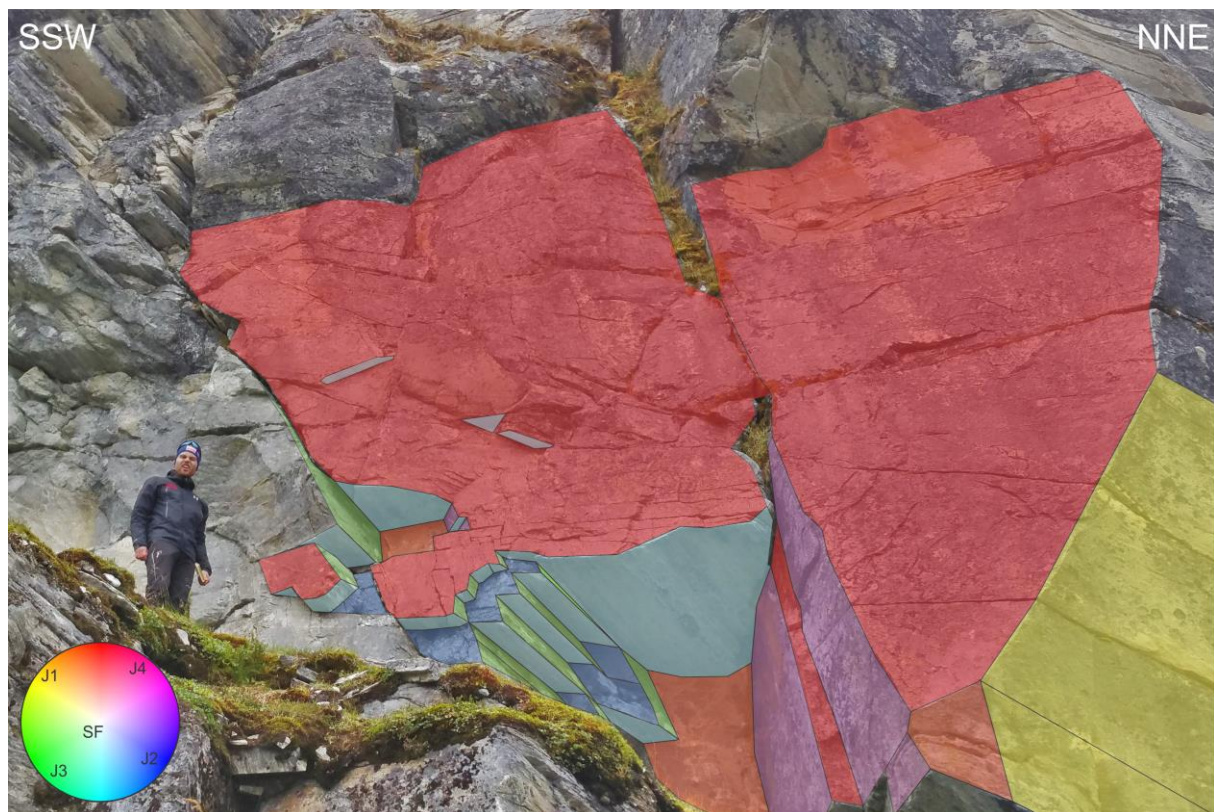
Figure 18 - Station 11. Joint set presentation. In-situ rocks 0.5 km south of Skredkallen. ESE facing aspect. Note the great variations within joint set 1 in terms of strike. NB: upwards perspective creates distortion so that J3 and J4 appear similar when in fact they are conjugate.

There are great variations within all joint sets in terms of strike/dip, and there is a possibility that more than four joint sets are present, most likely a near-vertical joint set striking N-S and dipping towards E, as seen from the cluster concentrations (Figure 17). This joint set might be a subsidiary set to J1. However as the sets were difficult to differentiate from each other, four sets that were clearly observed in the field were chosen. Joint set characteristics (spacing, persistence, shape and roughness) were mainly obtained from station 11 (Figure 18) south of the unstable area.

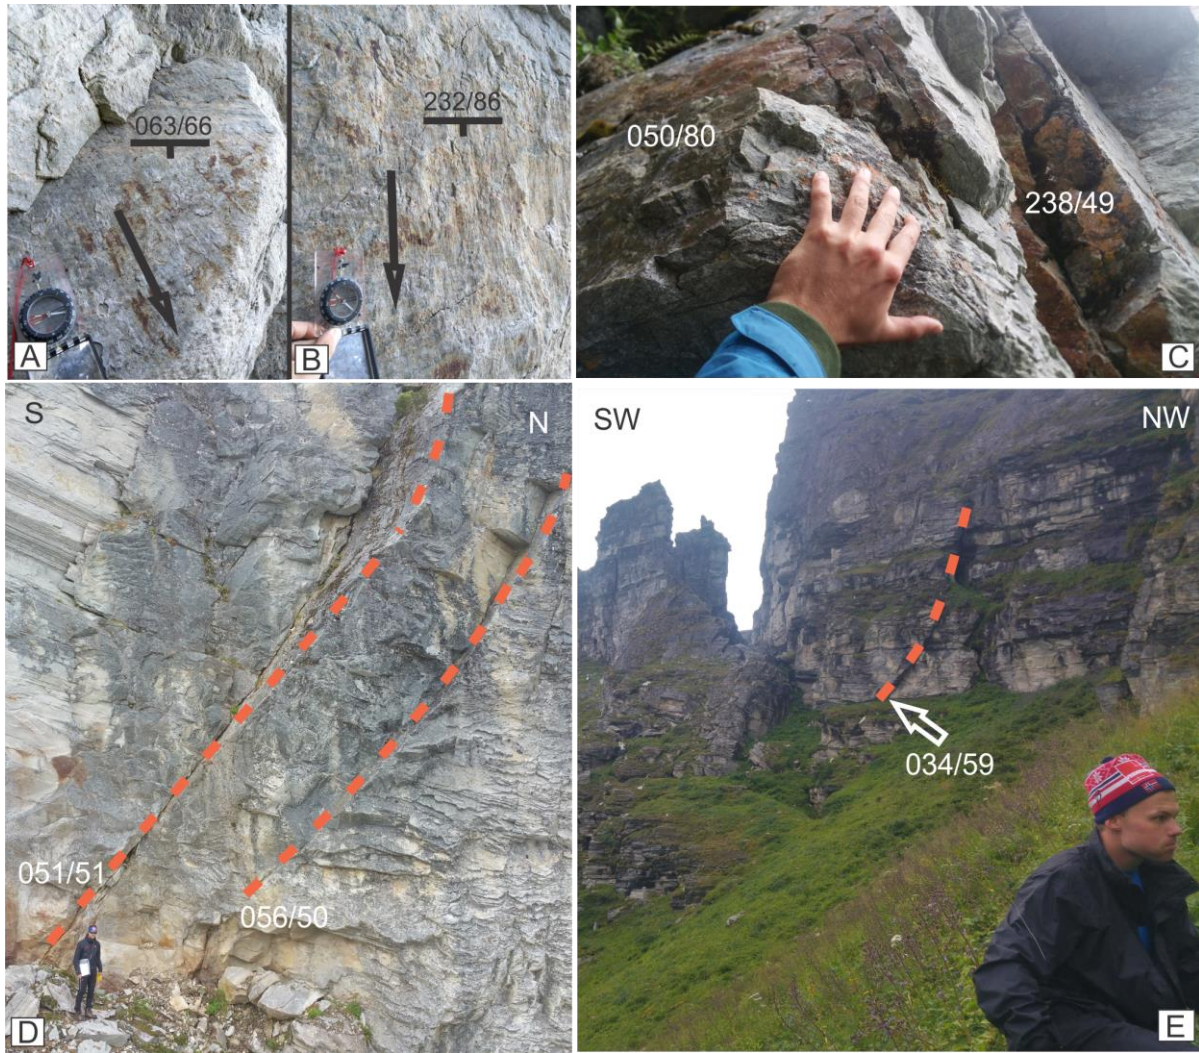
Figure 19 - A + B: Slickenlines (station 6). C: Conjugate set with orange coating (station 1). D and E: Joints with listric geometry (station 8).

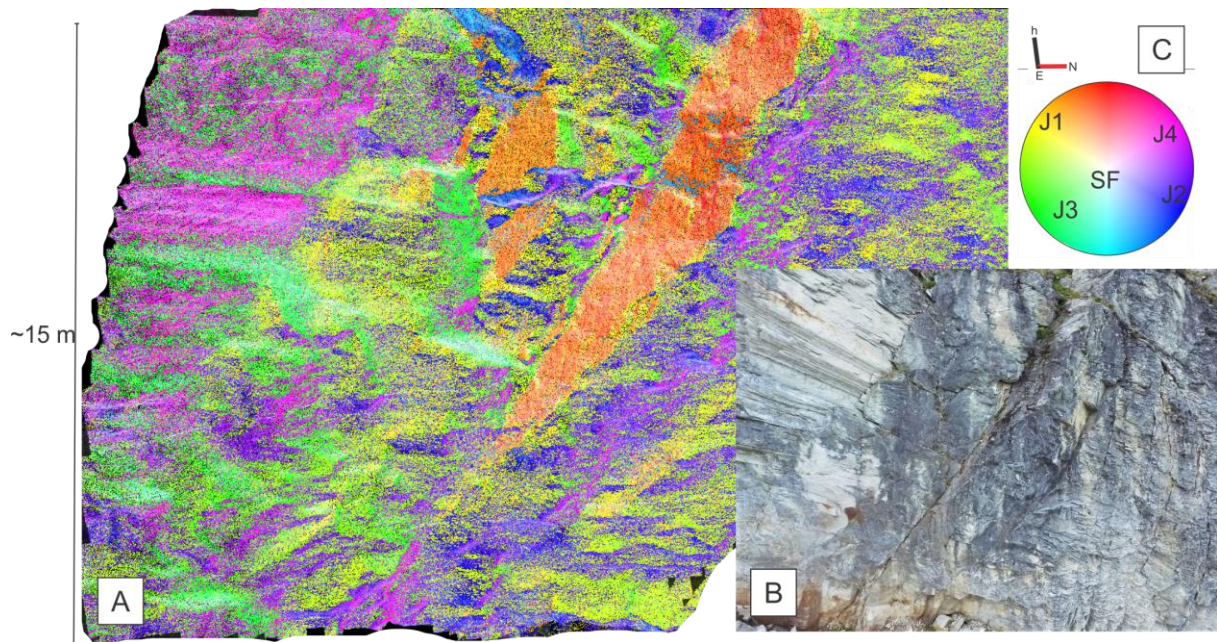
Figure 21 – The two listric joints presented in Figure 19D are in the center of A and B. A: Coltop-3D presentation B: Photo from the same perspective. C: HSI wheel.

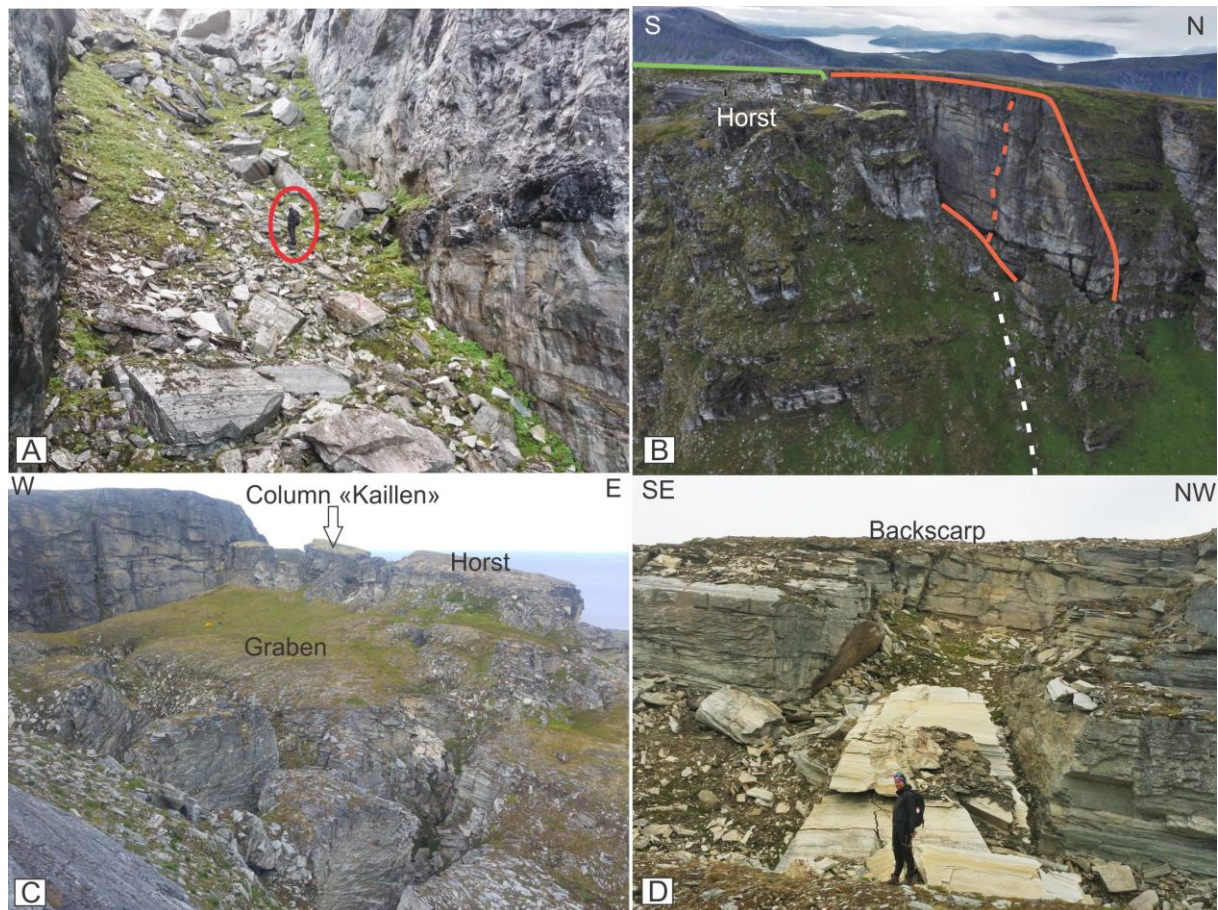
Figure 24 - A: Trench filled with fractured rock material (station 16). B: Drone photo displaying backscarp (orange/green) and delineation of the backscarp / defined instability area (white). C: Graben and horst surrounded by blocks. D: Block with trapezoid shape collapsed from the main backscarp (station 22).

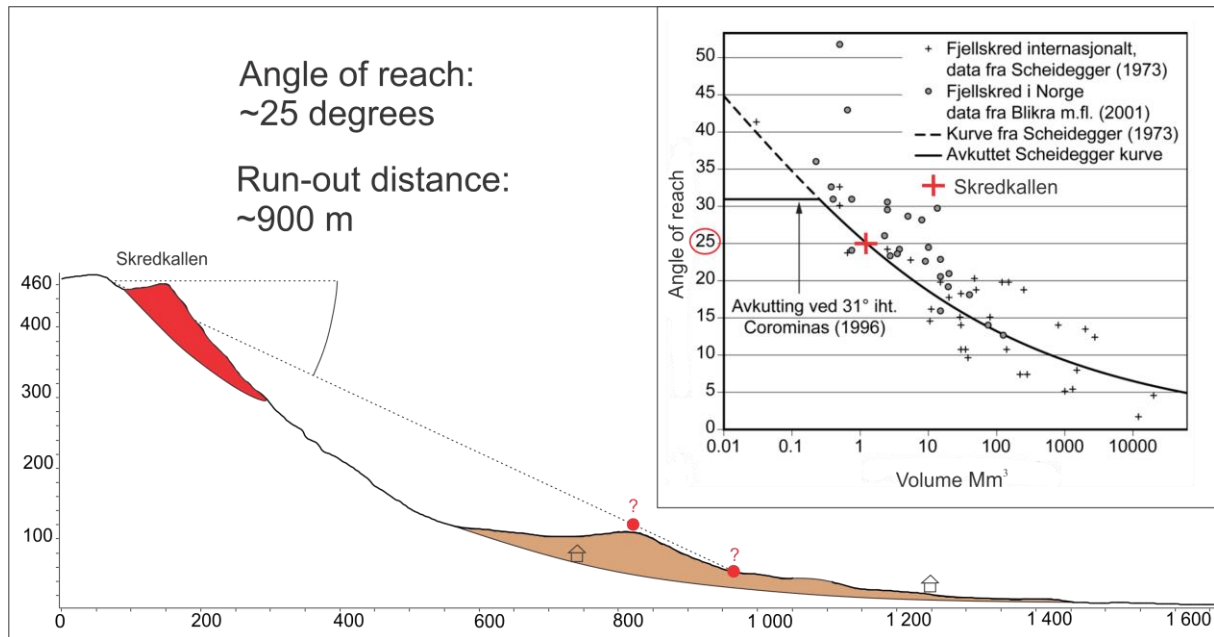
Figure 28 - Run-out distance based on the Scheidegger curve. Diagram from NGU.

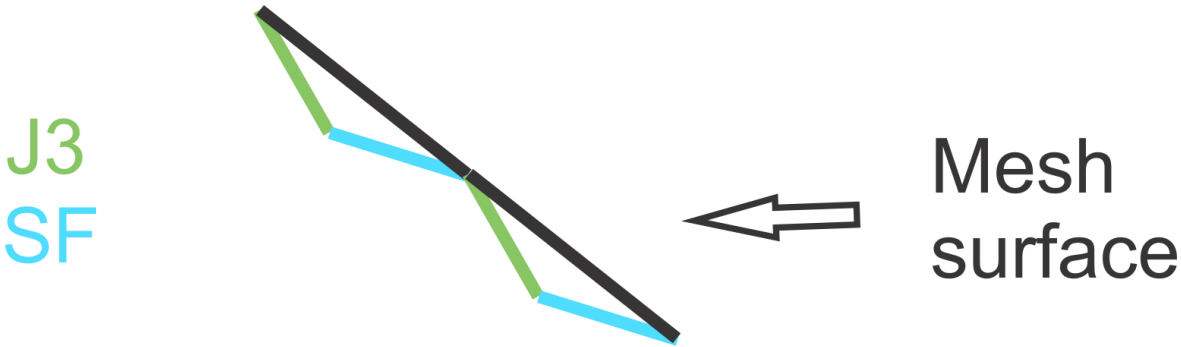
Figure 33 – Mesh surface missing structural planes (J3 and SF).

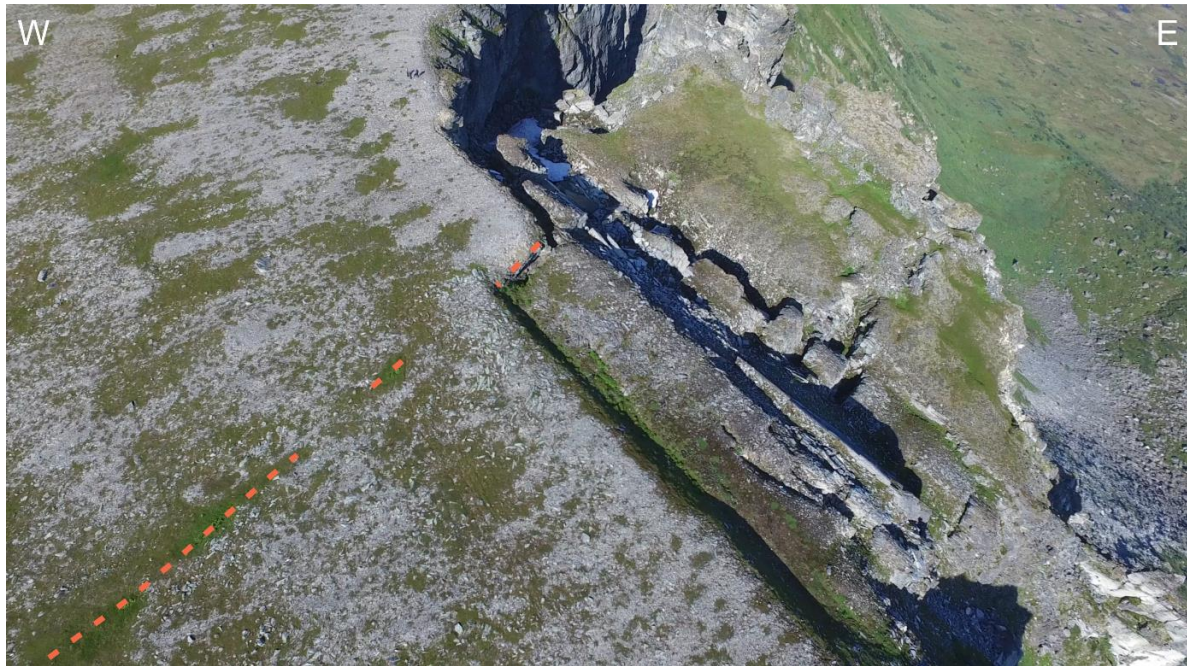
Figure 34 – Station 56. Drone photo. Morphological depression lines perfectly up with the backscarp.

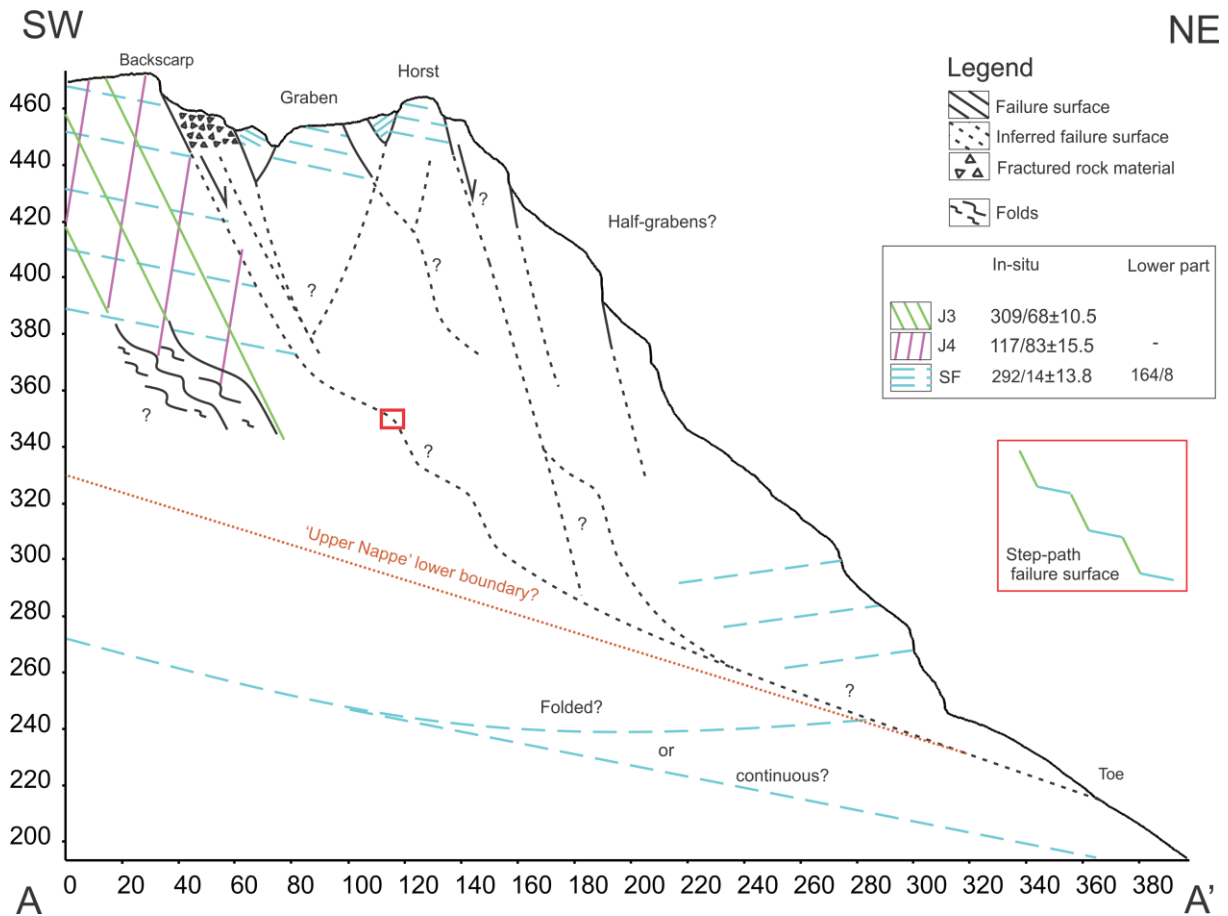
Figure 35 - Profile A-A'.
