# Structural assessment and characterisation of the rock slope failure at Skredkallen, Vannøya

*Structural analysis using field and desktop methods*

**Leif Trønnes**

*Master thesis in GEO-3900 May 2019*

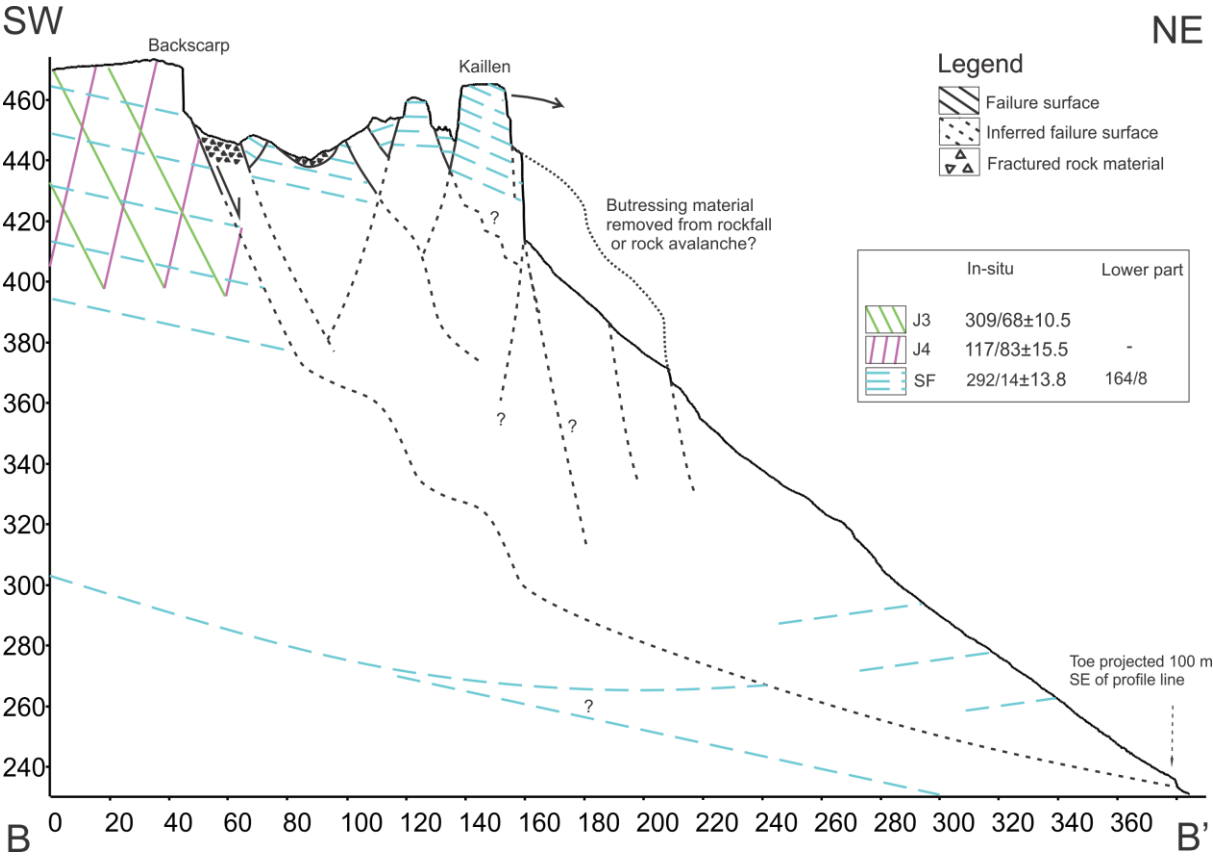
Figure 36 - Profile B-B'.

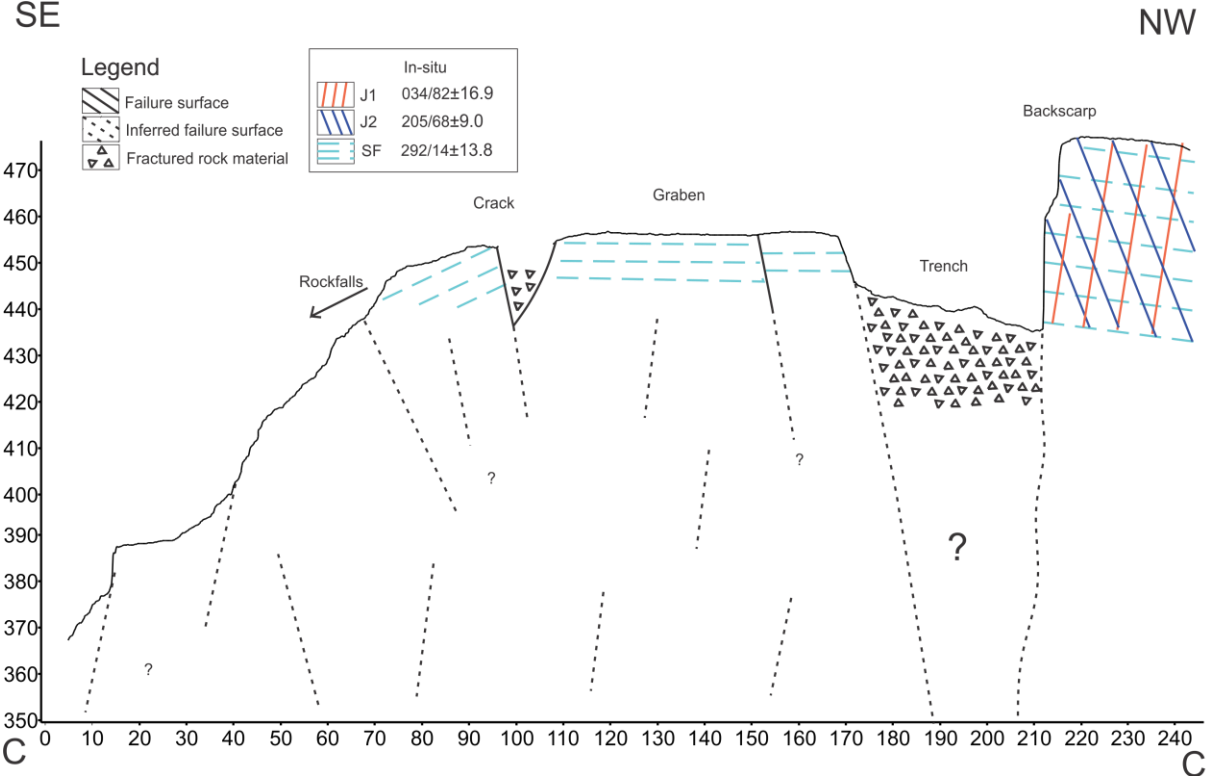
Figure 37 - Profile C-C'.

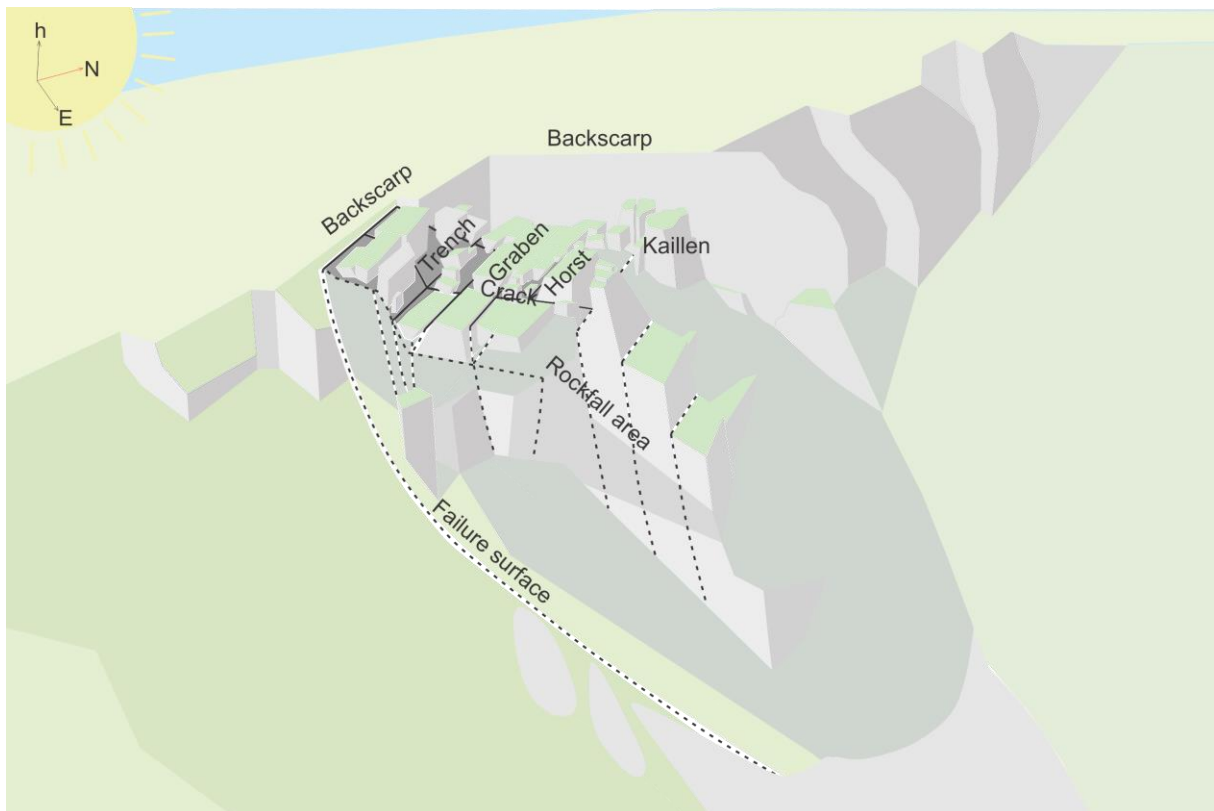
Figure 39 - Schematic 3D model presenting the main features of the URS.

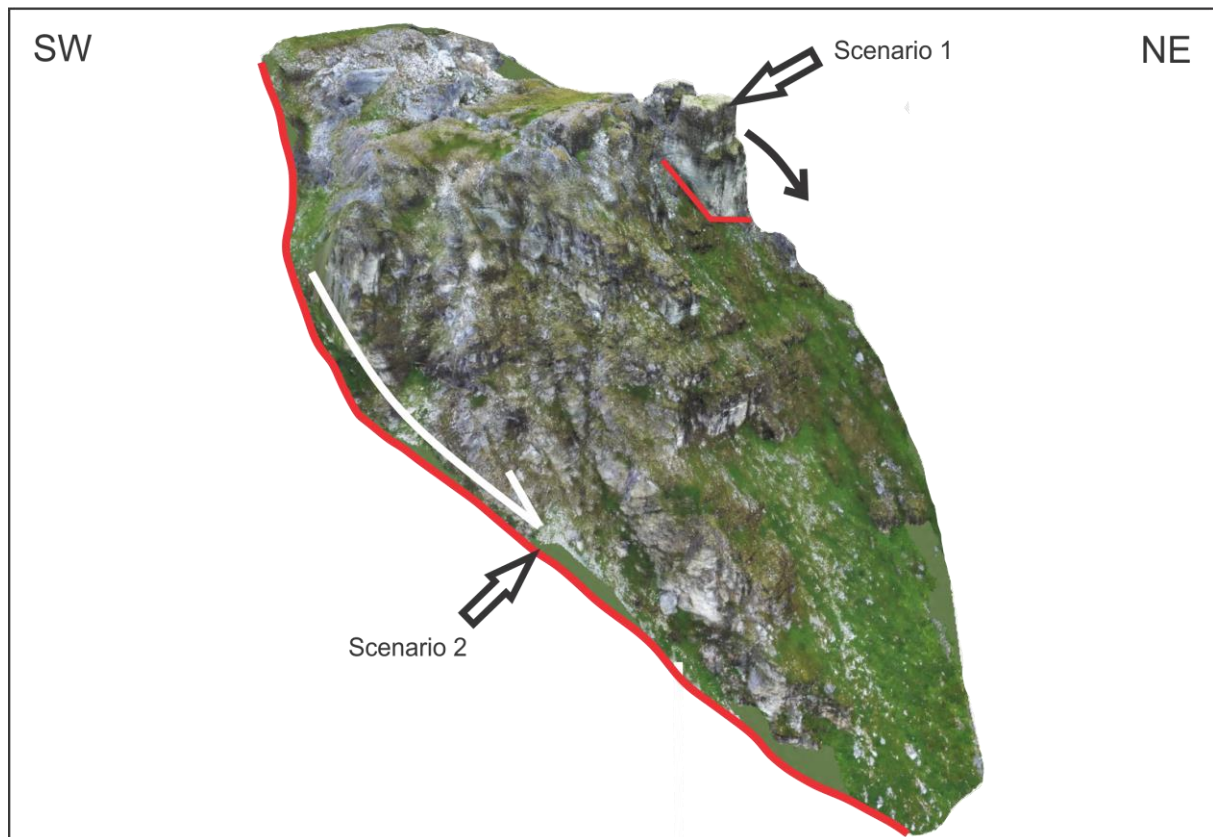
Figure 41 - Possible failure scenarios.

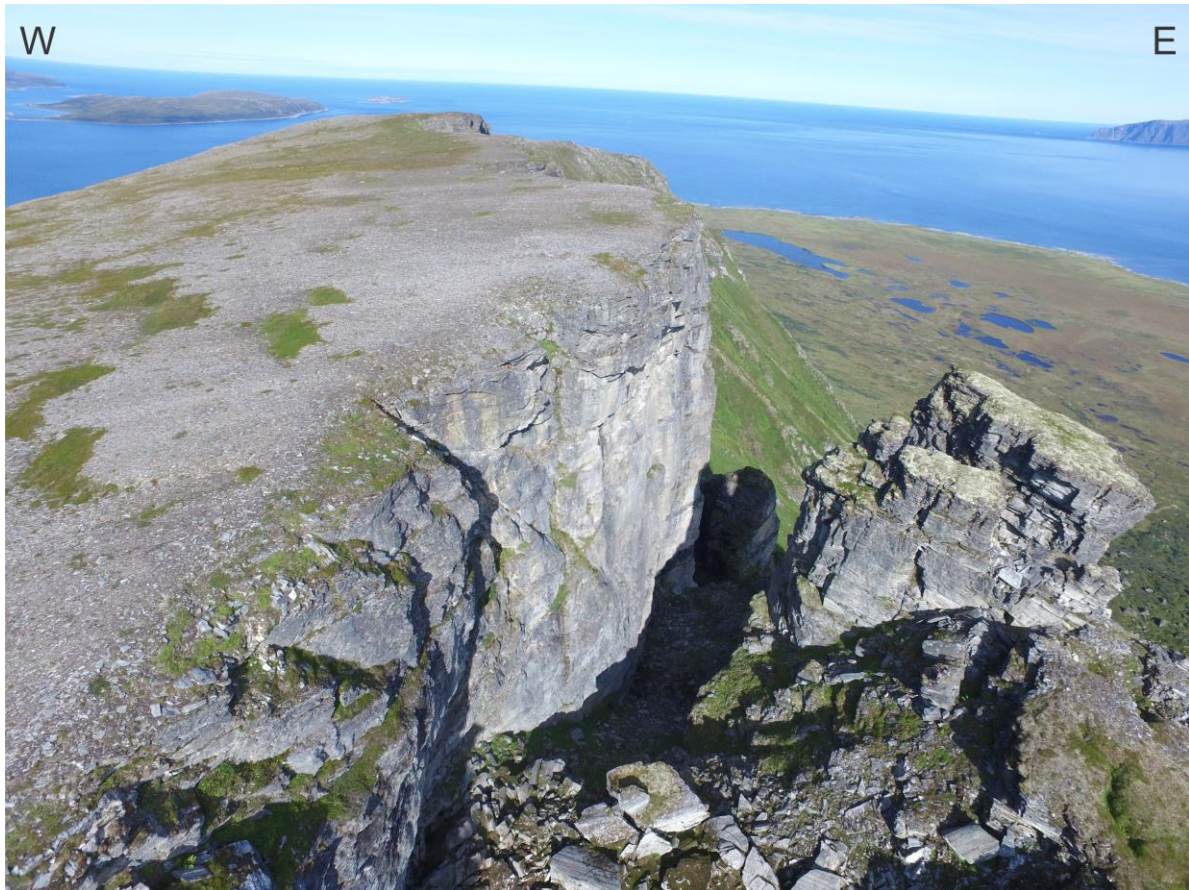
Figure 42 - Drone picture showing the dramatic tilt of Kaillen towards E.

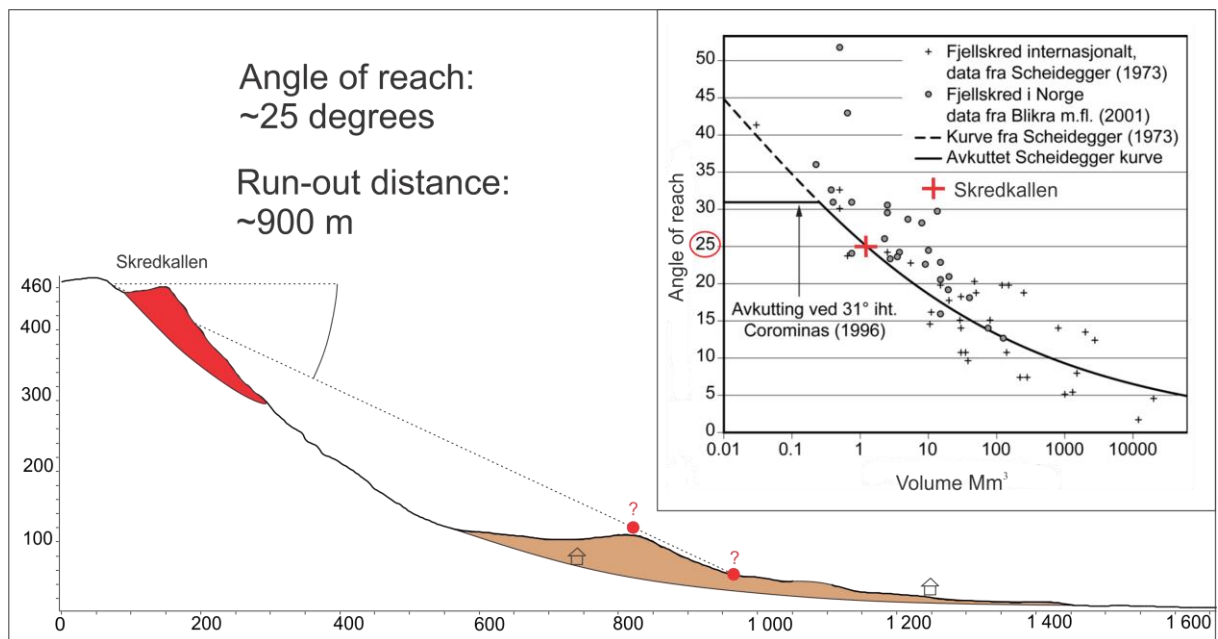
Figure 43 - Run-out distance based on the Scheidegger curve. Diagram from NGU.
