Evaluation of Probability of Failure of Static Equipment in Pressurized Mud Systems on an Offshore Drilling Installation

EOM-3901 Master's thesis in Energy, Climate and Environment – June 2015

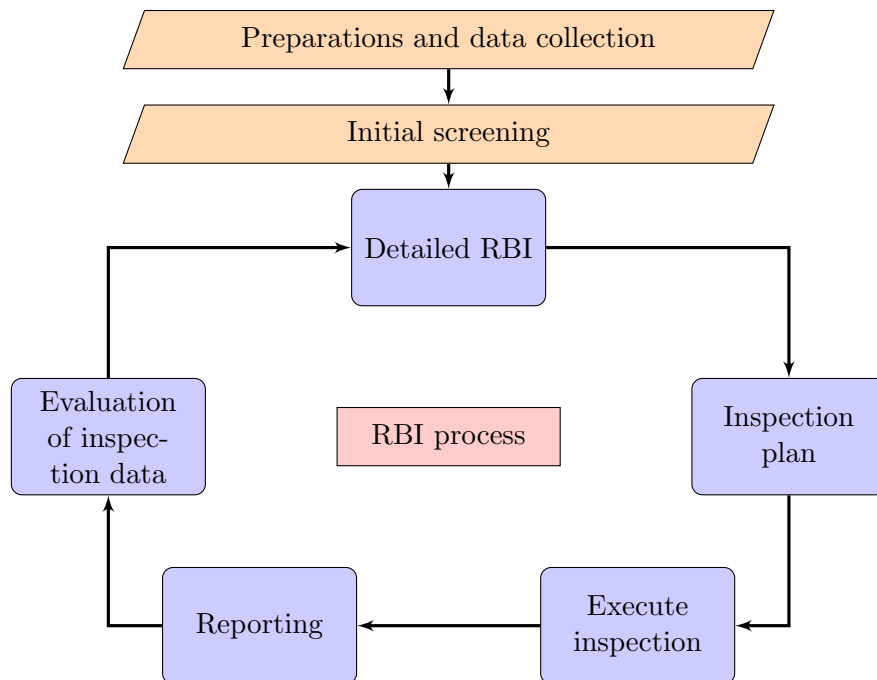
The RBI working process can be divided into several parts. The process starts with preparations and data collections and an initial screening. Then a detailed RBI assessment is performed and an inspection plan is established. After inspection is executed the data from inspection reports are evaluated and the RBI assessment is updated based on current data, and the process will repeat it self [DNV, 2010]. The process is illustrated in Figure 2.3, and further described in Section 2.4.

Figure 2.3: Illustration of Risk Based Inspection work process [DNV, 2010].

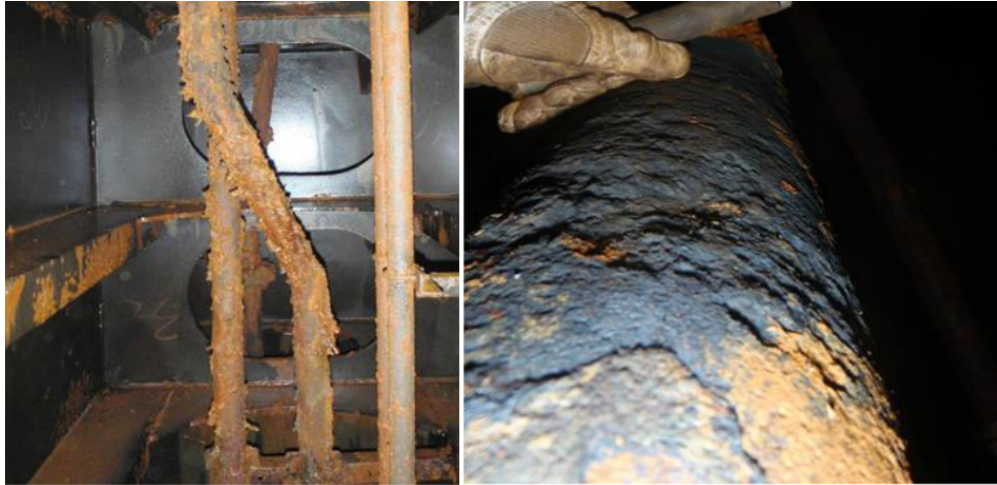
Ballast tanks are constant or frequent wetted and may experience higher corrosion rates than in normal weather exposed environment. In Figure 3.1 general external corrosion on pipes through a ballast tank is illustrated. The surface will become more uneven when the wall thickness loss is high.

Figure 3.1: Picture showing general external corrosion on pipes through a ballast tank. Rust scale is removed on the picture to the right. [Axess AS, 2015a]

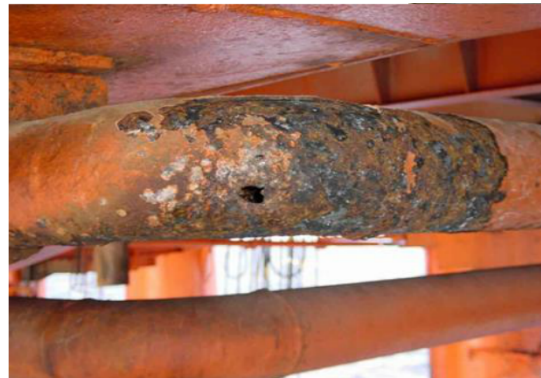
The main reason for the high corrosion rate could be the combination of high availability of oxygen and constant water wetting, in addition to non-galvanized lines. It is especially a problem on rigs older than 10 years [Axess AS, 2015a]. The corrosion rates will depend on the salinity of the water. Ordinary seawater has close to ideal salinity with respect to corrosion rate [Hasan, 2010]. Increase in salinity leads to an increase in electrolyte properties, but then the oxygen containment falls. In Figure 3.2 internal corrosion on a well test pipe is illustrated. Internal corrosion has led to holes in the bend of the pipe.

Figure 3.2: Internal corrosion on a well test pipe [Axess AS, 2015a].

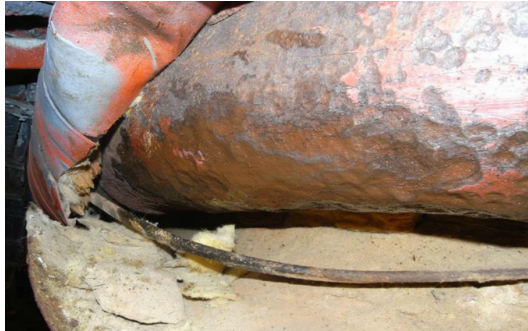
This is a corrosion form that takes place under insulation, often caused by wet insulation, damaged or missing coating and degraded seals on sheet metal coating. The rate of corrosion will be higher on warm pipework, 40 °C - 80 °C for carbon steel, and where salt is present [EI, 2008]. Lowered pH can also be a significant factor for development of localized corrosion for duplex and stainless steel. CUI appears locally and is therefore very difficult to handle [Axess AS, 2015a]. On drilling rigs, rockwool is often used for thermal and noise reducing purposes. Rockwool has the ability to absorb water and lead to a wetted steel surface [Wever and Kipp, 1998]. In addition, Rockwool can lower the pH of the absorbed water. Lines that often experience CUI is steam/condensate lines, exhaust piping, high pressure mud, firewater and well test lines. Indications of CUI can often be dripping and sagging insulation, pipe insulation in contact with deck plates, rust color wear coming from the insulation, damaged jacket allowing large amount of rainwater and sea water to run into lagging, and hot pipe surfaces [Axess AS, 2015a]. In Figure 3.3 corrosion on an insulated and head traced pipe is illustrated.

Figure 3.3: Picture showing an insulated and head trace pipe which have experienced CUI [Axess AS, 2015a].

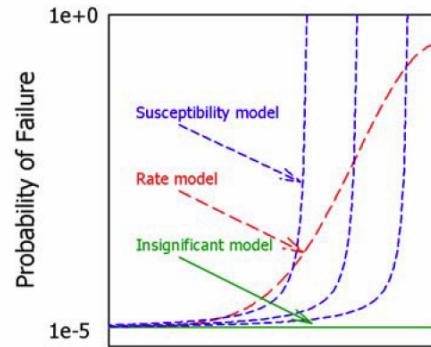
The rate model is used when damage results in local or general wall thinning of the component. The model assumes that the damage increases with time and resulting in general wall thinning, meaning that the PoF increases with time. Material properties, wall thickness, fluid properties and operating conditions will be influencing factors. A simplified rate model can be described by distribution type, mean and standard deviation. To fit the rate model to the actual situation, inspection data can be used. For normal distribution, Monte Carlo Simulation can be used to determine PoF. The PoF will be dependent on wall thickness and the allowed corrosion.

Figure 4.1: Models used to estimate degradation DNV [2010].

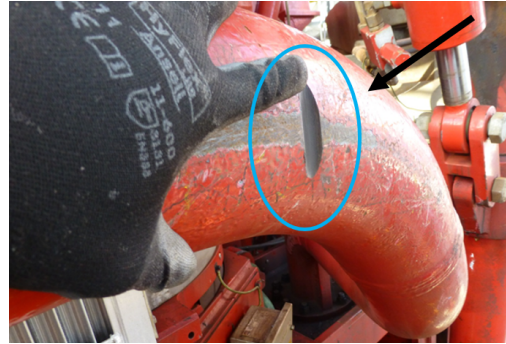
In those areas it often tends to be rough handling of material and equipment. During drilling operations the drill floor can be quite busy and quick solution is often chosen to get the job done. In the derrick there are several tugger wires used for lifting purposes. These can often interfere with piping going to the drilling machine and lead to external wear. It is observed several cases with major external wear. The s-pipes and goose necks are the pipes that are most prone to such damage and local loss of wall thickness can be up to 5mm. In Figure 5.6 a picture is illustrating a s-pipe that has been exposed to major external wear Axess AS [2015b].

Figure 5.6: S-pipe with external wear.

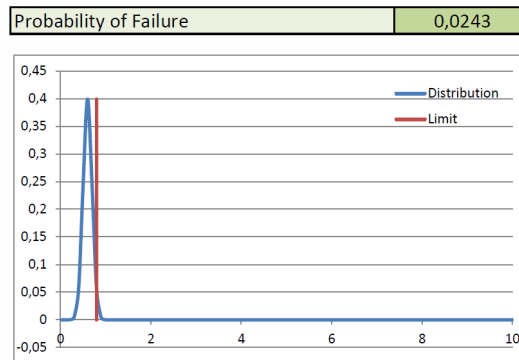
Figure 6.2: Output from simulation of probability of failure based on mean corrosion rate, allowed corrosion and standard deviation in a normal distribution [Singh, nd].

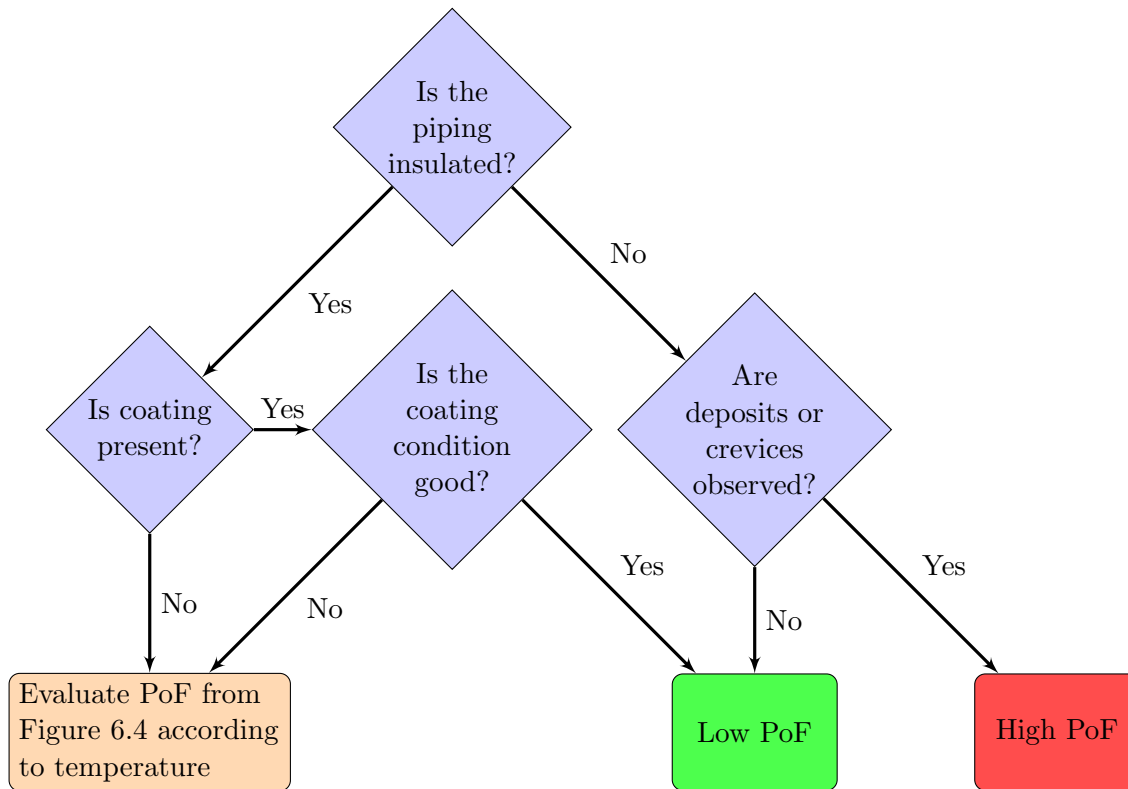
1. If there are no insulation present, the probability of failure will normally be at a low level, with a probability of failure of 10^{-4} per millimeter of wall thickness. The effect of coating is here not considered, since it will just lower the probability. Nevertheless, if crevices or deposits are observed, further investigations are needed and the probability is set at a fixed high level.
2. If the piping is insulated, the effect of coating must be considered. If coating is present and in good condition, the probability of failure is low.

Figure 6.3: Flow chart illustrating the process for evaluating PoF due to external corrosion of stainless steel.

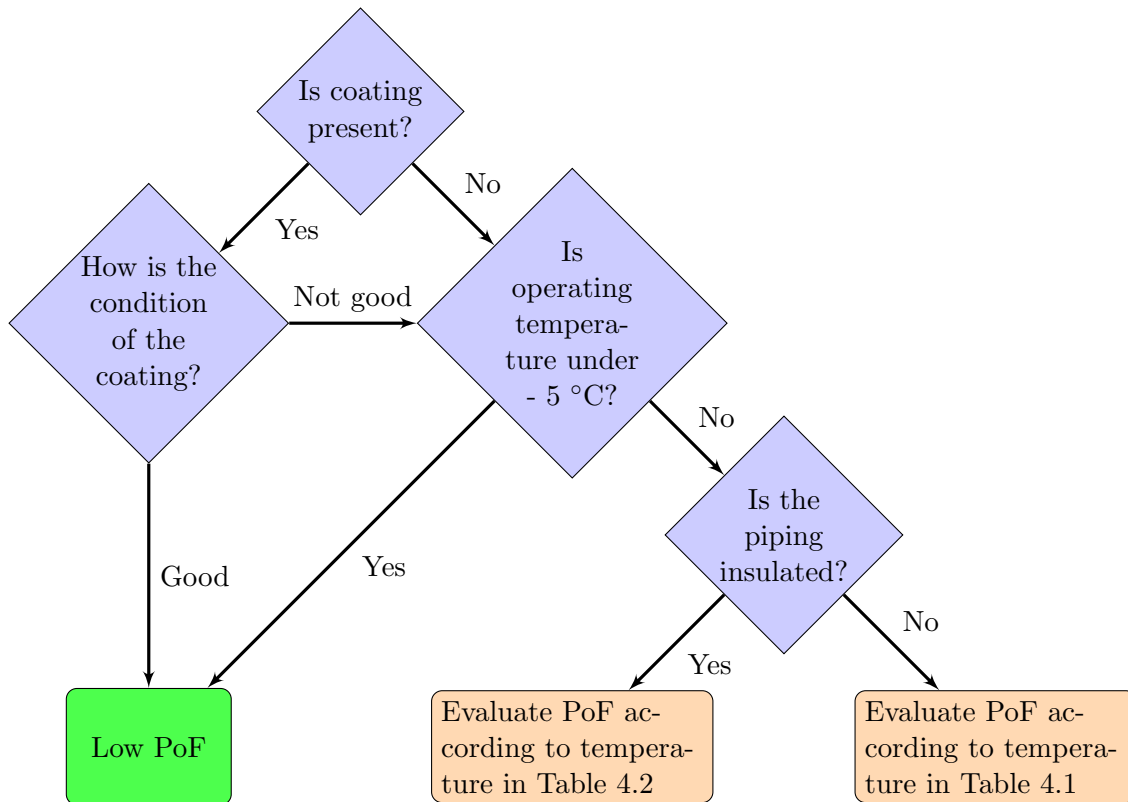
Figure 6.5: Flow chart used to evaluate PoF for carbon steel exposed to external corrosion.
