Rockfall hazard assessment based on semi-automatic point cloud analysis from UAV data

Karin Bergbjørn

Master's thesis in geology GEO-3900 - December 2018

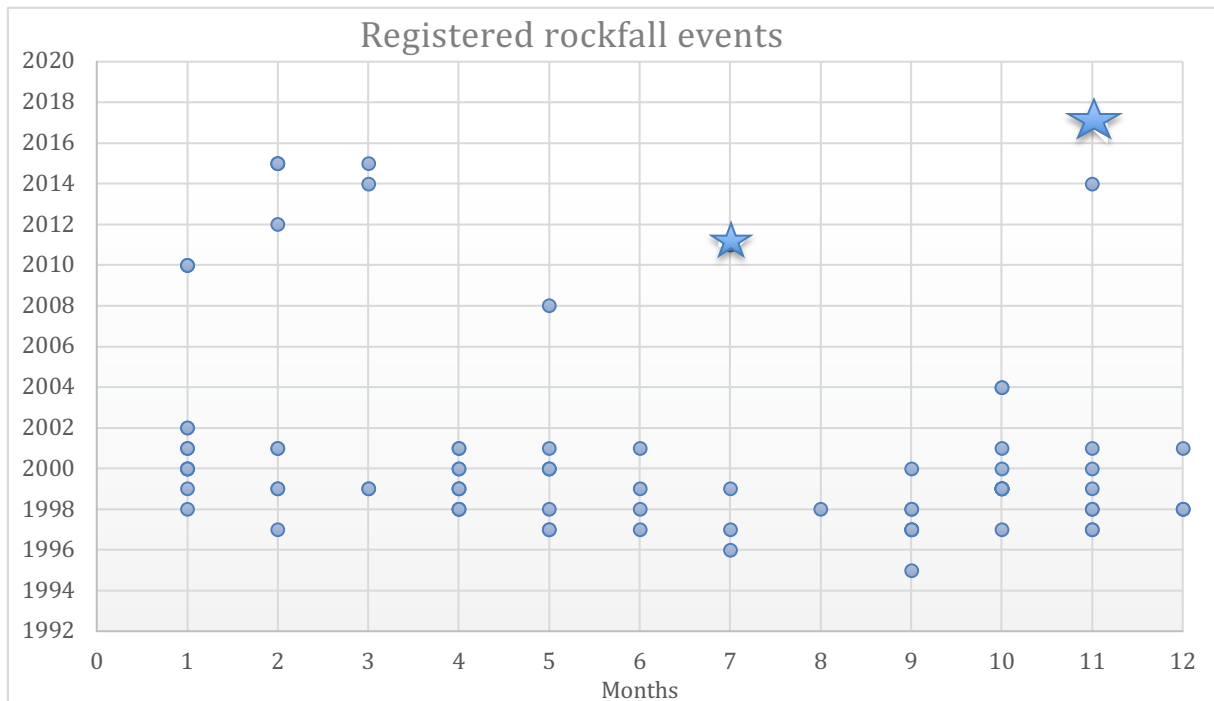
Hazards reaching the road, sorted on only rockfall, from SVV (Fig. 16) contains observations about the source area (Fig. 17) (in total 14 observations), only one of the sources for rockfall is higher than 200 m in altitude, meaning that most of these rockfalls are released from low on the rockwall. Out of 123 registered rockfall events, 18 of them has resulted in closure of the road.

Fig. 17 Registered rockfall events displayed over months and year, stars mark the two major events of 2011/17. There were more registered events 1997-2002, which is a result of logging differences, and so is also the gap between 2004-2008. There seem to be a trend of less rockfall during summermonths.

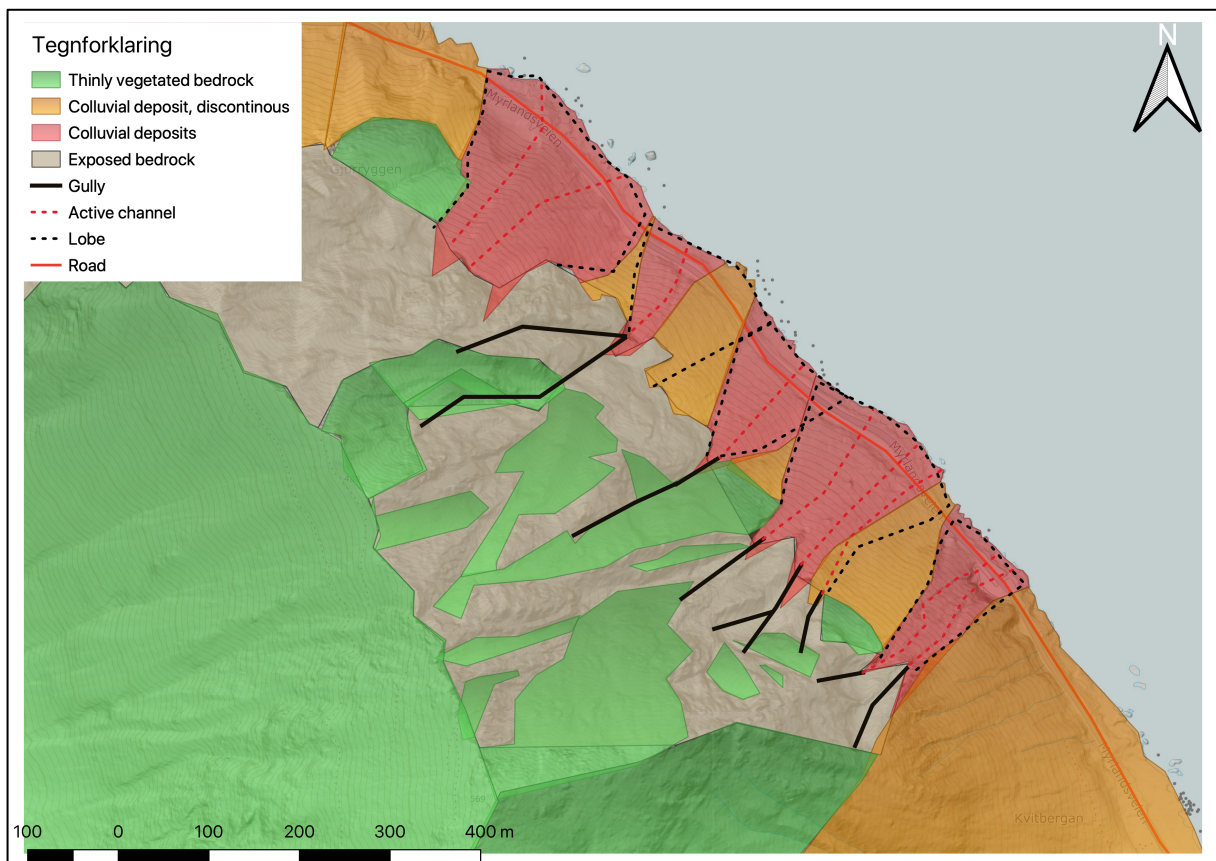
Fig. 31 Geomorphological map of Slettind. The colluvium covered slopes ranges from sea level to 200 m. a. s. l. There is little deposit on the slopes, suggesting that most deposit crosses road and reaches the sea.

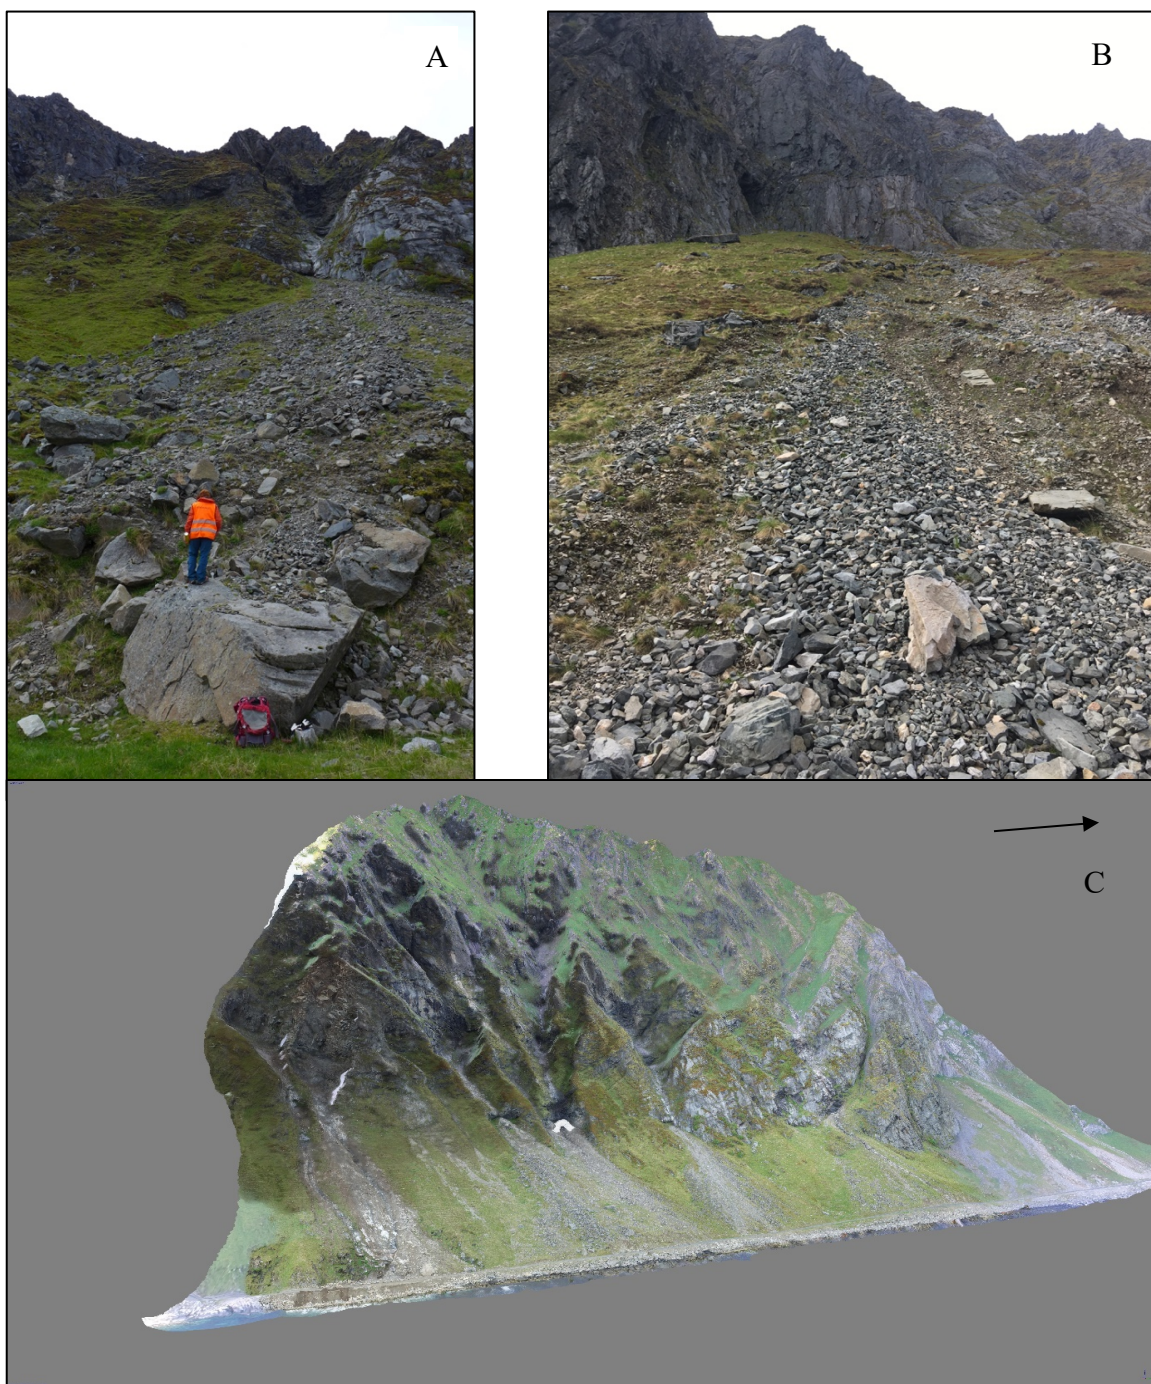
The spires and ridges of the NE slope are blocky, and there are no compact rockwall at the site. The joint sets divide the rock into smaller blocks that look like they are balancing on top of each other, and the spires have many minor scars from recent rockfalls. From 350 m. a. s. l. the slope becomes vertical and the vegetated shelves stop. The funnels surpass into successive overhangs of bare rock (Fig. 32), before reaching the colluvium fans.

Below the rockband the ground cover consists of colluvium fans, and thin, discontinuous debris (Fig. 32). The fans are steep (30-40°) and reach to sea level, suggesting that all larger rockfalls or avalanches cross the road and reach the sea. The sizes of these large boulders are from 2x2 to 4x4 m.

The colluvial fans success along the mountain and are at some places difficult to separate. There are clearly defined, eroded, debris channels, but no levees. Most large boulders reach the ocean and are visible in the sea at low tide, and the toe of the colluvium fans are visible under water on aerial photographs. Smaller rocks are dispersed on the slope (Fig. 32) the channels and are sorted, coarsening downwards. The blocks are angular, and somewhat aligned in the falling direction. The fans display layering, suggesting episodic events have formed them.

Fig. 32: Photos showing cliff section and various colluvial fans and debris. A) Colluvial fan with thin talus cover below the main bed rock cliff. Fan deposits have internal layering, mostly small rock fragments at the surface, suggesting that larger boulders have travelled further. C) 3D model of the entire hillside slope of Slettind, made from Agisoft. Note the many debris fans along the lower part of the cliff section.

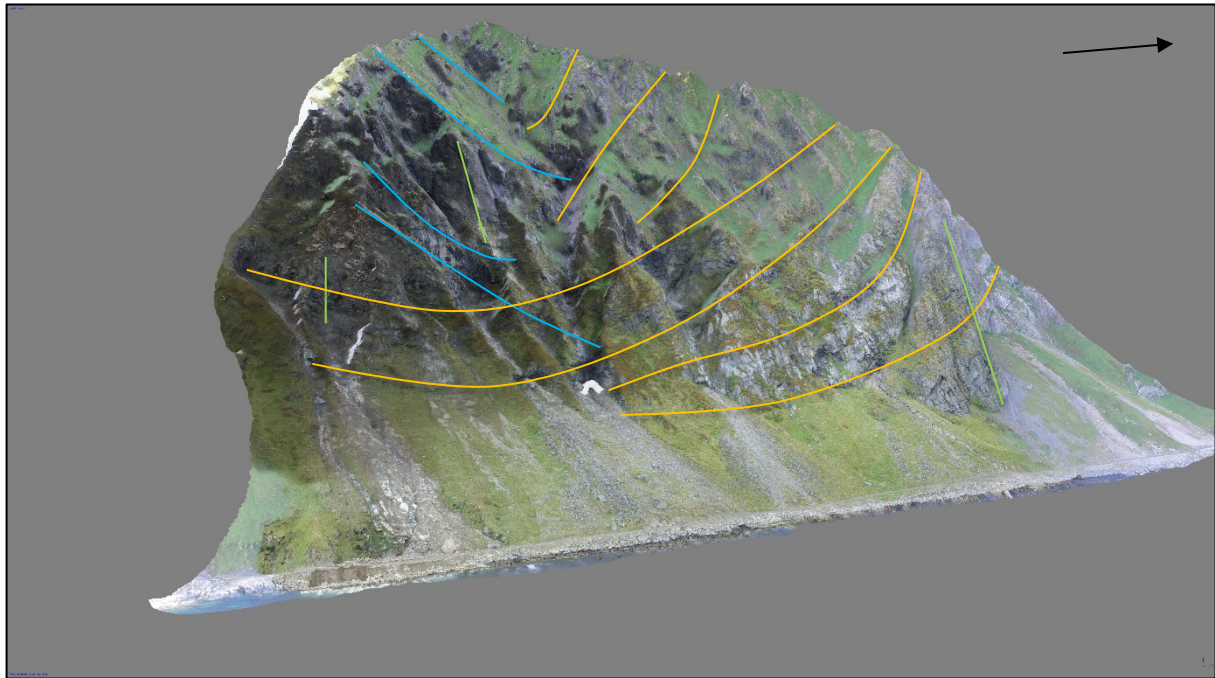
The 3D image of the steep mountain side at Slettind (Fig. 35) displays many detailed structures, and the high resolution of the image makes it easier to identify structural elements and their orientations compared to a 2D-map. The main bed rock foliation of the mangeritic gneisses is well outlined in the image, as alternating benches/layers of felsic and mafic units and dipping gently to the south (left in image). The foliation is parallel to a set of more steeply, south-dipping fractures (J1). In addition, the triangular, or wedge-shaped ravines and gullies, and corresponding ridges shelves aligned parallel to the J1 set, and a second lineament set (J2), are clearly visible. These structures are dominant in the southern and northern parts respectively. The third (J3) lineament set follows the hillside slope direction, and thus, is not well seen.

Fig. 35 Main structures marked (lines follow the dip of the structures) with orange, a steep north-south dipping feature, and blue, a low-angle north-dipping structure. Green marks the steeply dipping slope parallel lineament.

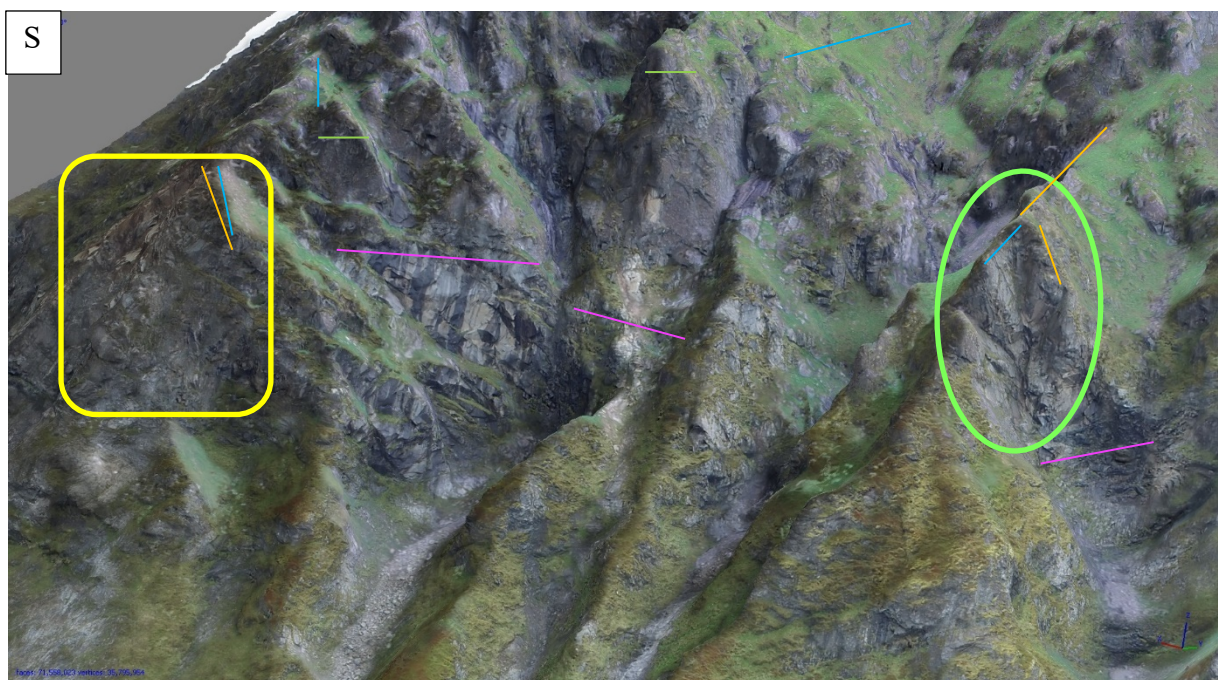
On a closer view at the 3D model (Fig. 36) the outline of the three different lineament sets are visible. In particular, the orientation of the first and second lineament sets (J1-J2), when they interact in outcrop, creates wedge-shaped structures.

Fig. 36 Detail map view from NE, outline of the 3D image in fig. 35 showing the source area of 2011/17 within the yellow box, and main structures marked by green, orange and blue lines following the strike. Foliation is marked in purple. The green circle marks a defined triangular shape.

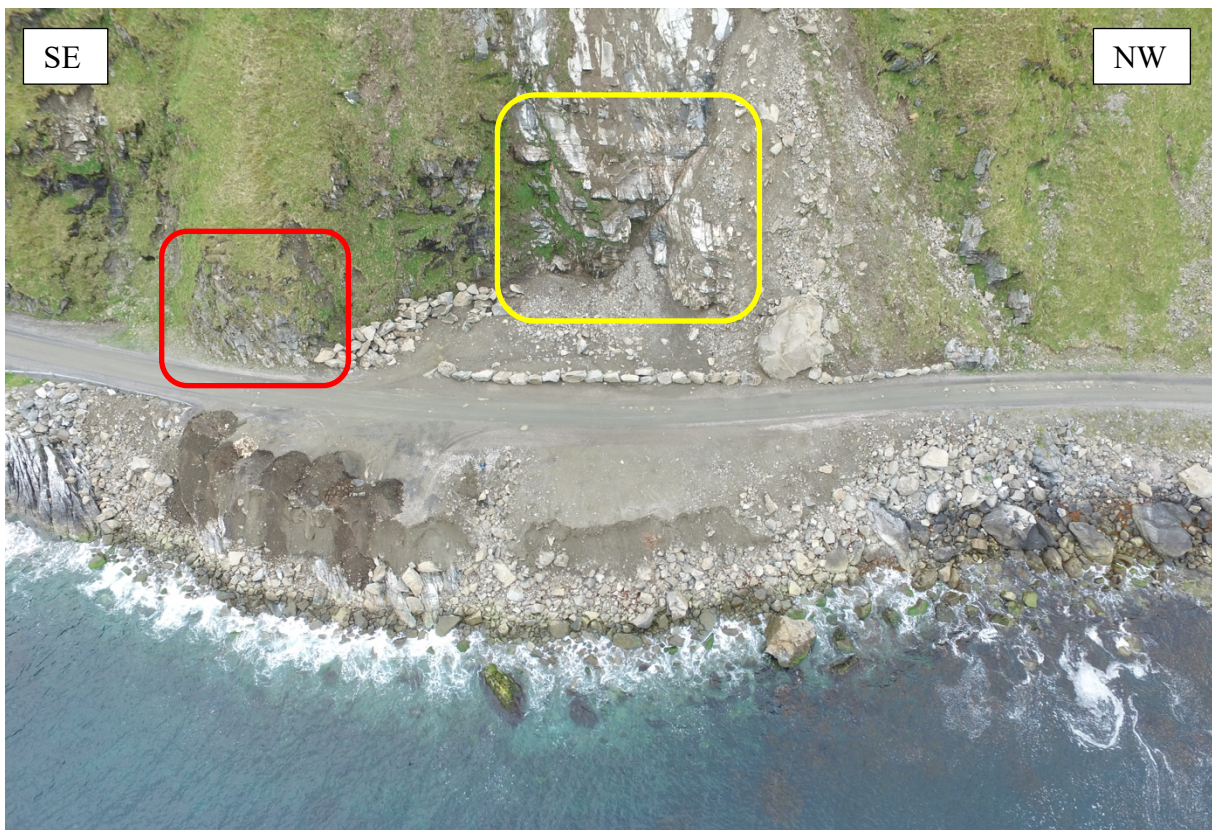
The roadcut is six meters high and surrounded by a thin layer of soil on talus from the rockfall and avalanches. Location 1.a is a roadcut that has been affected by blasting and 1.b is bedrock exposed by the regular rockfalls (Fig. 38 and 39).

Fig. 38 Picture showing an overview of the first outcrops. Location 1.a is within the red box and location 1.b within yellow box. Joint sets J1, J3 and J2 are visible in the picture. Picture taken with the UAV

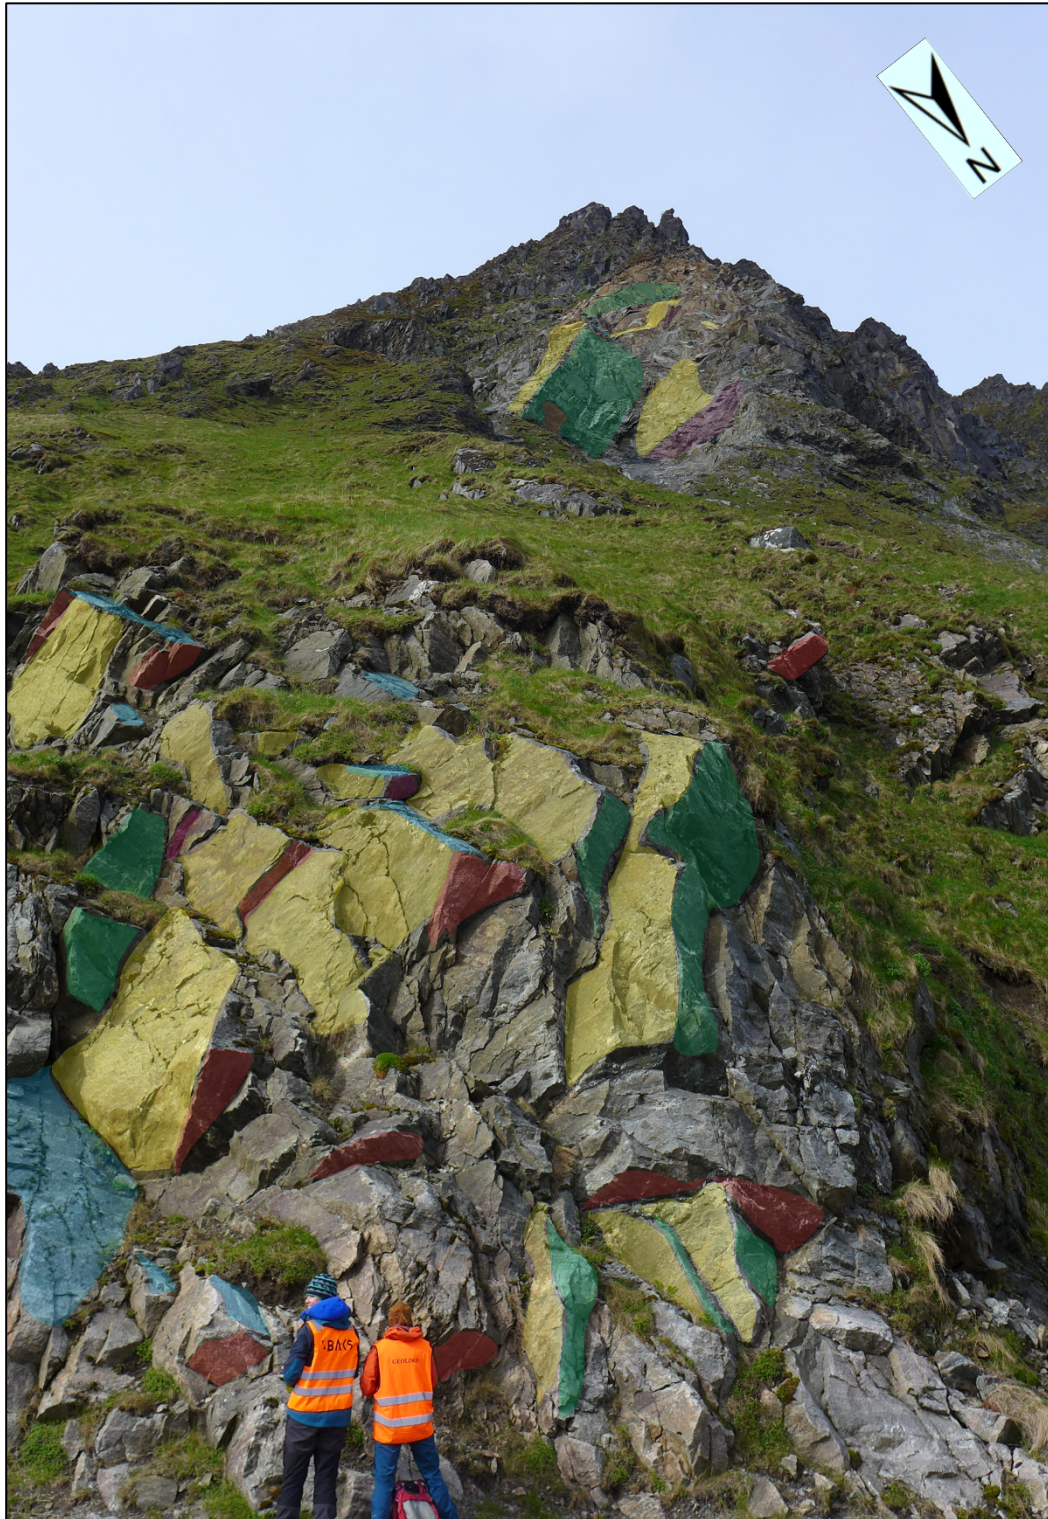
Fig. 39 Outcrop with numerous brittle fracture/joint at location 1, are marked in different colors according to their joint sets. Joint set J1 (yellow) facing towards E, joint J2 (blue) towards NE, joint set J3 (green) towards NE and foliation (red) towards SW. Private picture, 2018.

Three very clear joint surfaces intersect in combination with the foliation plane that dips SW about 60°. The sets have steep dip directions both to the NE and E, whereas the daylighting foliation plane dips SW and creates overhanging surfaces (Fig. 39). The bedrock is prone to toppling, wedge and planar failures with brittle joint fractures and smooth planes (Fig. 40).

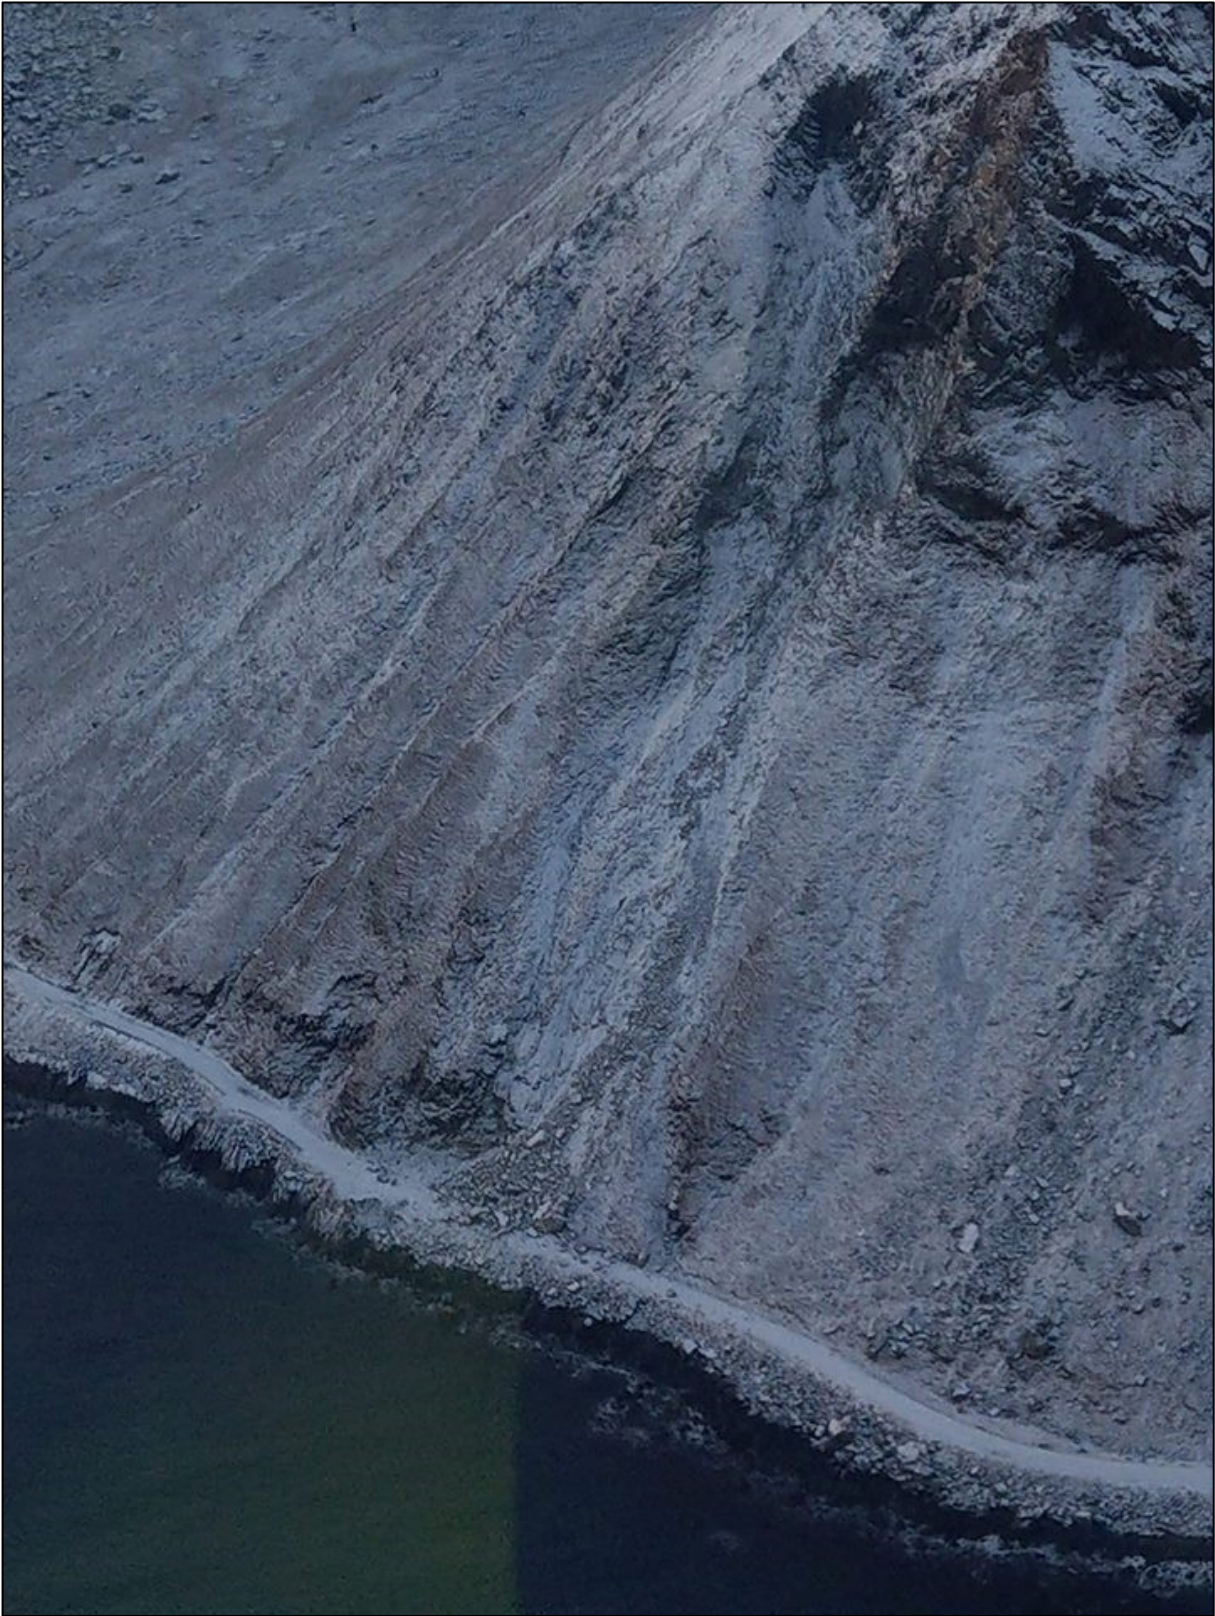
lineament is parallel to Nappstraumen and similarly oriented fjords in westernmost Lofoten. At Slettind the largest structure is the southern major wall dipping towards SE at the end of the ridge (Fig 64) and seen at the release area as the steep, straight and continuous lineaments (Fig. 65). They all show a straight to right-stepping geometry, where individual fault traces die out or breach along strike.

Fig. 65 Photograph from SVV, taken in helicopter of the release area 2011/17. The structures affecting the release area is really well seen from this angle and J1 and J2 is easily identified continuously through the entire rockslope. The similarity between J1 and the SE wall in the background (barely seen) is striking. Three minor surfaces of J3 is also shaping the area. Note the deposit from rockfall on the road.

The interacting between the N facing and E/SE facing surfaces creates low angle E facing dihedrals (Fig. 65). The low angle north facing shelves (J2) are grasscovered and free from debris but expose the steeper J1 (E/SE facing), that shows a blocky and heavily jointed surface, most likely similar to the outcrops with the fracture frequency of 1 m persistent joints for $<1 m^2$.

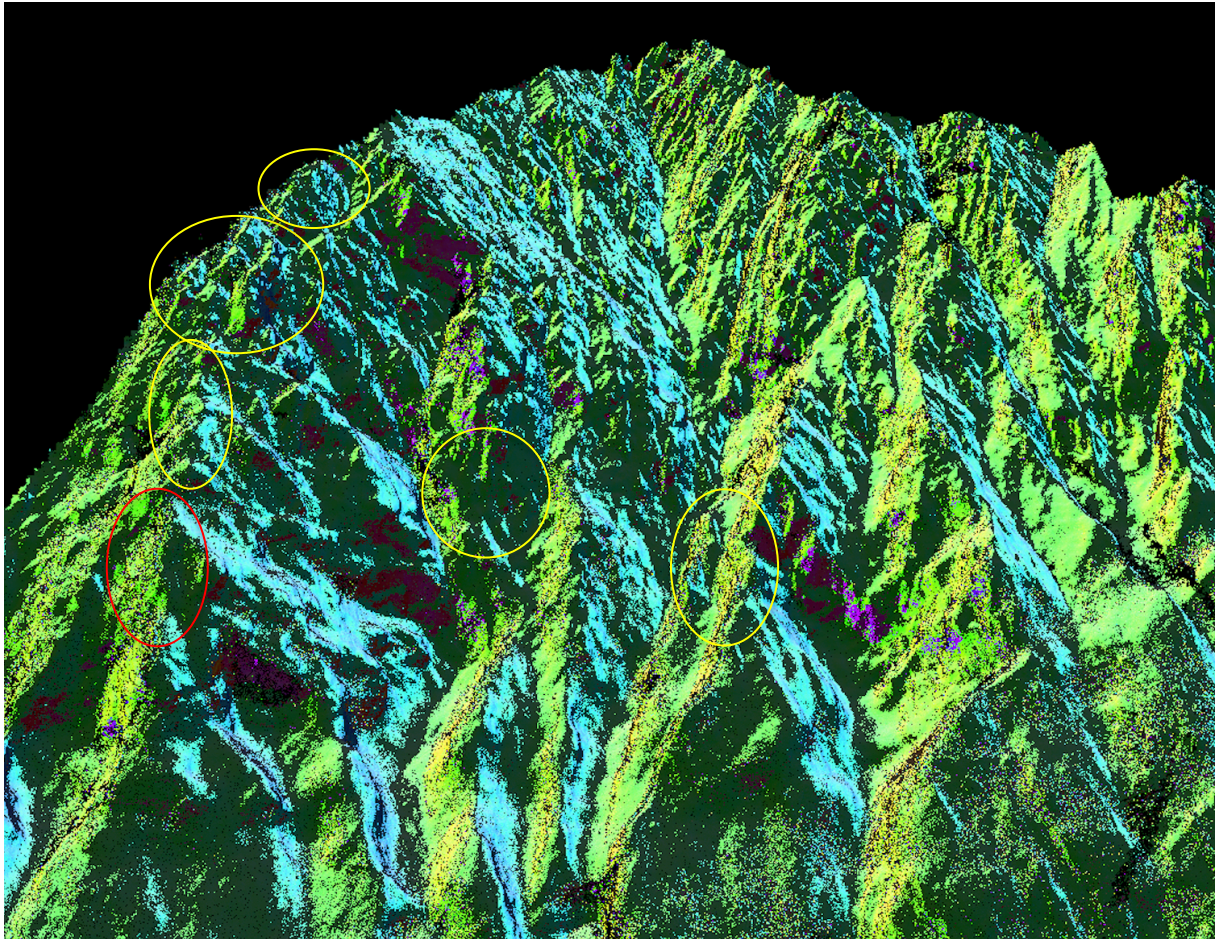
Kinematic analysis done in Dips shows that wedge failure is by far the most common failure mechanism, with 26% of critical vectors, failing between J1 and J2. The line of intersection and slope direction indicates that J2 act as sole sliding plane with failure towards N (i.e. 340° NWN), This means that failure is not along the large dihedrals that has a line of intersection towards E.

The sliding plane of J2 is low-angle and normally not usual to consider a critical sliding plane (field measurements: 20-30°) overcoming the friction angle of gneiss (27-34°). Reviewing the results in Coltop3D, it suggests that J2 is steeper than results from field measurements (29-46°). A change in lithology between the field locations and the release area, might be an explanation for this slight difference in inclination. The 3D model and photographs however clearly show a low-angle J2, well corresponding to the inclination of field measurements and observations. This indicates the presence of a triggering factor provoking failure along surfaces that normally wouldn't be suspected to slide.

Fig. 66 Highlighted surfaces corresponding to mean surfaces of J1 (lightblue) and J2 (yellow/green). Red circle indicates release area of 2011/2017 and the area is still unstable. Yellow circles indicates areas with identical failure mechanisms.

The weather statistic and reports available indicates that the event in the summer of 2011 was related to heavy precipitation in early summer (after snowmelt), while the event of 2017 followed a period of cold weather and snow and suddenly milder temperatures with rain. A triggering factor in this case was a combination of freeze/thaw dislocations and reducing of the friction angle by water.
